2015 - 2018 Corvette: Shift Concerns on 8-Speed Transmissions

November 29, 2023

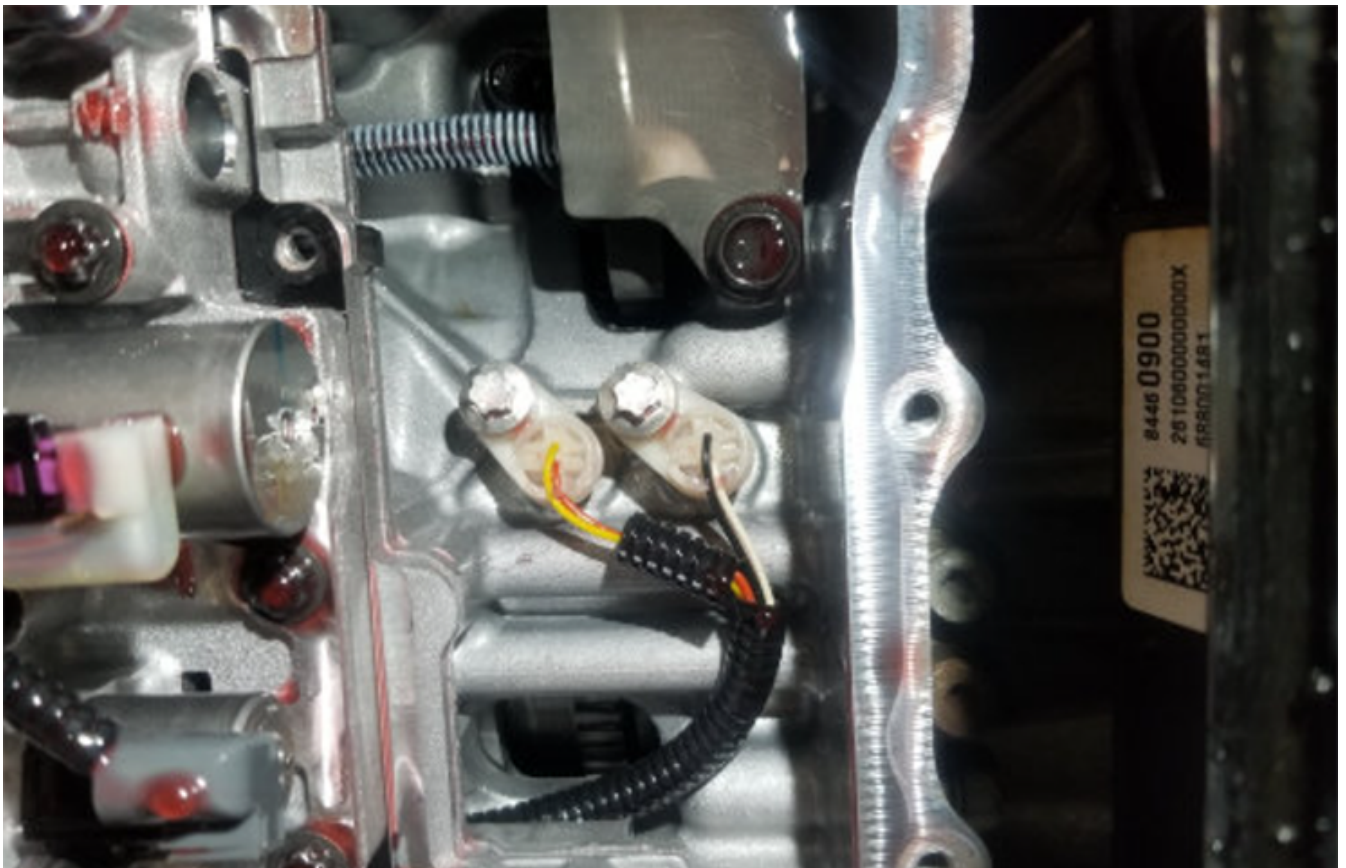
Fig. 7

In addition, if the speed sensors were recently replaced and the Transmission Service Fast Learn fails for excessive vehicle speed, or if DTCs P0717, P0722, P0746 and/or P0796 also set, inspect the speed sensors for the proper orientation. When correctly installed, the smaller portion of the sensor conduit should be facing the rear of the unit. (Fig. 7, Incorrect; Fig. 8, Correct)
