2015 - 2018 Corvette: Shift Concerns on 8-Speed Transmissions

November 29, 2023

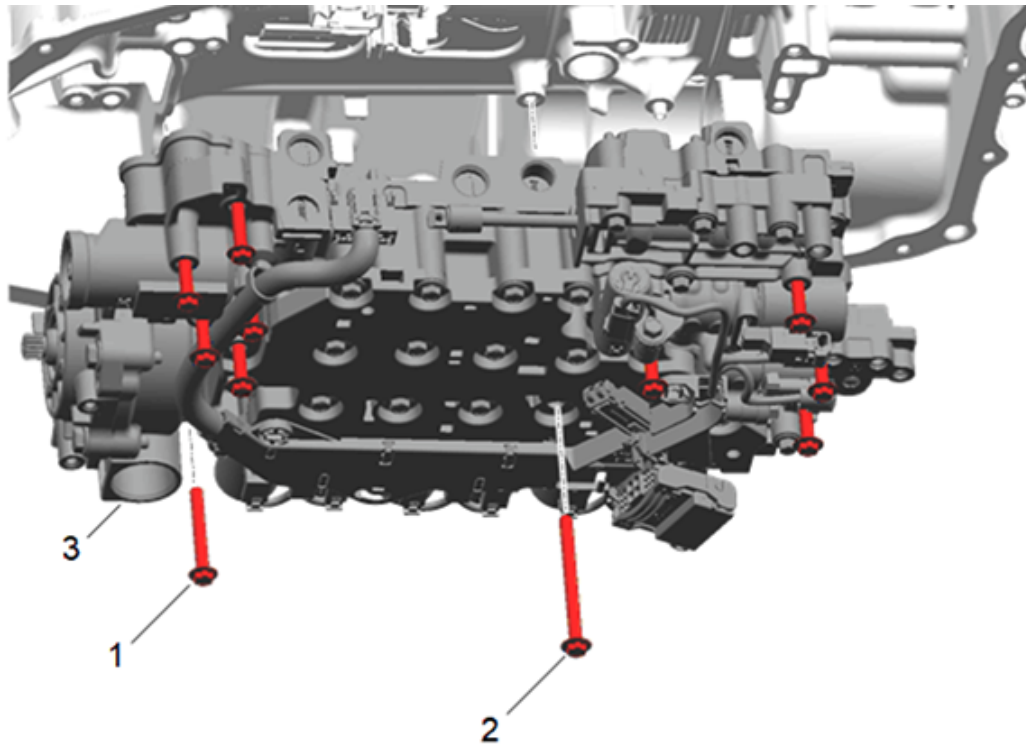
Fig. 6

On vehicles with greater than 3,000 miles (4,828 km), or vehicles that may have objectionable shifts once the adaptive learning procedures in Bulletin #16-NA-019 have been completed, remove the transmission pan and inspect for any debris. If there is not an unreasonable amount of debris found, based on the mileage of the vehicle, replace the valve body. (Fig. 6) After installing the valve body, complete the procedures in Bulletin #16-NA-019.

If there is excessive debris in the transmission pan, or the condition remains following the valve body replacement and after performing the adaptive learning procedures, remove the transmission and inspect and reset the clutch pack travel as necessary.
