2020 - 2024 Corvette: Front Fascia and Headlight Adjustment

November 20, 2023

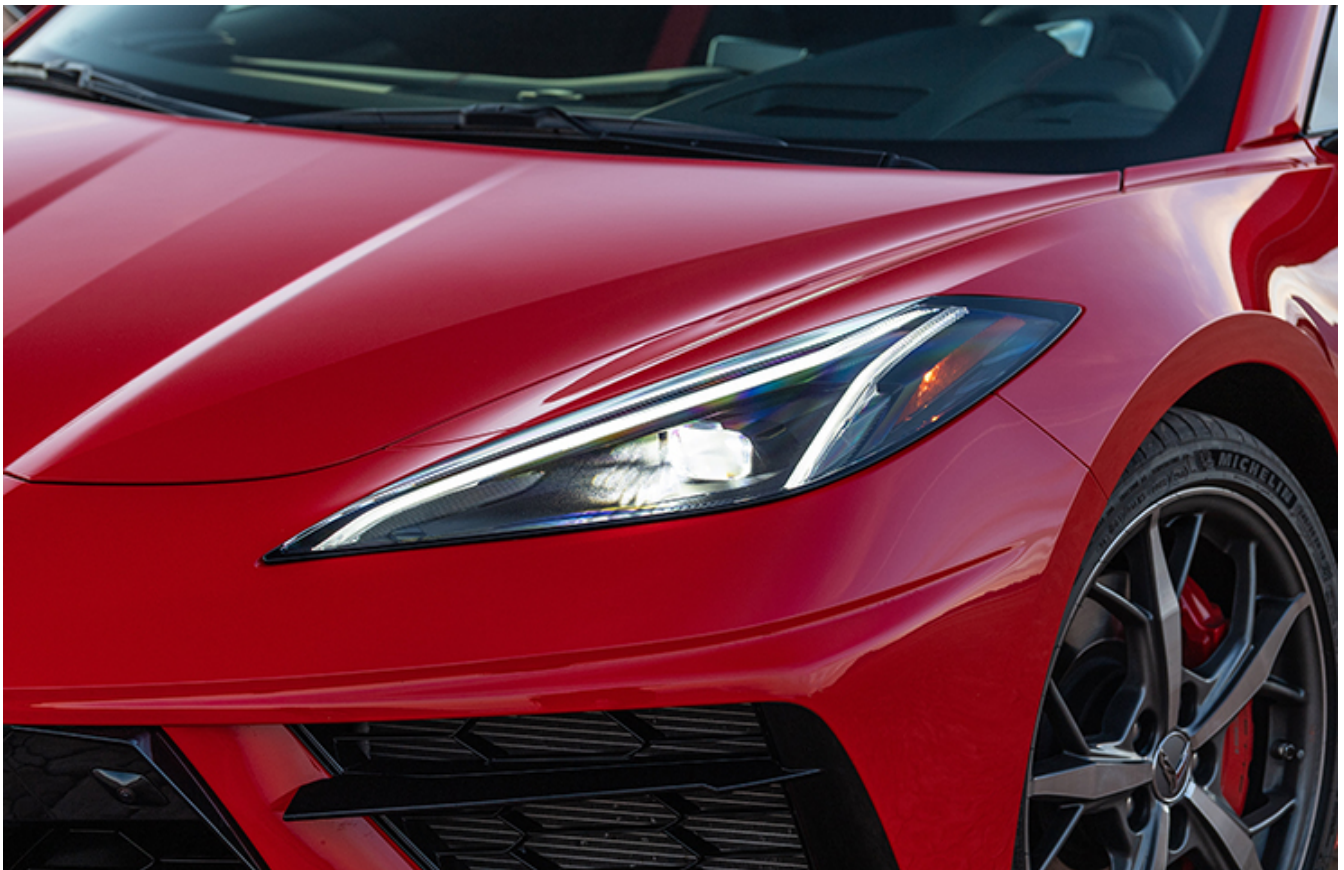
Fig. 9

The paint may have chipped or peeled on the front fascia or fender-to-fascia body seam on some 2020-2024 Corvettes. (Fig. 9) The paint chip may be due to the headlamp being positioned too tightly to the body panel. The fit between the front fascia and fender also may be too tight on the same vehicle.
