1984 Corvette: Campaign: Power Steering Pump Pulley Failure

Number: 84C03

Date: 1983

Subject: P/S Pump Pulley Failure

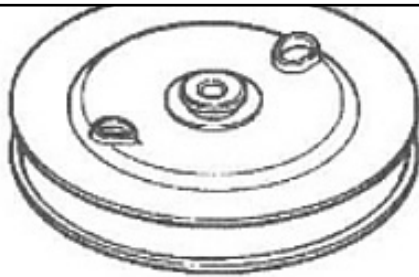
DISCONTINUED
PULLEY

General Motors has determined that certain 1984 Chevrolet Corvettes are equipped with power steering pump pulleys which may crack at the outer edge. Continued operation may cause the pulley to break, resulting in loss of the drive belt. If the pulley cracks, vehicle occupants should be alerted by a rattling sound coming from the engine compartment.
