# 2014 Corvette: Techlink Article: Corvette Driveline Support Alignment

**Source:** GM TechLink

**Date:** December 5, 2013

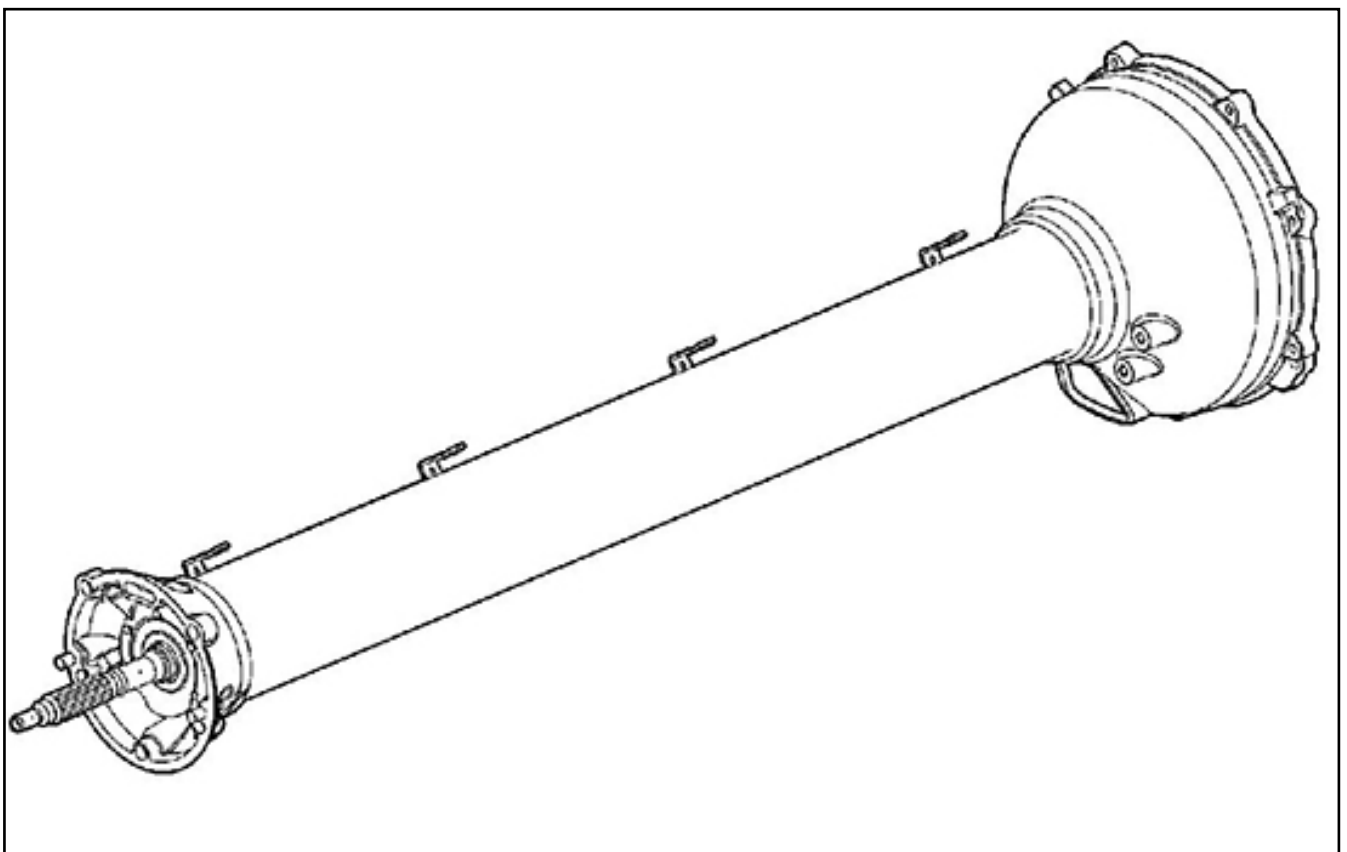
**Fig 7**

If the driveline support (torque tube) is removed from the 2014 Corvette for any reason, special care must be taken to make sure the propeller shaft splines are in alignment with the front hub bearing. The Driveline Support (Fig. 7) must be aligned with the engine bell housing before attempting to tighten any attachment bolts.

**TIP:** The propeller input shaft front bearing positioning system is designed to withstand an insertion force of no more than 582 Y (130 lb). If the

fastening bolts are used as an installation method, it may create force above this amount and damage the crankshaft thrust bearing.

When reinstalling the driveline support, the angle may be slightly off horizontally or vertically. This can make the driveline support difficult to align. Do not use the bell housing attachment bolts to draw the driveline support tight against the bell housing. Any small amount of misalignment may cause the input splines of the propeller shaft to catch on the crankshaft, driving it forward. If the engine is started in this condition, it may cause the crankshaft thrust bearing to be immediately worn, necessitating engine replacement.

Refer to the appropriate Service Information for complete procedures on alignment and installation of the driveline support to ensure that the propeller shaft is properly aligned to the front hub bearing.
