2014 Corvette: Techlink Article: Tire Chatter

Source: GM TechLink

Date: December 5, 2013

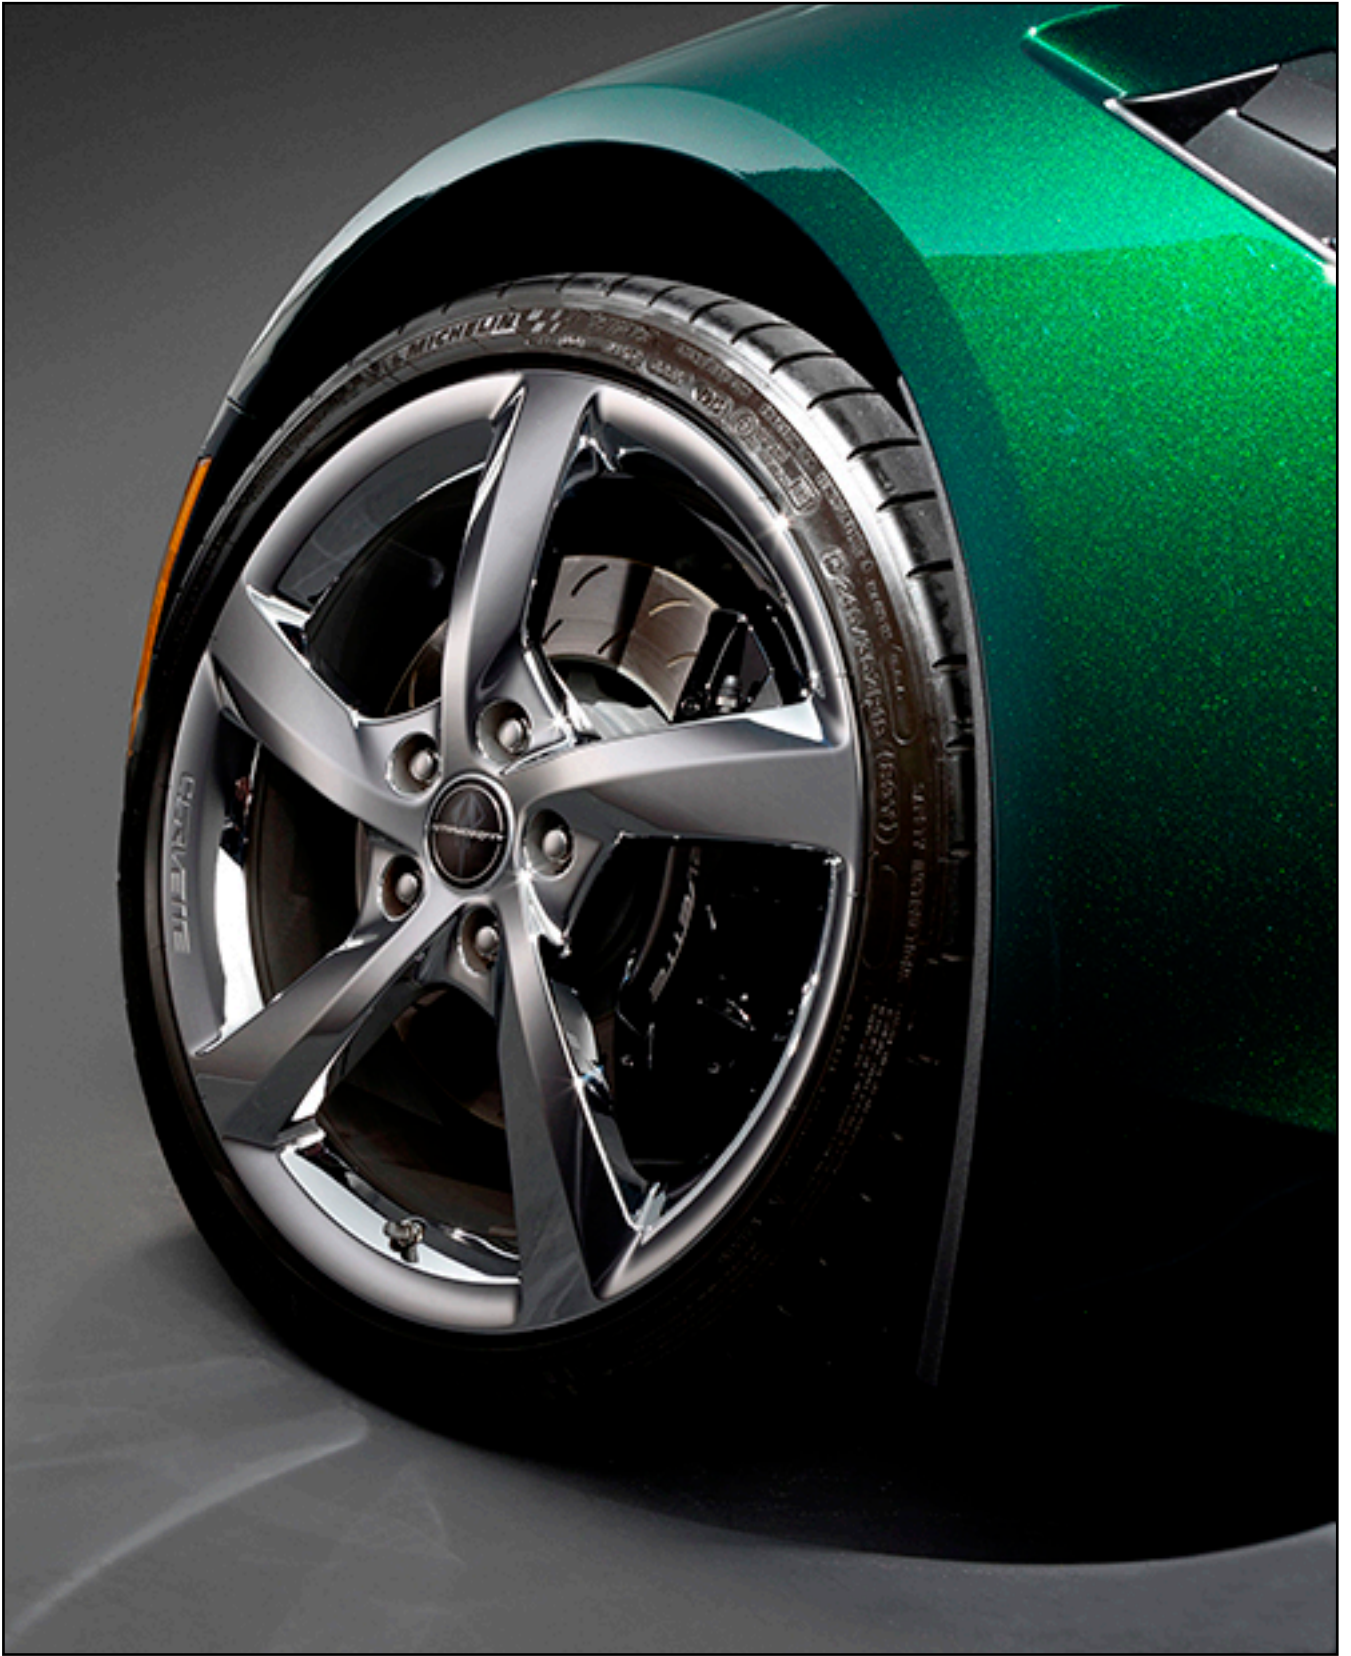
Fig. 9

The 2014 Corvette is equipped with standard P245/40ZR18 front and P285/35ZR19 rear performance summer-only tires and the Z51 Performance Package includes P245/35ZR19 front and P285/30ZR20 rear Michelin Pilot Super Sport ZP summer-only tires. (Fig. 9) These tires may have a chatter noise during low speed turns.

Tire chatter noise, caused by the large amount of tire scrubbing across the pavement, occurs most often during low speed, tight turns (in all directions) when the tires are cool, usually after an extensive ambient soak of the vehicle. The chatter typically diminishes when the tires warm up, but may increase on wet pavement. This is a normal characteristic of the high-performance tires.
