1977 - 1978 Corvette: Service Bulletin: Rear Bumper Cover Wavy

Subject: Rear Bumper Cover Wavy
Model and Year: 1977 - 1978 Corvette
Source: Chevrolet Dealer Service Bulletin
Number: 78-T-42
Section: XIV
Date: July 1978

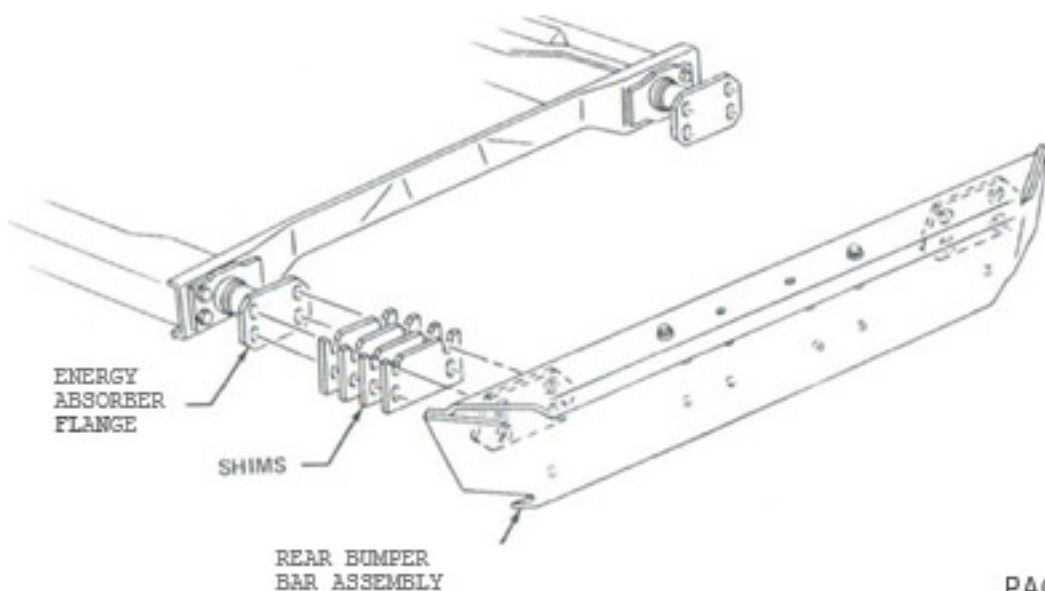
Some 1977-78 Corvettes may exhibit a wavy rear bumper cover above the tail lamps. This condition could be caused by the position of the rear bumper bar relative to the energy absorber. In January, 1978, the assembly plant started using a fixture to improve the adjustment of the bar, thus eliminating the distortion.

1. Loosen the bolts which attach the rear bumper bar to the energy absorber assembly. See illustration. To remove depressions from the cover, raise the bumper bar. If the cover is bulged, lower the bar. If a satisfactory fit is obtained, tighten the bolts (70 Nm/52 ft. lb.). If the cover is still wavy, mark the bumper bar at the point of best vertical fit to the energy absorber.
2. Remove the lower two bolts on each side. Refer to illustration. Since the shims are slotted at the top, removal of the upper bolts is not required.
3. The bar is shimmed at assembly, but may not be at the optimum position. Adding shims (PIN 473279) will stretch the cover and removing shims will

relax it. Shims should be added or removed one at a time.

4. When a satisfactory cover fit is achieved, tighten the energy absorber to bumper bar bolts.

Each site must be adjusted independently. Due to manufacturing tolerances, one side of the bar may have more shims than the other and be at a different position in the energy absorber slots.
