1997 - 1998 Corvette: Chevrolet Pro Service News: Water Leak Repair Guide

Source: Chevrolet Pro Service News

Date: June 1998, Volume 7, Issue Number 6

Subject: Corvette Water Leak Repair

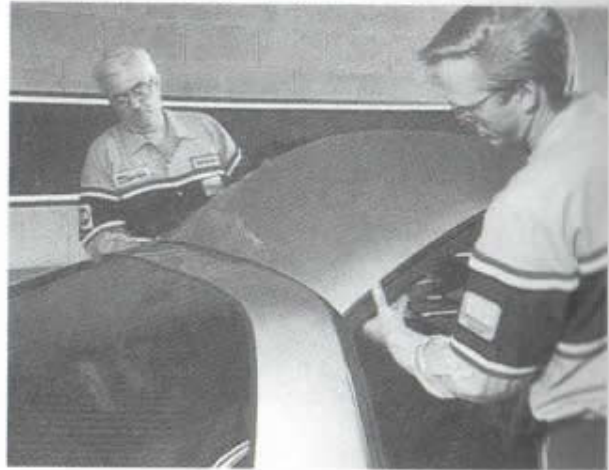
Pivoting roof panel on dowel pins

To correct it, remove the panel and position the rear dowel pins first. Use the dowel pins as pivots to lower the front of the panel onto its seal, then secure the roof latches.

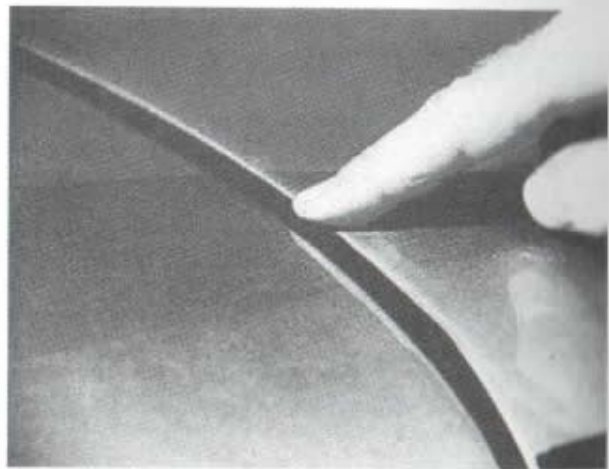
Confirm that only the smooth edge of the rear weatherstrip seal is visible with the roof panel installed. You can prevent comebacks for this condition by demonstrating proper roof panel installation to the customer.

Smooth rear weatherstrip seal edge

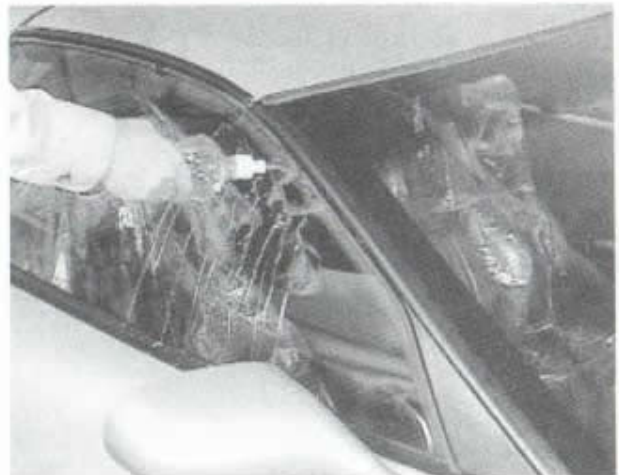
Window tip-in adjustments can also affect leaks at the front edge of the door glass. A confirmed leak along the windshield weatherstrip means you'll need to increase tip-in at the front of the window, ahead of the blow-out clip.

Leaks ahead of the blow-out clip require tip-in adjustment.

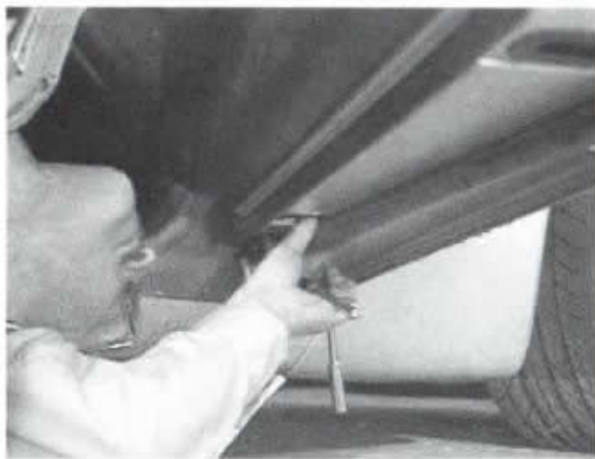
Sliding regulator outboard

Start front tip-in adjustments by removing the front lower access plug from the door. Loosen the front lower regulator nut inside the door, slide the regulator outboard and retighten the nut. Reinstall the lower access plug.

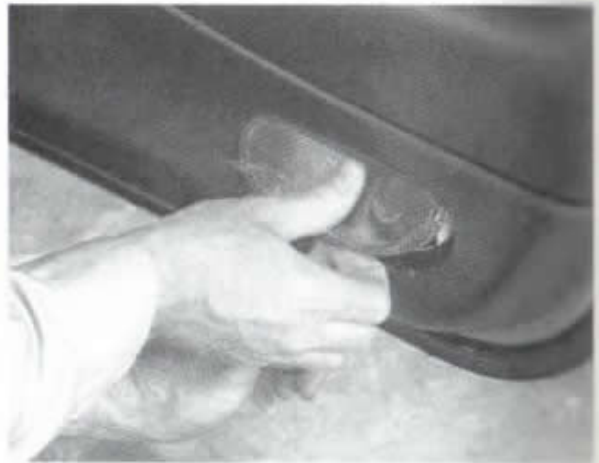
Removing reflector

If rear window tip-in is necessary, remove the reflector from the door after removing the front plug and loosening the regulator nut. Loosen the jack screw jam nut, and turn the jack screw counterclockwise to increase rear tip-in pressure. Finish by locking down the jam nut and re-installing the door reflector.

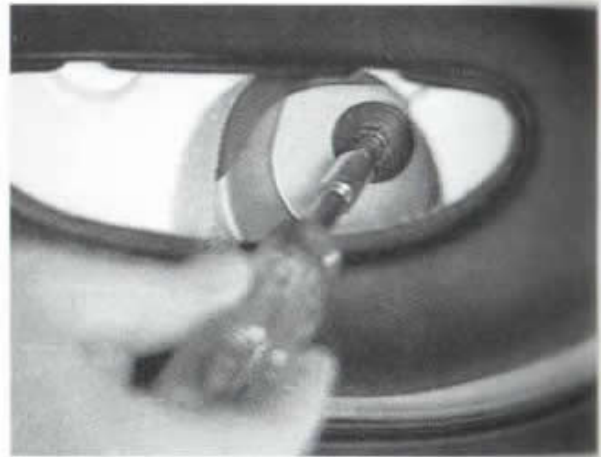
Jack screw is located behind reflector.

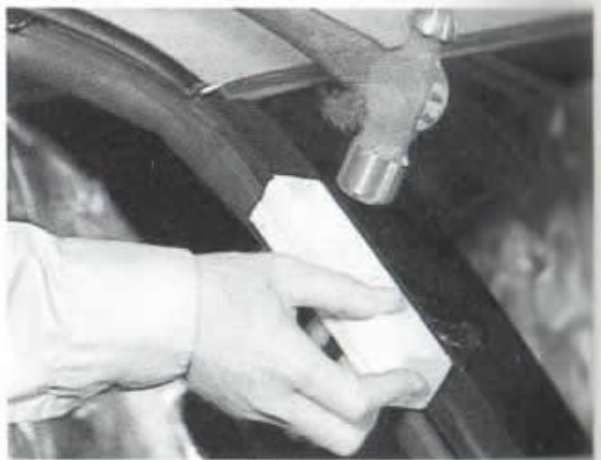
Bending windshield weatherstrip retainer downward

If door glass front edge leaks persist following tip-in adjustment, place a block of wood along the lip of the windshield weatherstrip retainer. Tap the block with a hammer to bend the retainer slightly downward toward the window.

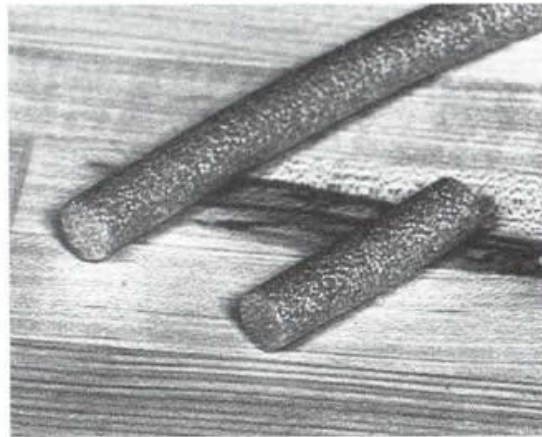
Closed-cell foam weatherstrip, 1/2 inch in diameter, 1-1/2 inches long
