# 1997 - 1998 Corvette: Chevrolet Pro Service News: Water Leak Repair Guide

**Source:** Chevrolet Pro Service News

**Date:** June 1998, Volume 7, Issue Number 6

**Subject:** Corvette Water Leak Repair

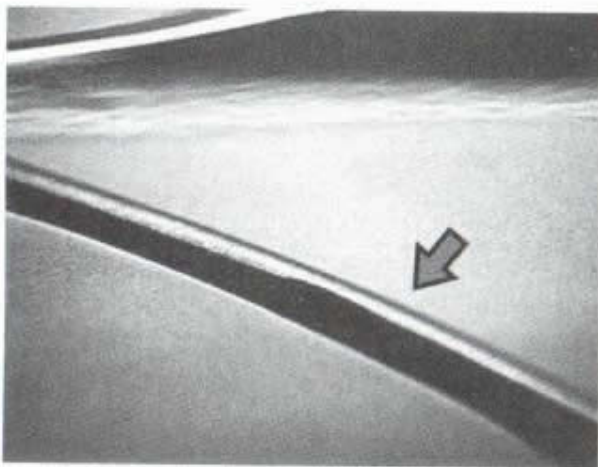
*Rolled roof bow weatherstrip*

A drip from either rear corner of the roof panel is generally the simplest to correct. First, confirm the leak. Then check to see whether the forward edge of the roof weatherstrip has rolled rearward and overlaps the rear weatherstrip edge. The condition is caused during incorrect roof panel installation, where the customer lays the roof panel flat, and slides it into place from the front to the rear.

To correct it, remove the panel and position the rear dowel pins first. Use the dowel pins as pivots to lower the front of the panel onto its seal, then secure the roof latches.

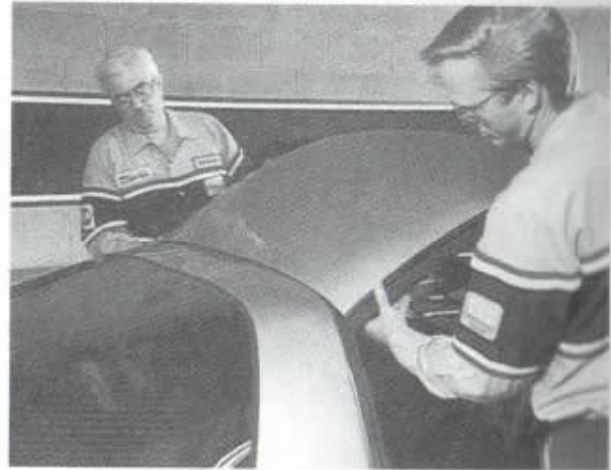
*Pivoting roof panel on dowel pins*

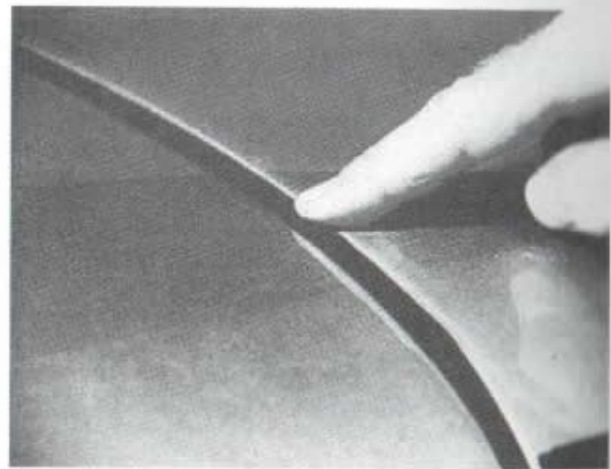
*Smooth rear weatherstrip seal edge*

Confirm that only the smooth edge of the rear weatherstrip seal is visible with the roof panel installed. You can prevent comebacks for this condition by demonstrating proper roof panel installation to the customer.

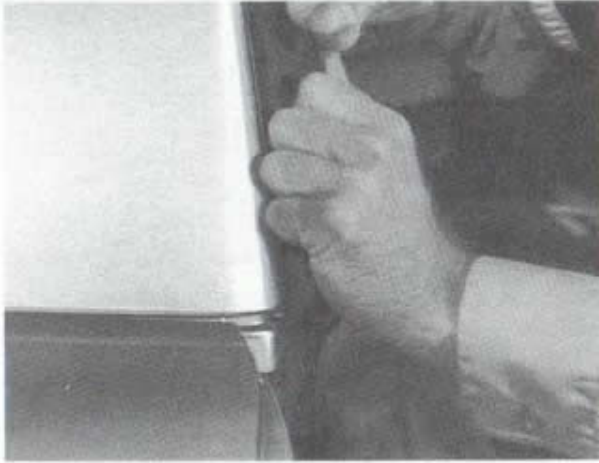
A leak at the rear edge of either door window results from a lack of contact pressure between the window and the roof bow weatherstrip. To correct it, firmly grasp the roof bow side glass weatherstrip at its midway point up the glass. Then stretch the lower portion of the weatherstrip down in its retainer, forming a slight bulge near the bottom.

*Stretching lower portion of weatherstrip downward*

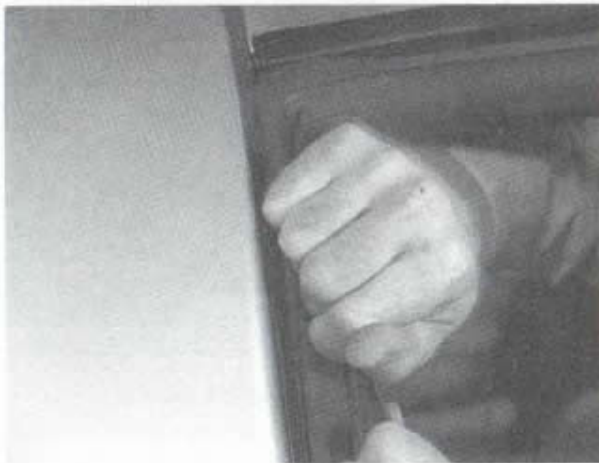
*Stretching upper portion of weatherstrip upward*

Continue holding the center of the weatherstrip in place, and stretch its upper portion snug against the roof weatherstrip. If the area still leaks, rear window tip-in adjustment is necessary to increase pressure between the door glass and the roof bow weatherstrip.

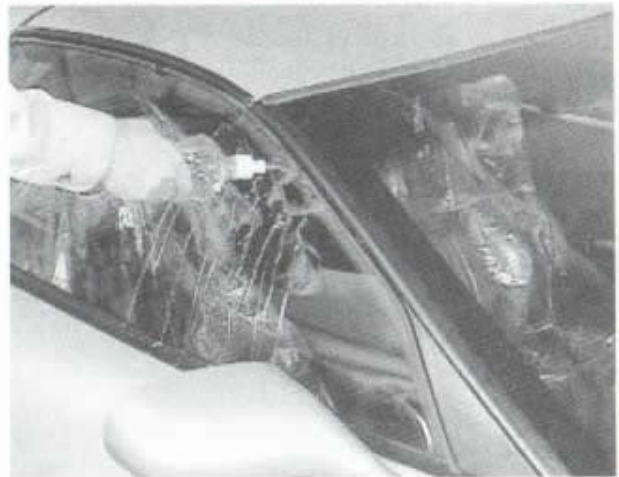
Window tip-in adjustments can also affect leaks at the front edge of the door glass. A confirmed leak along the windshield weatherstrip means you'll need to increase tip-in at the front of the window, ahead of the blow-out clip.

*Leaks ahead of the blow-out clip require tip-in adjustment.*

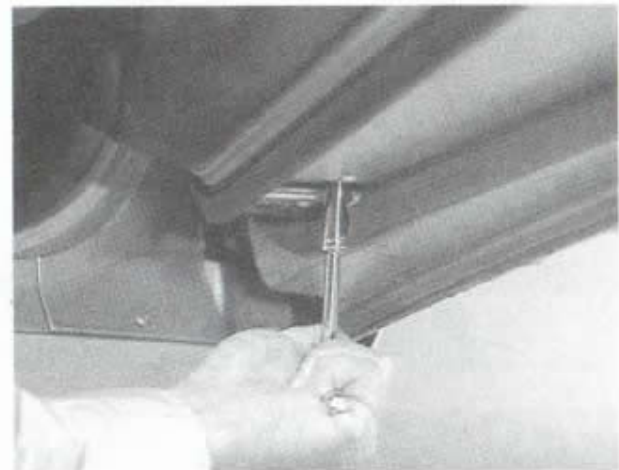
*Loosening front lower regulator nut*

Start front tip-in adjustments by removing the front lower access plug from the door. Loosen the front lower regulator nut inside the door, slide the regulator outboard and retighten the nut. Reinstall the lower access plug.

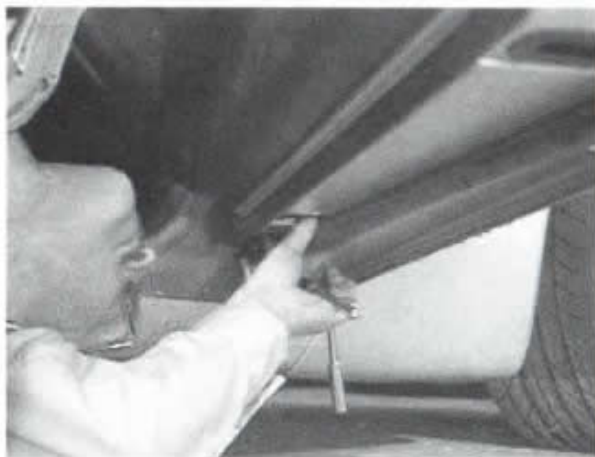
*Sliding regulator outboard*

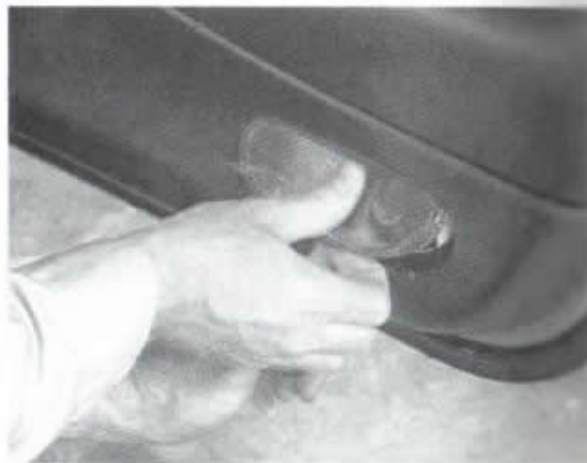
*Removing reflector*

If rear window tip-in is necessary, remove the reflector from the door after removing the front plug and loosening the regulator nut. Loosen the jack screw jam nut, and turn the jack screw counterclockwise to increase rear tip-in pressure. Finish by locking down the jam nut and re-installing the door reflector.

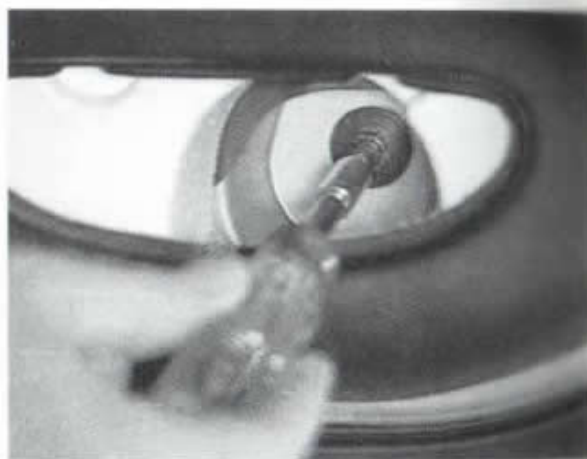
*Jack screw is located behind reflector.*

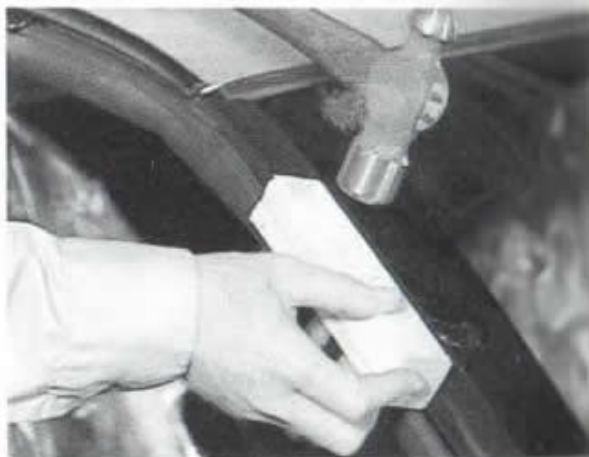
*Bending windshield weatherstrip retainer downward*

If door glass front edge leaks persist following tip-in adjustment, place a block of wood along the lip of the windshield weatherstrip retainer. Tap the block with a hammer to bend the retainer slightly downward toward the window.

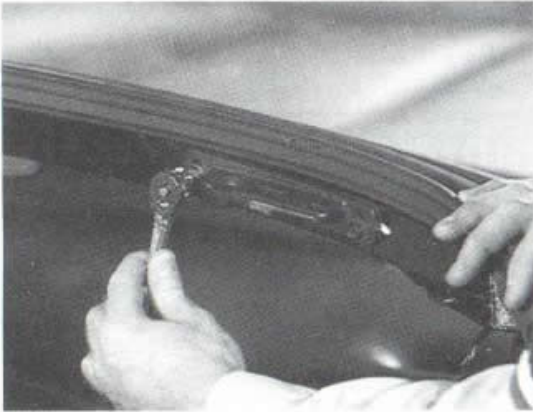
*Loosening latch striker bolts*

Leaks from the roof at the upper corner of the A-pillar are caused by a lack of contact pressure between the roof panel and the windshield weatherstrip. This condition requires a roof latch adjustment. After water-testing, remove the roof panel, upper garnish trim and sunshades. Then loosen the latch striker bolts on each side. Adjust the strikers downward to increase the contact pressure of the roof panel to the windshield weatherstrip. Retighten the bolts, reinstall the roof panel and water-test to confirm the fix, and reinstall the garnish trim and sunshades.

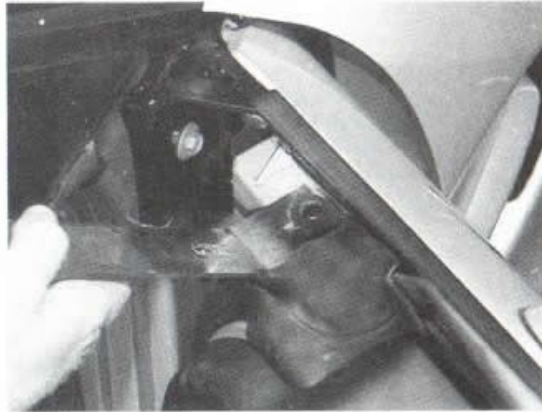
*Fir tree fastener at front lip of door weatherstrip*

Complaints of leaks from the bottom of the windshield A-pillar onto the door trim panel are due to a collapsing door weatherstrip pocket. The collapsed pocket results in a lack of contact pressure between the windshield and door weatherstrips. After water-testing, remove the fir tree fastener at the front lip of the door weatherstrip. Then obtain a piece of closed-cell foam weatherstripping, about 1/2 inch in diameter by 1-1/2 inches long (12mm x 62mm). Rubber hose will also work. The insert stuffer simply needs to be water-resistant and moderately resilient.

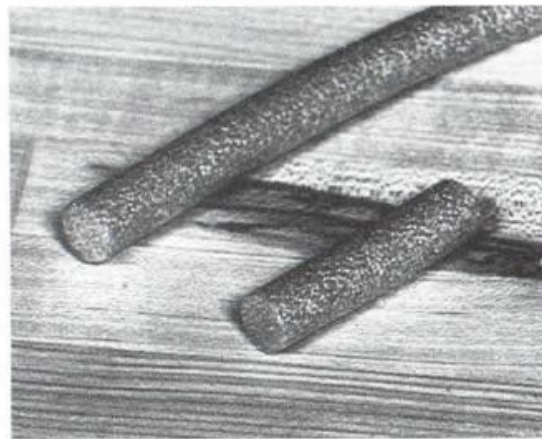
*Closed-cell foam weatherstrip, 1/2 inch in diameter, 1-1/2 inches long*

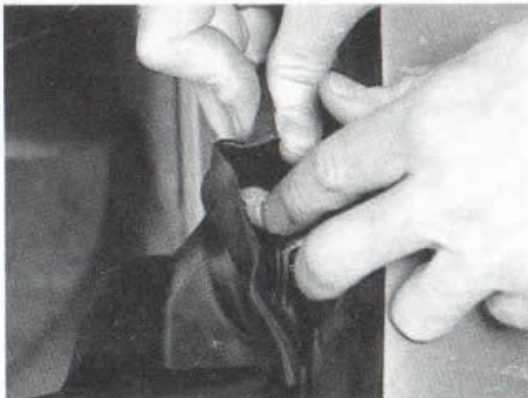
*Inserting stuffer into door weatherstrip pocket*

Push the stuffer into the door weatherstrip pocket until it just reaches the edge of the door trim panel. The stuffer increases contact pressure between the weatherstrips inboard of the A-pillar weatherstrip drain. It also prevents the collapse of the door weatherstrip under pressure.
