1997 - 2000 Corvette: Chevrolet Pro Service News: Corvette Windnoise

Source: Chevrolet Pro Service News

Date: September 1998, Volume 7, Issue #9

CORVETTE WINDNOISE

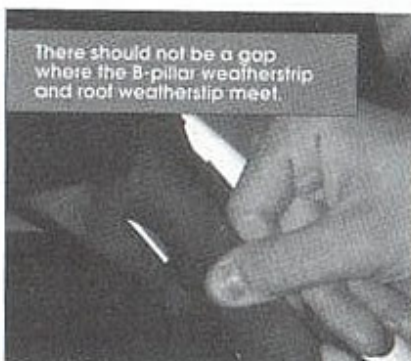
Windnoise also may occur where the B-pillar weatherstrip overlaps the roof weatherstrip. If there is a gap, slide the B-pillar weatherstrip upward in the retainer so it tightly contacts the roof weatherstrip.

There should not be a gap where the B-pillar weatherstrip and roof weatherstrip meet.

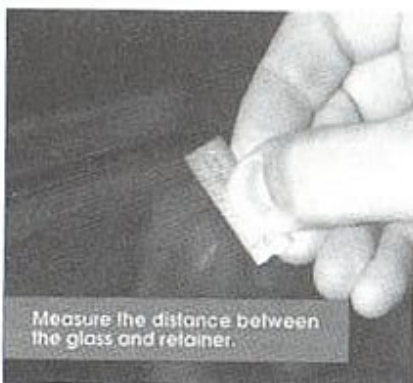
but are integral in diagnosing and correcting windnoise conditions. If you detect windnoise from around the glass, check the distance between the glass and the retainer. You can accomplish this by pushing the edge of the weatherstrip under the glass before measuring. The distance between the two should measure

between 4 mm and 8 mm. The distance from the rear edge of the glass to the retainer should be 7 mm to 9 mm.

Measure the distance between the glass and retainer.

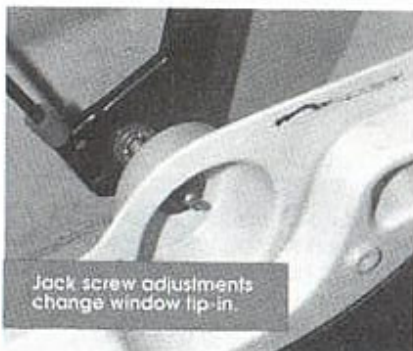
Jack screw adjustments change window tip-in.

rear of the door glass, you may need to adjust the window tip-in. The glass should be flush, to 2 mm under flush, to the B-pillar retainer.

You can adjust the tip-in using the jack screw. A counterclockwise adjustment increases tip-in, and clockwise decreases. Refer to the service manual for more information on tip-in

If the glass doesn't roll up easily after adding tip-in, loosen the front lower regulator attachment, lower the glass, and tighten the lower front attachment.

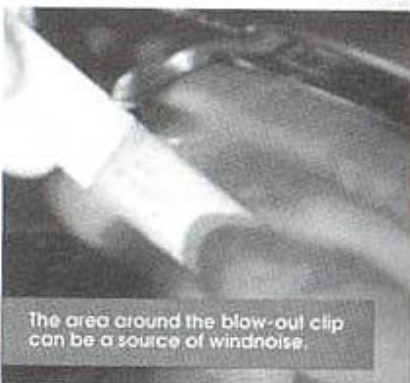
The area around the blow-out clip can be a source of windnoise.

One last area to examine is the distance between the glass and the blow-out clip. The clearance between the two should be 4 mm, within 1 mm.

If the distance is too great, carefully tap the blow-out clip with a rubber mallet.
