1997 - 2000 Corvette: Chevrolet Pro Service News: Corvette Windnoise

Date: September 1998, Volume 7, Issue #9

CORVETTE WINDNOISE

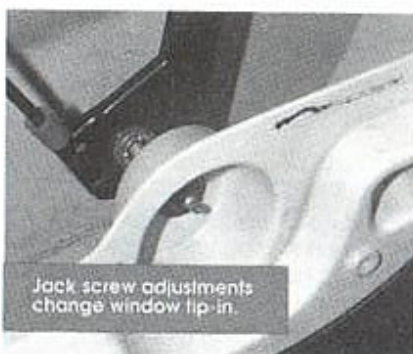
Jack screw adjustments change window tip-in.

rear of the door glass, you may need to adjust the window tip-in. The glass should be flush, to 2 mm under flush, to the B-pillar retainer.

You can adjust the tip-in using the jack screw. A counterclockwise adjustment increases tip-in, and clockwise decreases. Refer to the service manual for more information on tip-in

If the glass doesn't roll up easily after adding tip-in, loosen the front lower regulator attachment, lower the glass, and tighten the lower front attachment.
