# 2012 - 2013 Corvette: GM Techlink Article: Instrument Panel Tweeter Noise

**Source:** GM TechLink

**Date:** August 2012

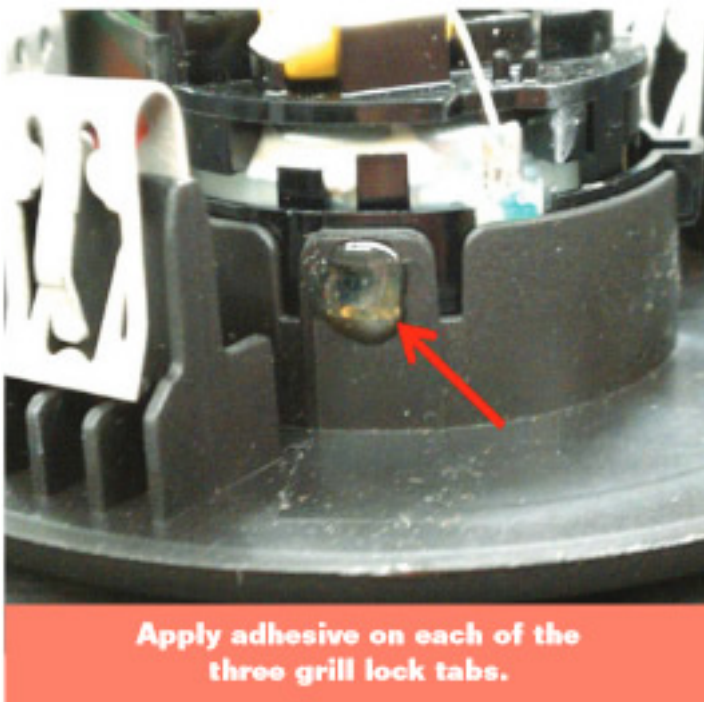
A rattle noise in left side of the instrument panel may be heard on some 2012-2013 Corvettes. The noise may be caused by the tweeter not being secured to the tweeter grill. The curvature of the instrument panel causes the rattle to appear to be on the left side.

Remove the tweeter assembly from the instrument panel. Secure the tweeter in the grill by applying a small dot of hot melt adhesive on each of the three lock tabs. Only apply enough glue to fill each tab window. Reinstall the speaker assembly to the vehicle and confirm the repair.

**Apply adhesive on each of the three grill lock tabs.**
