# 1997 - 2002 Corvette: Service Bulletin: Door Rattle with Moderate to High Audio System Volume

**Number:** 01-08-64-009A

**Date:** 06-19-2002

**Model Year:** 1997-2002 Chevrolet Corvette

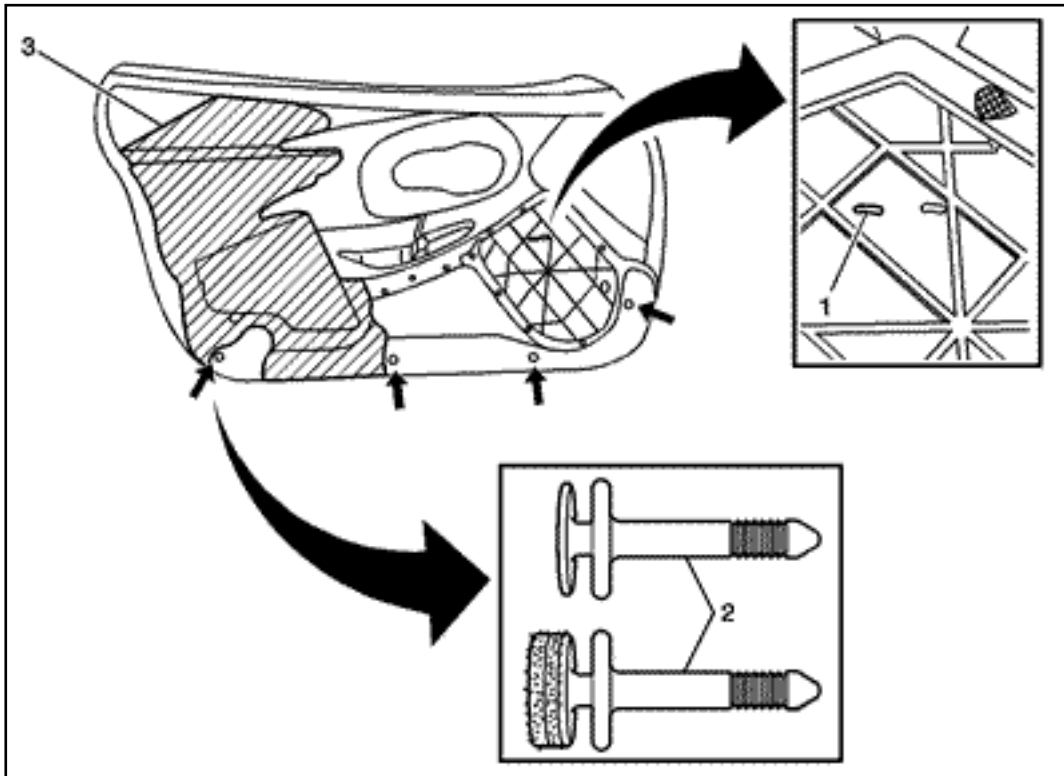
New speaker screen is made from a different material and Bose® emblem is provided due to risk of old emblem becoming damaged while removing.

1. Straighten the speaker grille tabs and remove the grille from the door panel.
2. Remove the Bose® emblem from the speaker grille and discard.
3. Remove the speaker screen from the grille and discard.
4. Install the new speaker screen to the grille.
5. Install the new Bose® emblem and carefully crimp the staples (1) to the speaker grille.
6. Insert the speaker grille tabs into the door panel slots and bend the tabs

to lock the grille in place.

7. Trim any extra loose door panel leather skin from around the speaker grille area on the back side of the door panel.
8. Repeat above steps for opposite side.

1. Remove the 4 lower door trim panel retainers (2) from both door panels.
2. Cut 16 dime sized coins from the fine side of Velcro®, 3M® P/N 051131-06481, or equivalent.
3. Install 2 Velcro® coins to each of the 8 door trim panel retainers (2).
4. Reinstall the door trim panel retainers (2) into the door trim panels.

1. Only perform the following procedure if the side impact styrofoam (3) is loose from the door panels.
2. Resecure the side impact foam (3) to the door trim panels using 3M® Urethane, P/N 051135-08690, or equivalent.
