1997 - 2002 Corvette: Service Bulletin: Door Rattle with Moderate to High Audio System Volume

Number: 01-08-64-009A

Date: 06-19-2002

Model Year: 1997-2002 Chevrolet Corvette

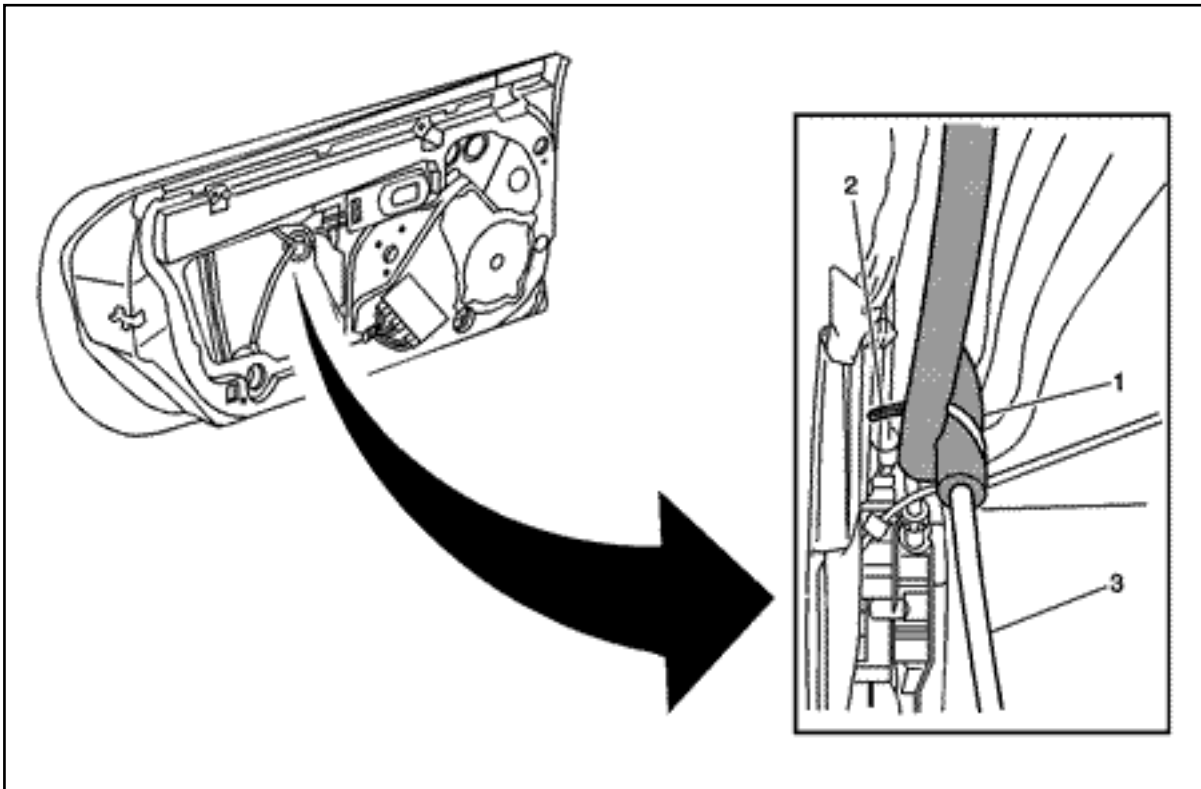
Change implemented in 1999 VIN breakpoint 133100. Vehicles built prior to this breakpoint will require the following procedure.

1. Remove the water deflector.

Do not damage the push-in retainer/tie straps (2). They are to be reused.

2. Remove the push-in retainer/tie straps (2) that retain the window regulator cables (3) to the inner door panels.
3. Reposition the push-in retainer/tie straps (2) out of the way.
4. Add 122 mm (5 in) of 3M® Open Cell Interior Foam Tape (1), P/N 051131-62385, or equivalent, to the window regulator cables (3) where they contact each other and the inner door panels.

5. Reinstall the push-in retainer/tie straps (2).
6. Reinstall the water deflector.
