# 1998 - 2002 Corvette: Service Bulletin: Audible Spark Knock (Detonation), MIL Illuminated, DTC P0332 Set

**Subject:** Audible Spark Knock (Detonation), MIL Illuminated, DTC P0332 Set  
(Replace Rear Bank Knock Sensor and RTV Area Around Sensor)

**Number:** 02-06-04-023

**Models:** 1998-2002 Chevrolet Camaro, Corvette, 1998-2002 Pontiac Firebird with 5.7L Engine (VIN G -- RPO LS1)

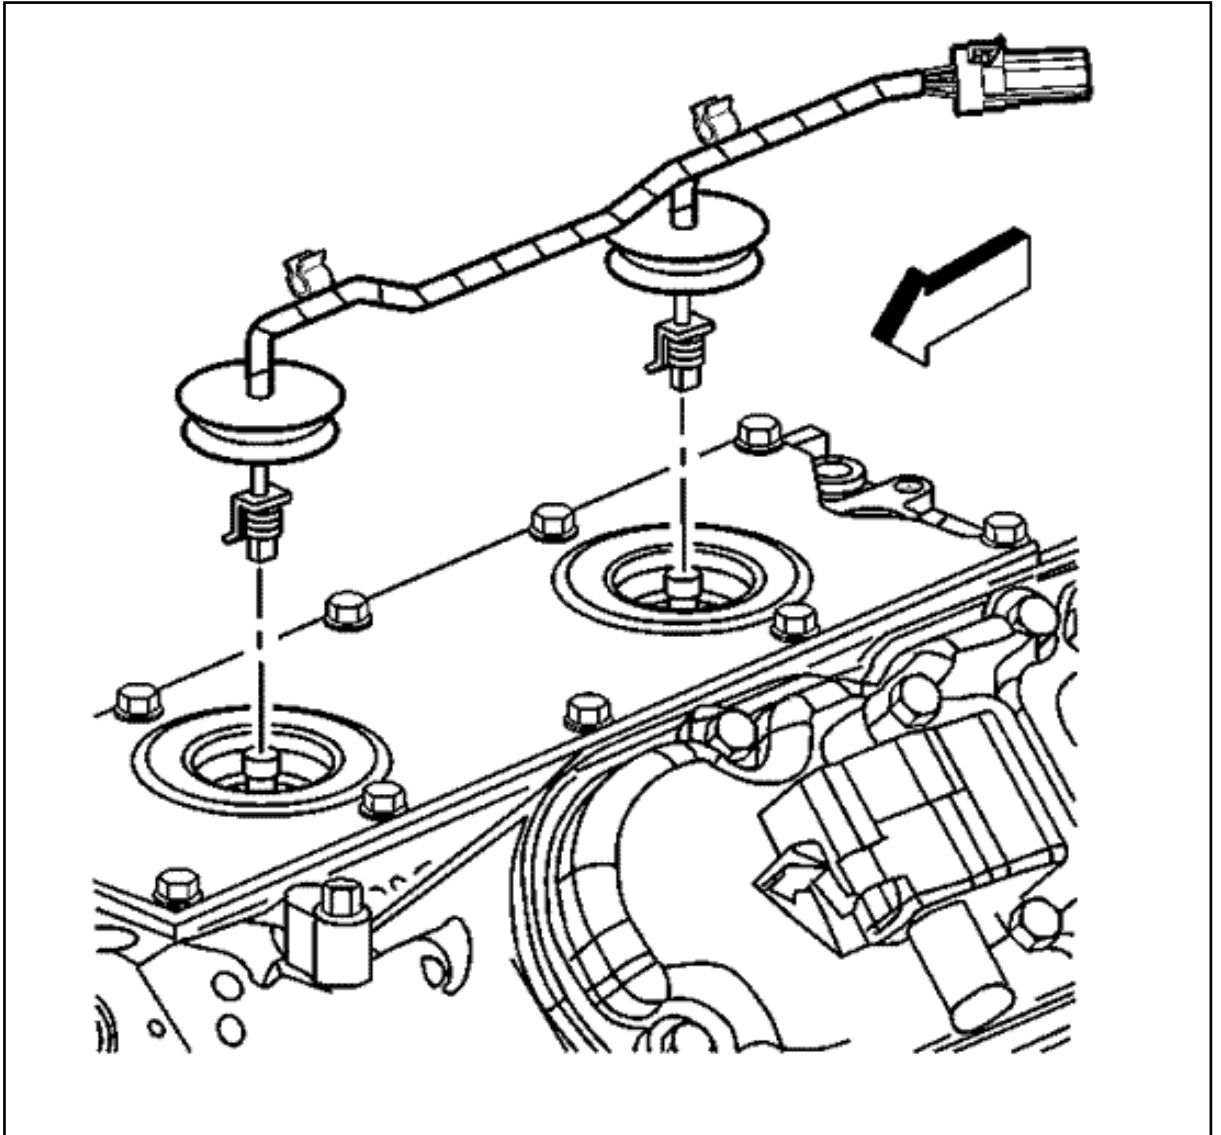
This condition may be the result of corrosion of the rear bank knock sensor due to water intrusion into the sensor cavity. This condition is more apparent on vehicles in which customers frequently wash the engine compartment.

- Remove the intake manifold. Refer to the Intake Manifold

Replacement procedure in the Engine Controls sub-section of the appropriate Service Manual.
