1998 - 2001 Corvette Convertible: Service Bulletin: Squeak From Rear of Convertible Top (Replace Protector Assembly)

Source: Chevrolet Dealer Service Bulletin

Number: 01-08-67-003

Model Year: 1998-2001 Corvette

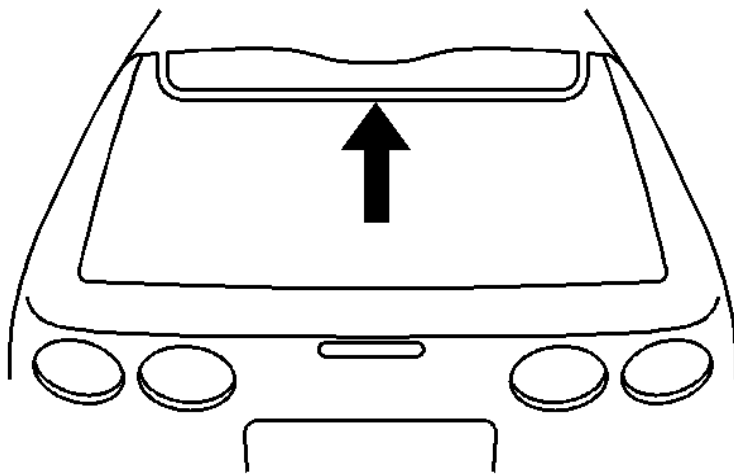
This condition may be caused by interference between the fifth bow seal and the tonneau cover rub strip. (Refer to the illustration above).

1. Remove the old seal.
2. Remove any two way tape from the body.
3. Clean the surface.
4. Install a new front top stow compartment lid protector assembly.
