# 1998 - 2001 Corvette Convertible: Service Bulletin: Squeak From Rear of Convertible Top (Replace Protector Assembly)

**Number:** 01-08-67-003

**Subject:** Squeak From Rear of Convertible Top (Replace Protector Assembly)

**Model Year:** 1998-2001 Corvette

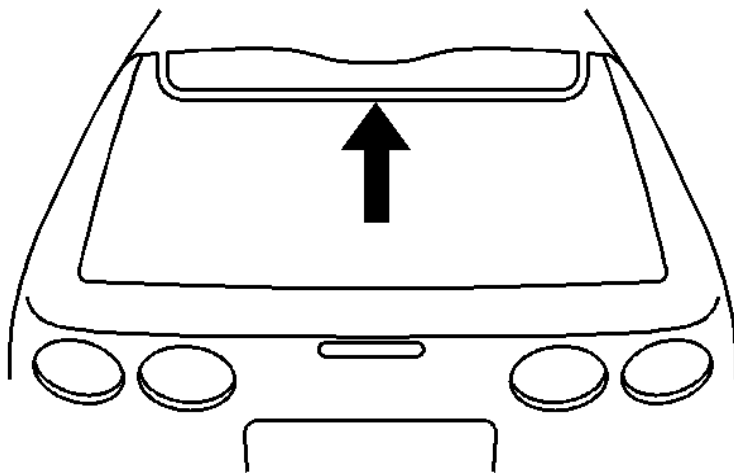
This condition may be caused by interference between the fifth bow seal and the tonneau cover rub strip. (Refer to the illustration above).

1. Remove the old seal.
2. Remove any two way tape from the body.
3. Clean the surface.
4. Install a new front top stow compartment lid protector assembly.
