1998 Corvette Convertible: Service Bulletin: Tonneau Cover Makes Noise When Going Over Bumps

Subject: TONNEAU COVER MAKES NOISE WHEN GOING OVER BUMPS
(INSTALL TAPE)

Source: Chevrolet Dealer Technical Service Bulletin

Number: 83-15-06 - (04/22/1998)

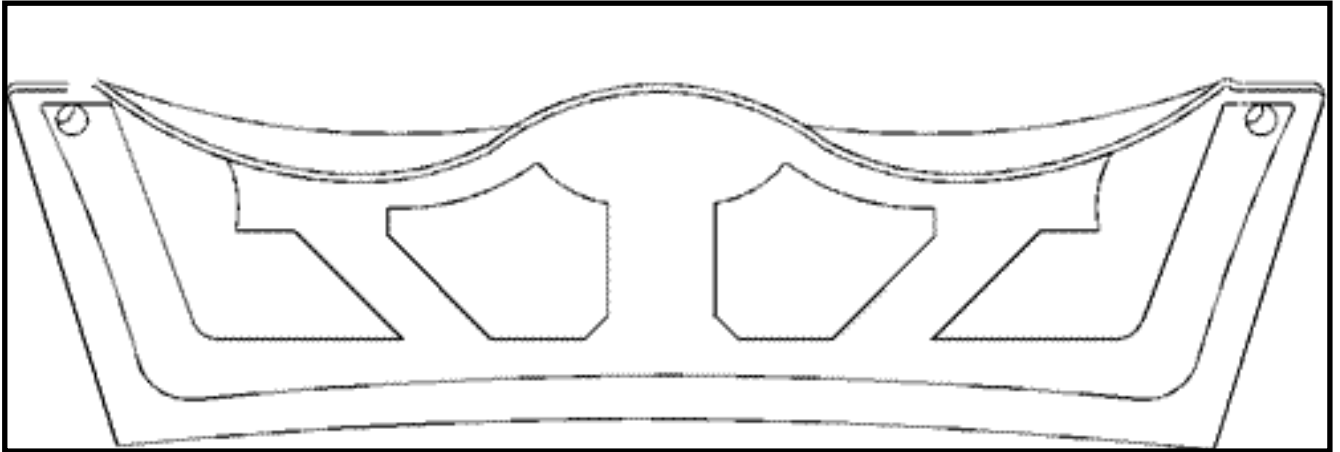
SOME CUSTOMERS MAY COMMENT THAT THE TONNEAU COVER MAKES NOISE WHEN GOING OVER BUMPS, WITH TOP IN THE UP POSITION.

THIS SITUATION MAY BE CAUSED BY THE RUBBER STOP BUMPERS HAVING A STICK/SLIP CONDITION TO THE TONNEAU COVER.

1. CLEAN TONNEAU COVER IN THE AREA SHOWN (FIGURE 1) WITH A GENERAL PURPOSE CLEANER.
2. INSTALL A PIECE OF 3M(R) SCOTCH SQUEAK REDUCTION TAPE (P/N 06356), OR EQUIVALENT, TO THE TONNEAU COVER.
