1997 - 2004 Corvette: Service Bulletin: General Waterleak Guide

Subject: General Waterleak Guide

Source: Chevrolet Dealer Technical Service Bulletin

Number: 02-08-57-003

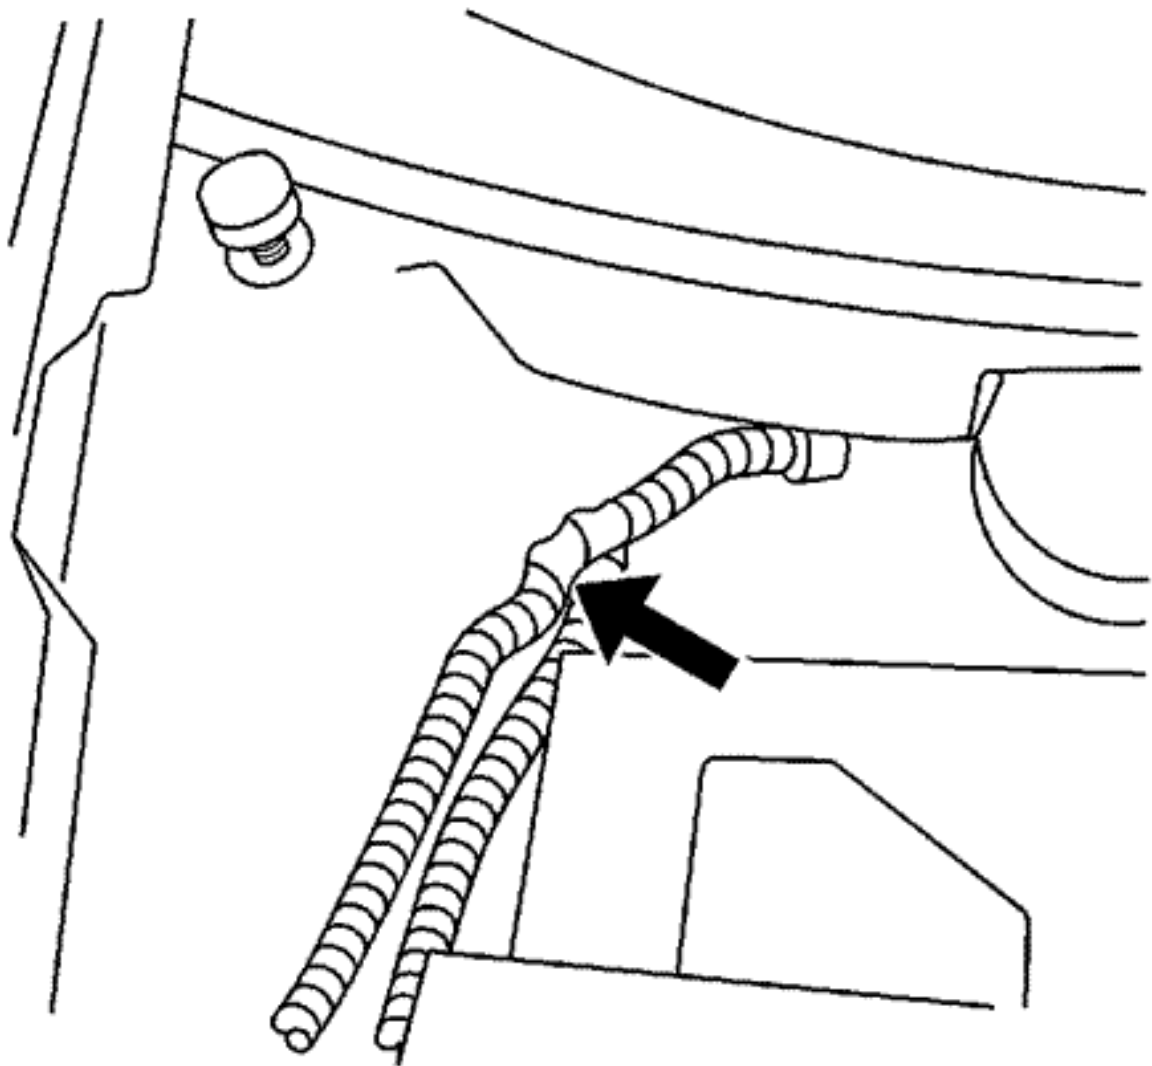
Water is dripping on top of the passenger side carpet.

A wire harness leading into the passenger side compartment may be mis-routed (bent upward) at the first split in the wire harness. This may allow water to enter the harness and into the passenger side compartment. Refer to the arrow in the illustration.

Remove the battery and push the harness downward.

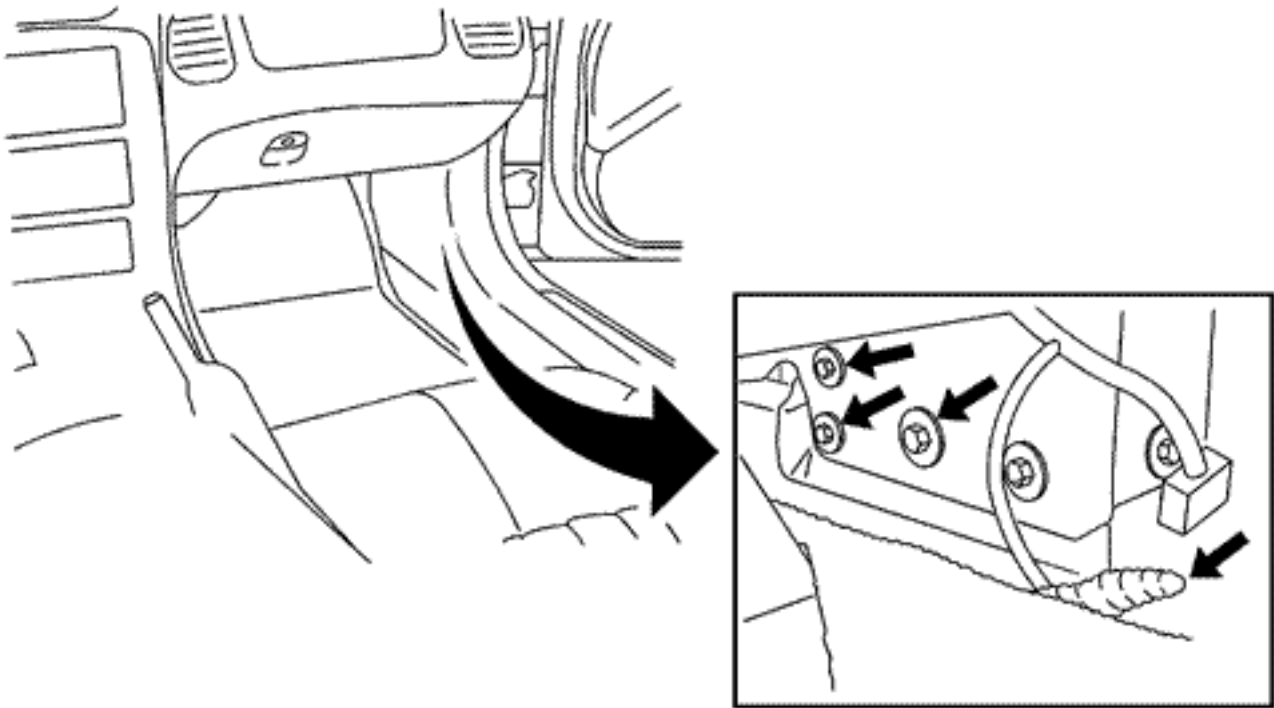
The carpet is wet under the passenger side floor.

The dash attaching bolts may not be sealed. Refer to the bolts in the illustration.

The lower hinge pillar may not be sealed. Refer to the arrow in the lower right hand corner in the illustration above.

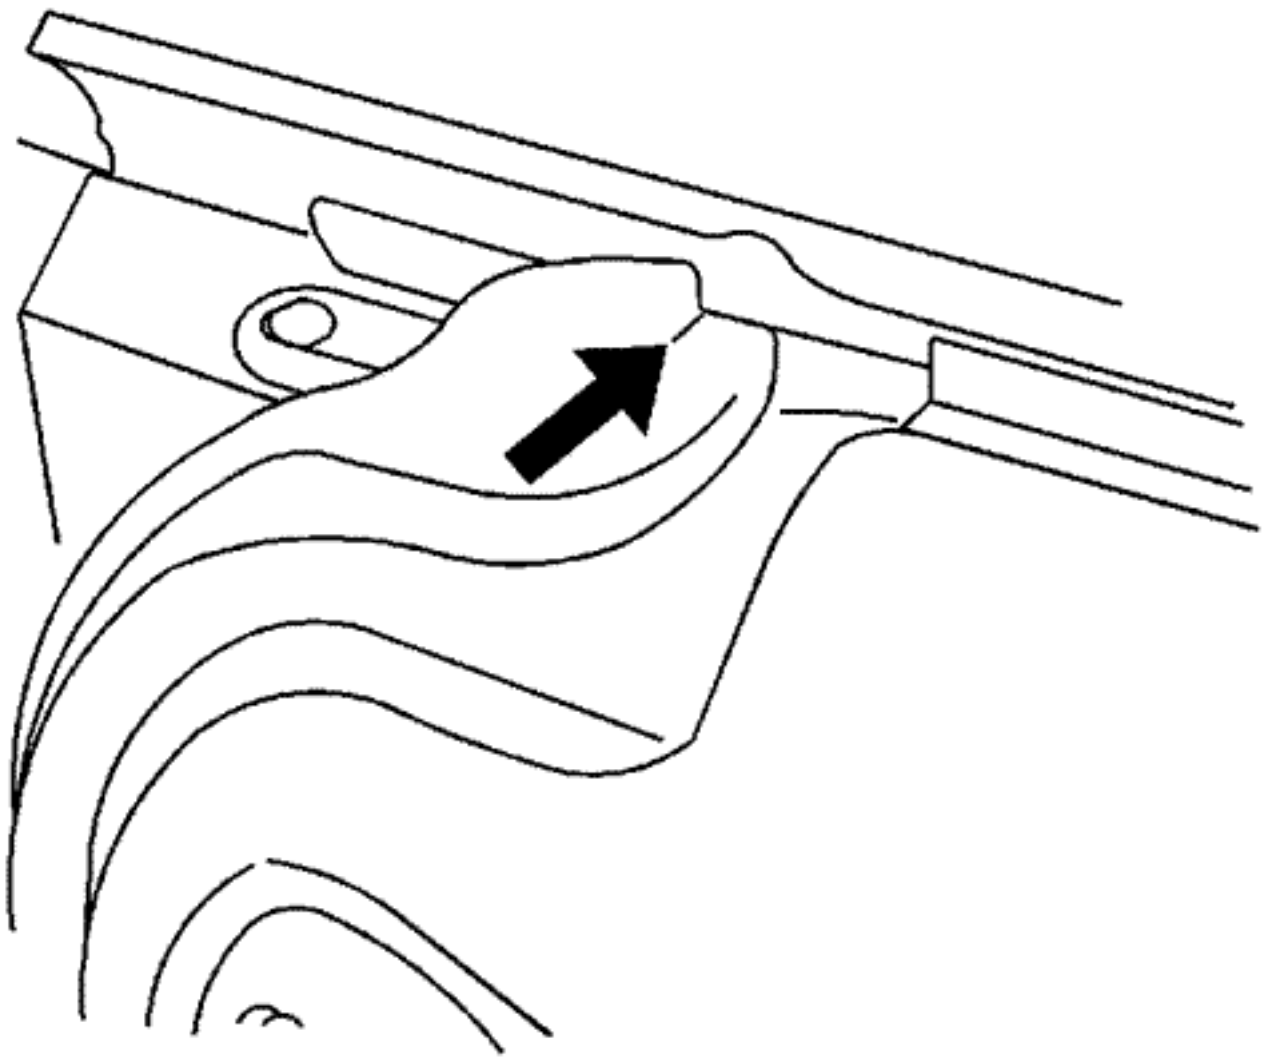
Water is running down the front edge of the door or water is on top of the sill plate.

Water may be leaking around the weatherstrip at the top of the door due to an undesirable nub in the weatherstrip at the top of the door. Refer to the arrow in the illustration .

Replace the weatherstrip.

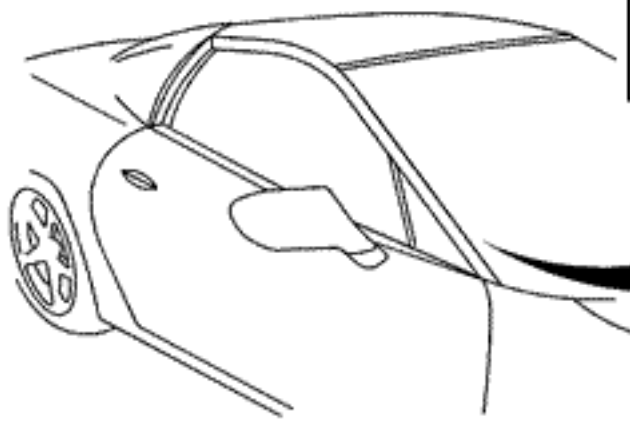
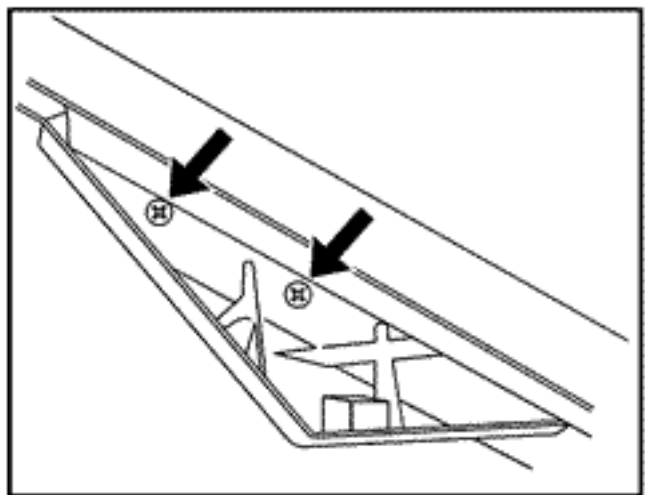
Two screws may not be sealed under the "A" pillar garnish molding. Refer to the illustration. During water test with the "A" pillar molding off, there may be water coming out of either the garnish molding retaining hole or the wire harness retaining hole. Refer to the arrow in the illustration.

Seal the two screws with the Kent™ sealer listed below.

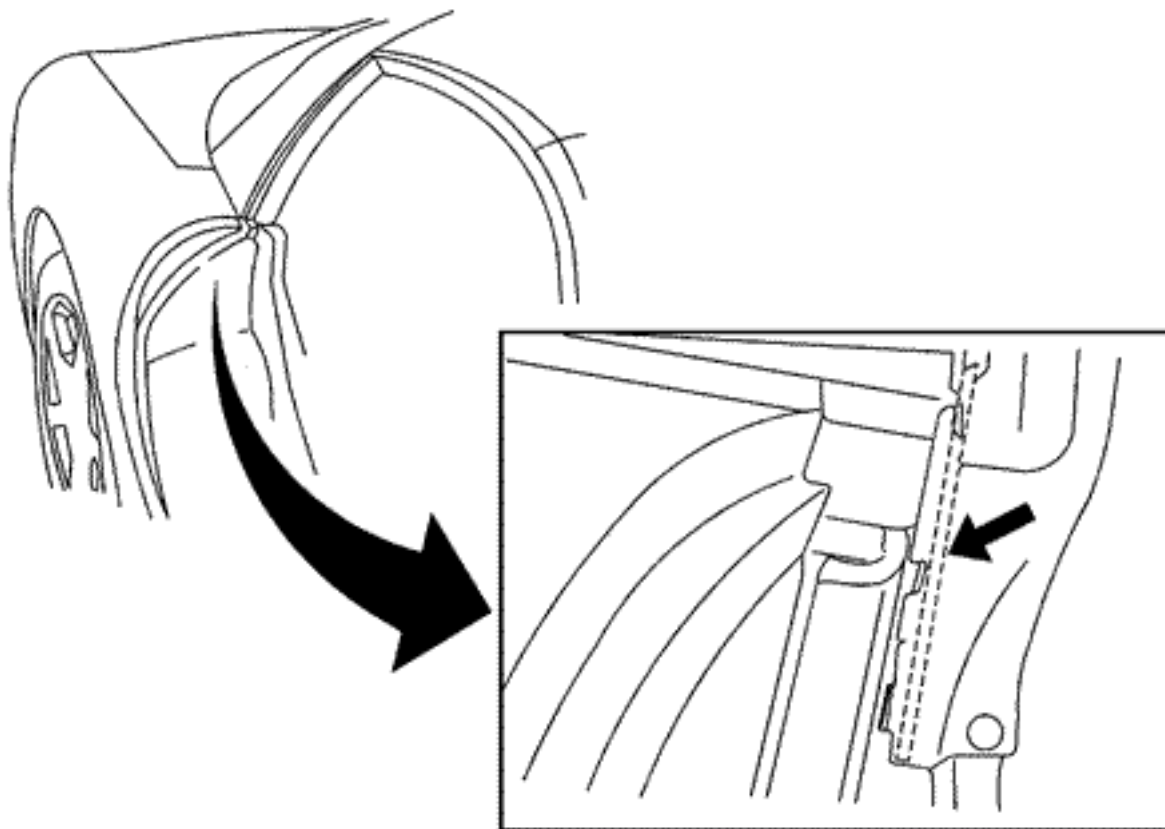
The floor is wet behind the seat belts.

The "B" pillar weatherstrip may not be sealed properly.

Reseal the weatherstrip with the GM sealer listed below. Refer to the dotted line in the illustration for sealing area.

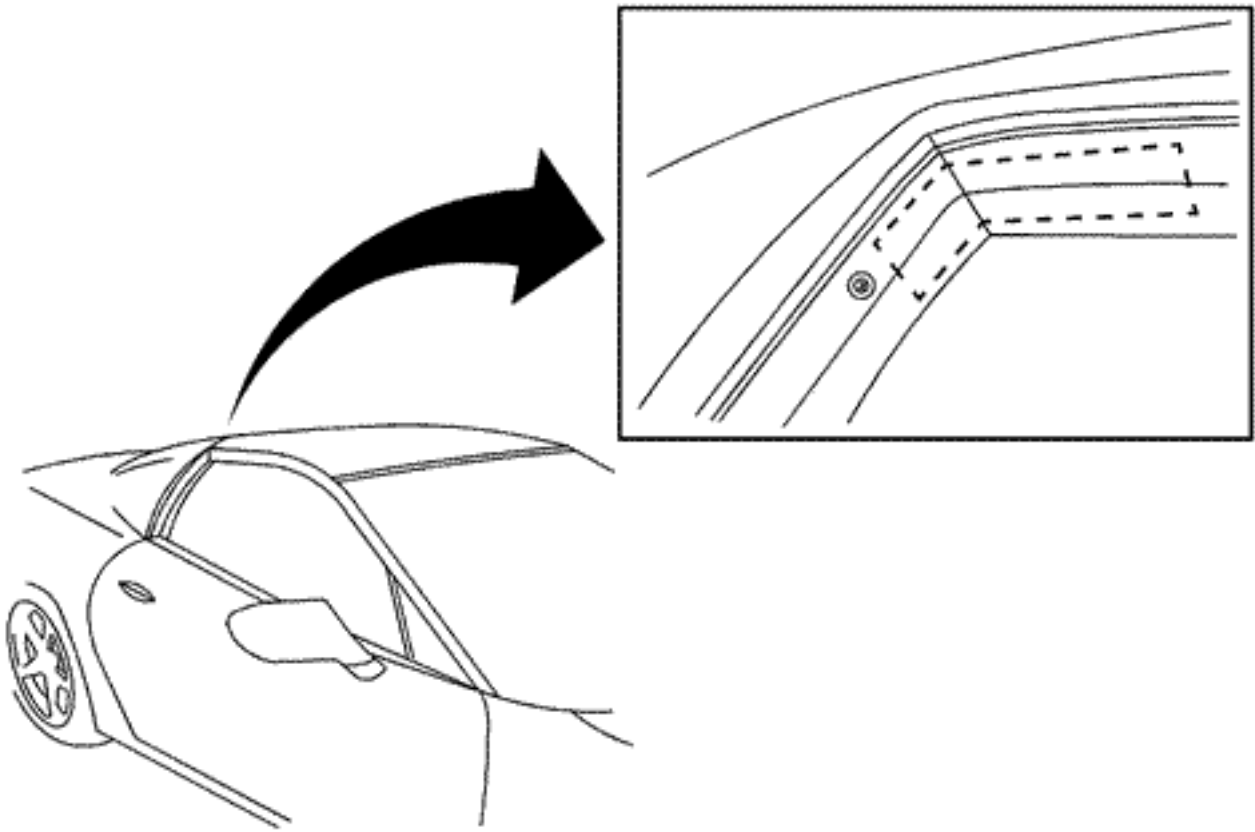
The floor is wet behind the seat belts (Hardtop/ Z06 only).

The top corner of the weatherstrip may not be sealed properly. Refer to the area shown in the illustration.

Reseal the weatherstrip with the GM sealer listed below. Refer to the sealer in the illustration.
