# 1997 - 2004 Corvette: Service Bulletin: General Waterleak Guide

**Subject:** General Waterleak Guide

**Number:** 02-08-57-003

**Models:** 1997-2002 Chevrolet Corvette

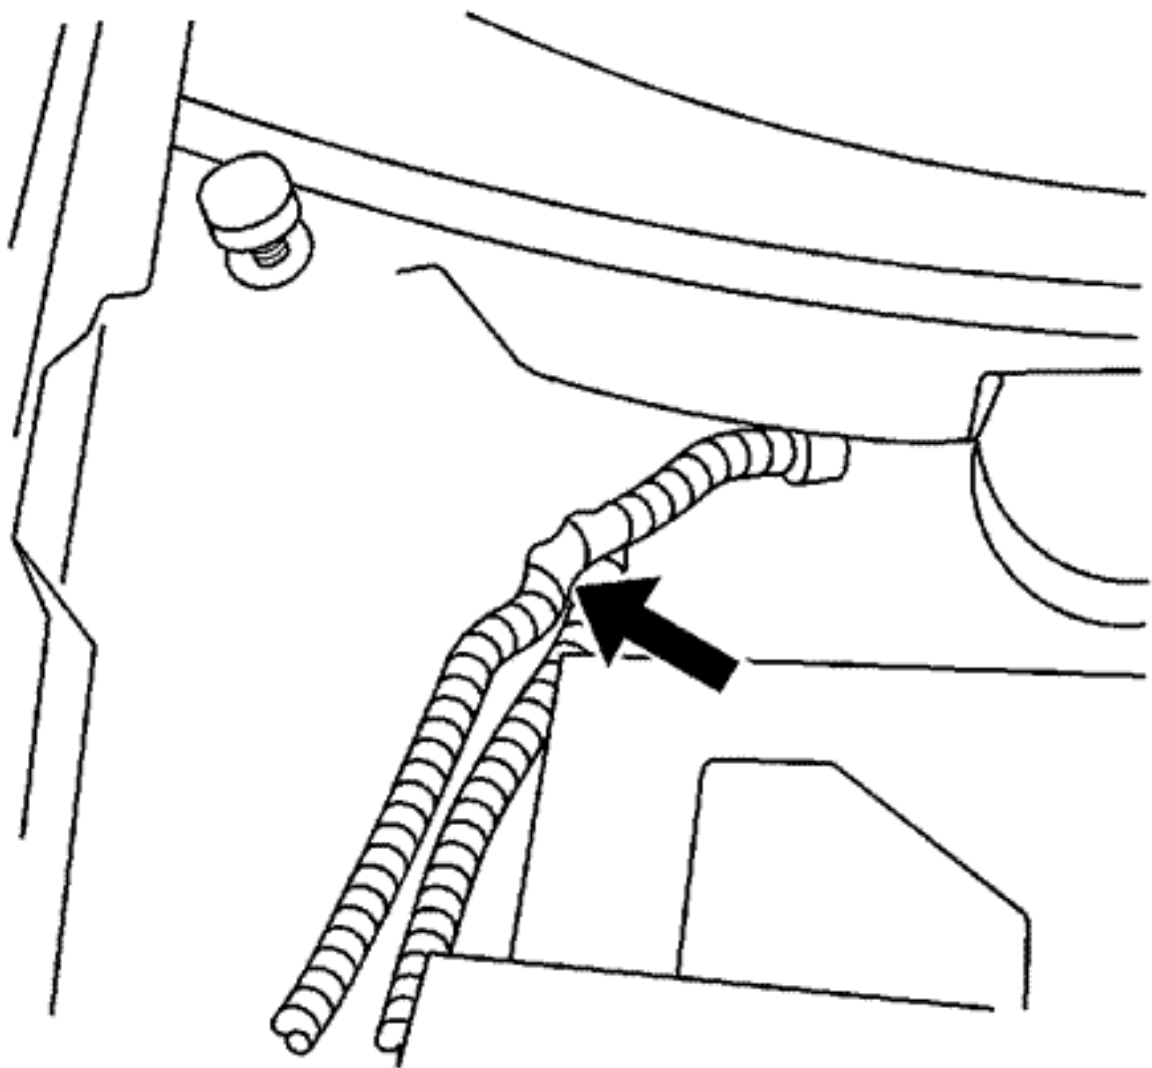
Water is dripping on top of the passenger side carpet.

A wire harness leading into the passenger side compartment may be mis-routed (bent upward) at the first split in the wire harness. This may allow water to enter the harness and into the passenger side compartment. Refer to the arrow in the illustration.

Remove the battery and push the harness downward.

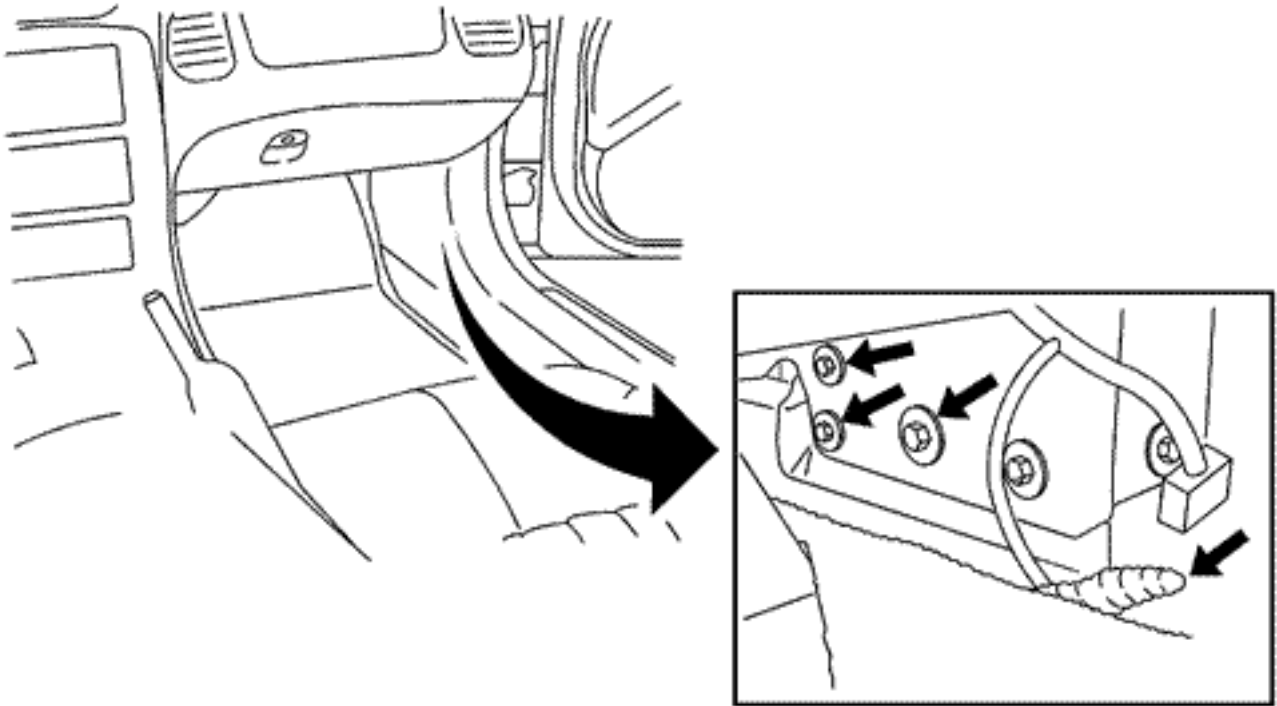
The carpet is wet under the passenger side floor.

The dash attaching bolts may not be sealed. Refer to the bolts in the illustration.

The lower hinge pillar may not be sealed. Refer to the arrow in the lower right hand corner in the illustration above.

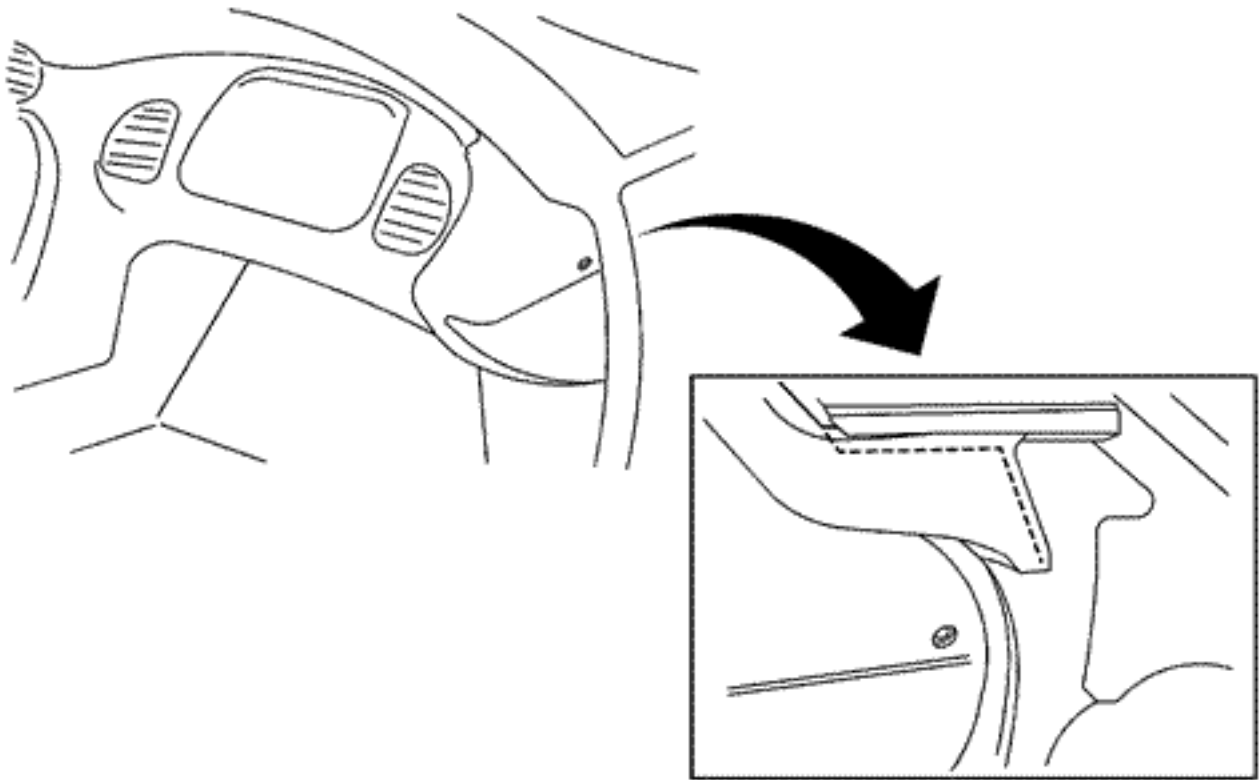
Water is running down the front edge of the door or water is on top of the sill plate.

The butyl strip under the seal at the base of the "A" pillar may not be sealing properly or the push-in fastener may not be seated.

Clean the area with one of the cleaners listed below.

Reseal the "A" pillar starting at the bottom of the weatherstrip retainer with the GM sealer listed below. Refer to the dotted line in the illustration for sealing.

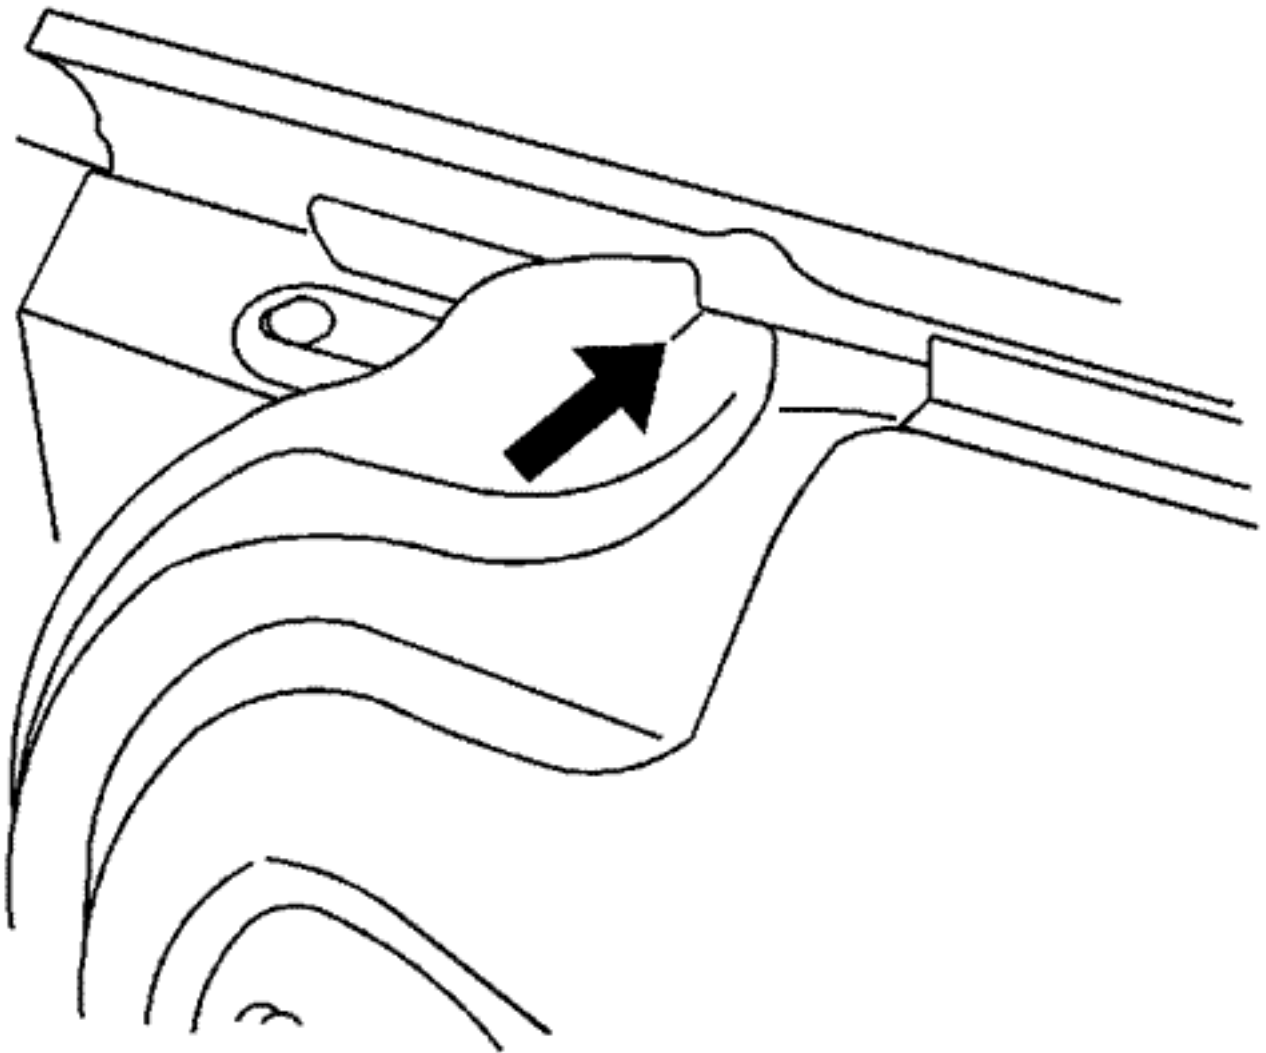
Water may be leaking around the weatherstrip at the top of the door due to an undesirable nub in the weatherstrip at the top of the door. Refer to the arrow in the illustration .

Replace the weatherstrip.

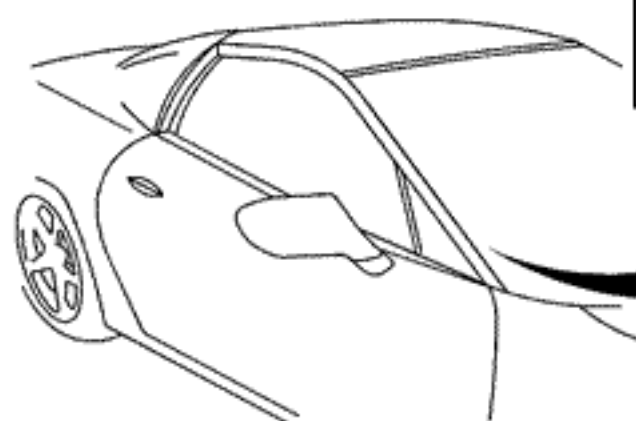
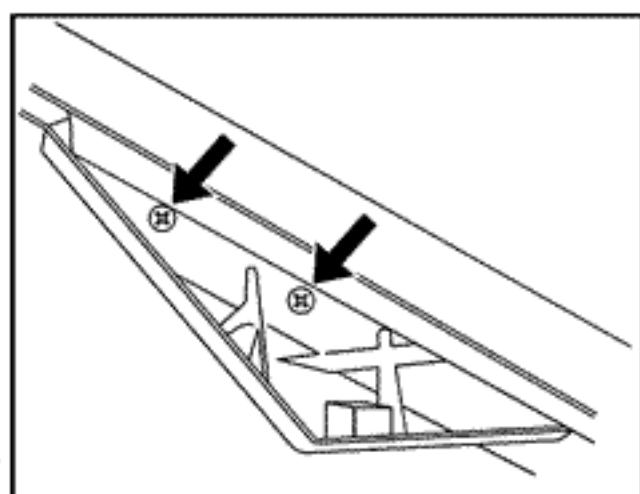
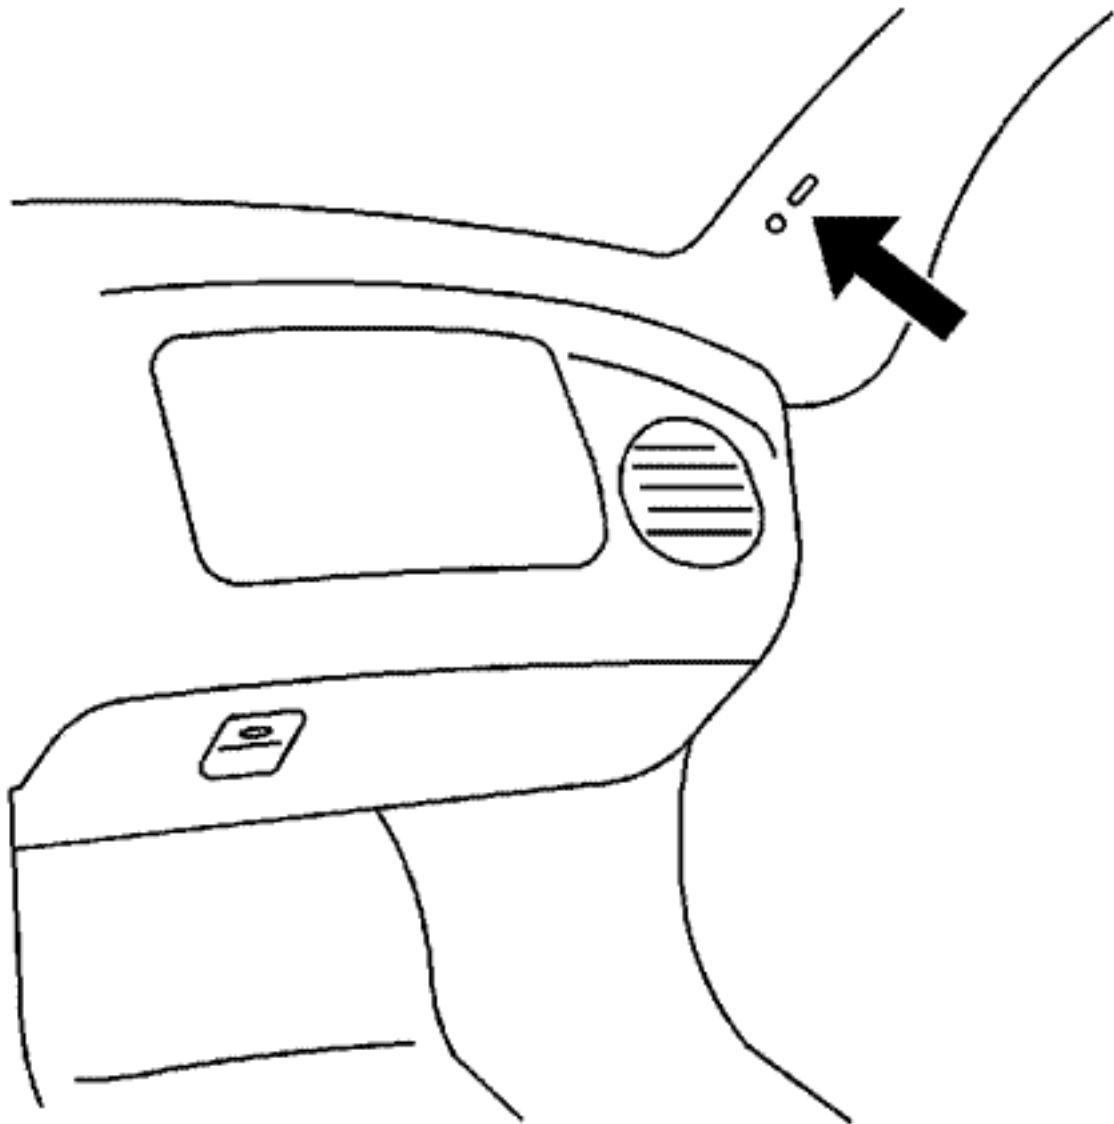
Two screws may not be sealed under the "A" pillar garnish molding. Refer to the illustration. During water test with the "A" pillar molding off, there may be water coming out of either the garnish molding retaining hole or the wire harness retaining hole. Refer to the arrow in the illustration.

Seal the two screws with the Kent™ sealer listed below.

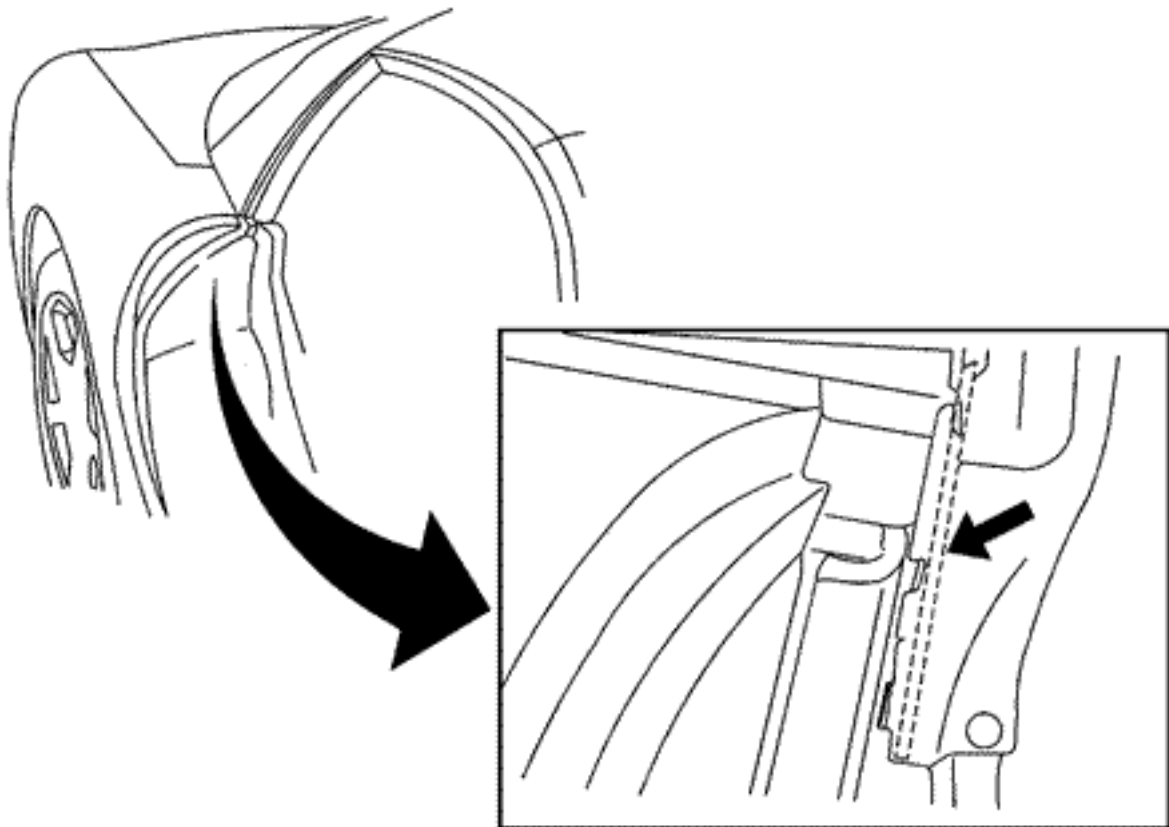
The floor is wet behind the seat belts.

The "B" pillar weatherstrip may not be sealed properly.

Reseal the weatherstrip with the GM sealer listed below. Refer to the dotted line in the illustration for sealing area.

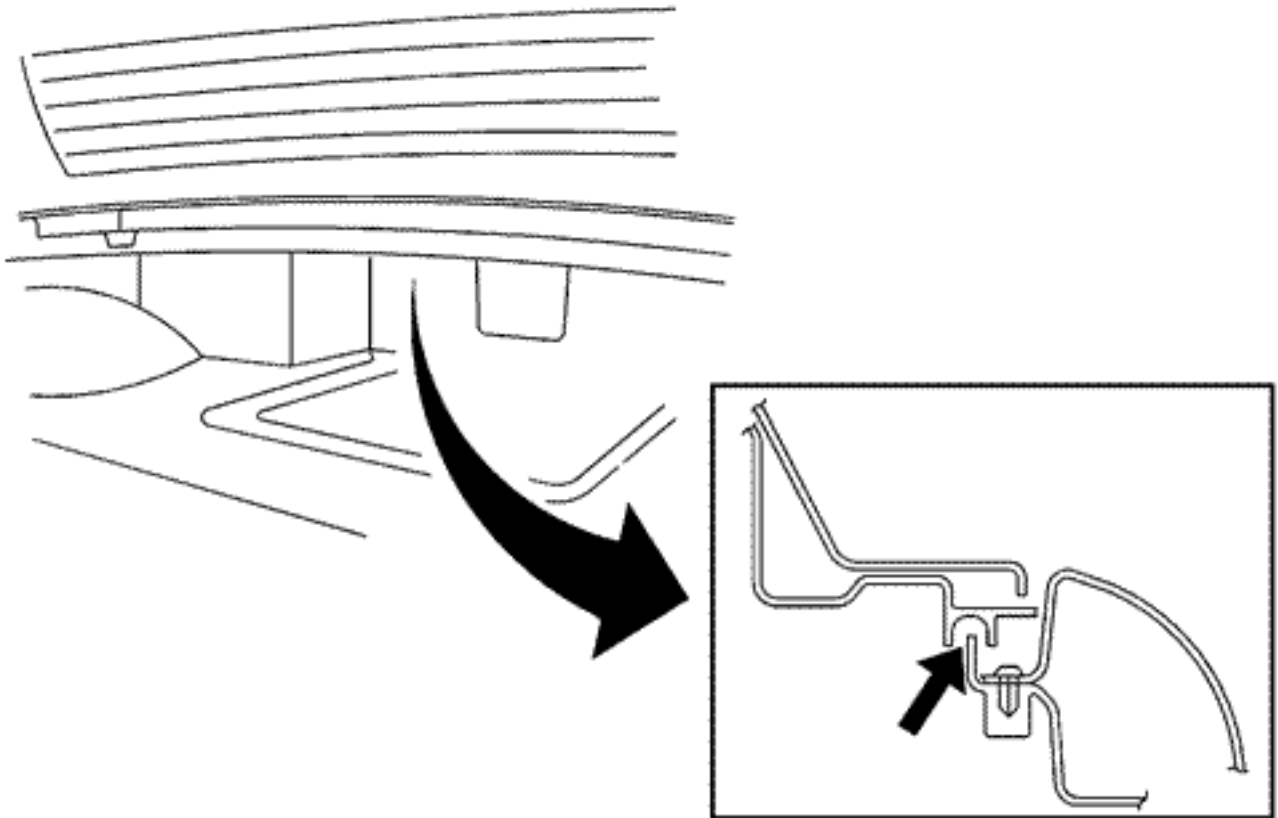
There may be a leak around the perimeter of the hard top causing water to drip from the garnish molding into the rear compartment.

There may be a void in the sealer between the body and the hard top.

Clean the area with one of the cleaners listed below and seal the area shown in the illustration with the Kent™ sealer listed below.

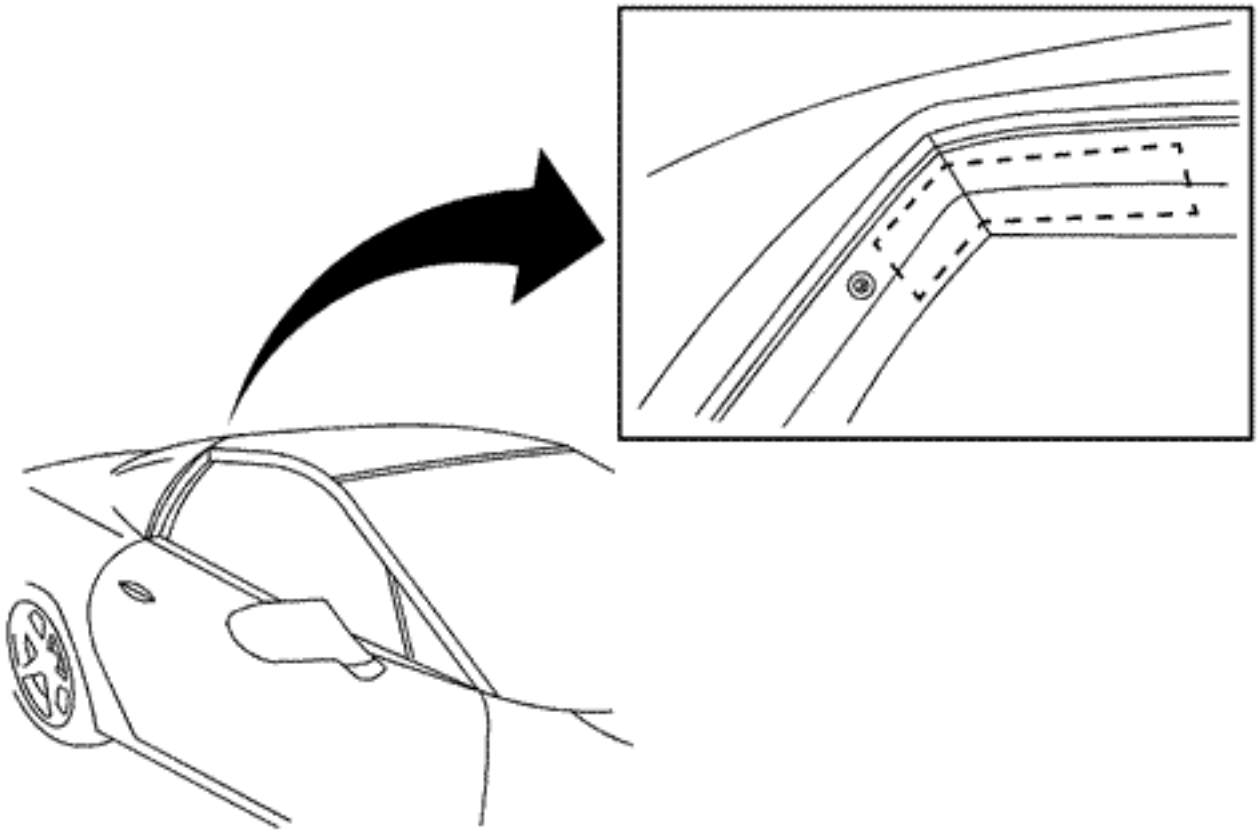
The floor is wet behind the seat belts (Hardtop/ Z06 only).

The top corner of the weatherstrip may not be sealed properly. Refer to the area shown in the illustration.

Reseal the weatherstrip with the GM sealer listed below. Refer to the sealer in the illustration.

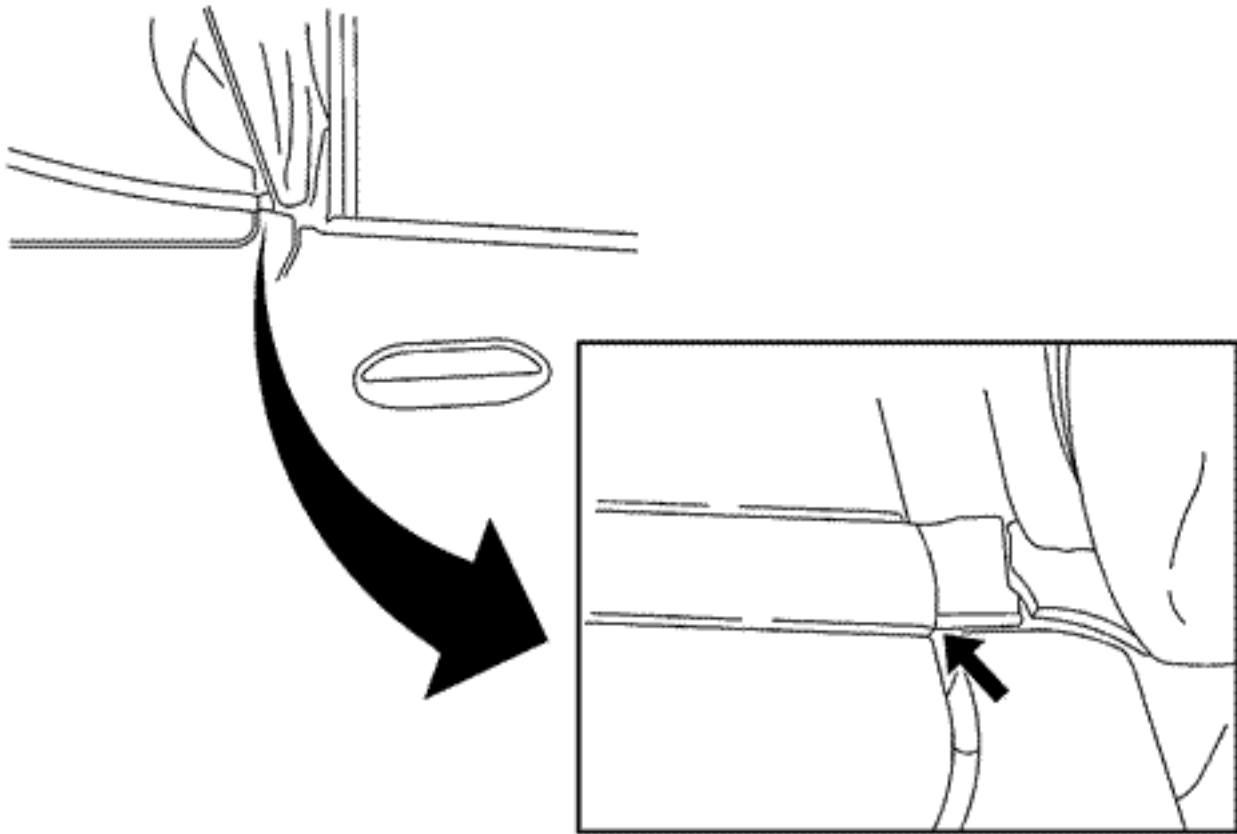
The floor is wet behind the seat belts or water seems to be entering through the hole in the interior trim panel where the seat belt feeds through.

The fit where the front edge of the convertible top stowage compartment lid "protector" contacts the rear edge "bulb seal" of the "mucket"\*. Refer to the illustration above.

The front edge of the stowage lid protector should overhang the stowage lid by approximately 3 mm (0.12 in). That 3 mm (0.12 in) overhang should then firmly contact the bulb seal rear edge of the mucket to complete the seal between the stowage lid and the lower "B" pillar.
