1997 - 1998 Corvette: Service Bulletin: Hiss Type Noise Coming From Weatherstrip When Closing Right or Left Door

Source: Chevrolet Dealer Technical Service Bulletin

Number: 83-15-07

Models: 1997-1998 Chevrolet Corvette Coupe and 1998 Chevrolet Corvette

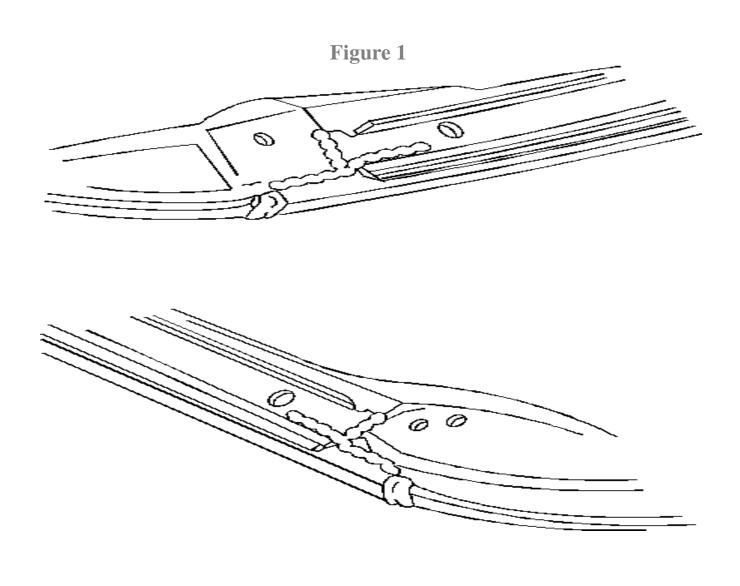
Condition: SOME CUSTOMERS MAY COMMENT ON A HISS TYPE NOISE COMING FROM THE WEATHERSTRIP WHEN CLOSING THE RIGHT AND/OR LEFT DOOR WITH THE GLASS IN THE FULL UP POSITION.

- 1. REMOVE THE WEATHERSTRIP ABOVE THE DOOR GLASS AND CUT AN AIR RELIEF HOLE 3MM WIDE (.12 IN) BY 10MM LONG (.4 IN) IN THE BACK OF THE WEATHERSTRIP.
- 2. RESEAL THE FRONT AND REAR CORNERS ON THE COUPE OR THE FRONT CORNER OF THE CONVERTIBLE WITH WEATHERSTRIP ADHESIVE; 3M(R) P/N 08011, OR EQUIVALENT. SEE FIGURE 1.
- 3. REINSTALL WEATHERSTRIP.
