# 1992 Corvette ZR-1: Service Bulletin: Lack of Wide Open Throttle Engine Underpower

**Subject:** LACK OF WOT-LOW ENGINE POWER REVISED CABLE ADJUSTMENT PROC.

**Model and Year:** 1992 CORVETTE ZR-1 WITH 5.7L ENGINE AND MANUAL TRANSMISSION

**Bulletin Number:** 92-214A-7B - (07/01/1992)

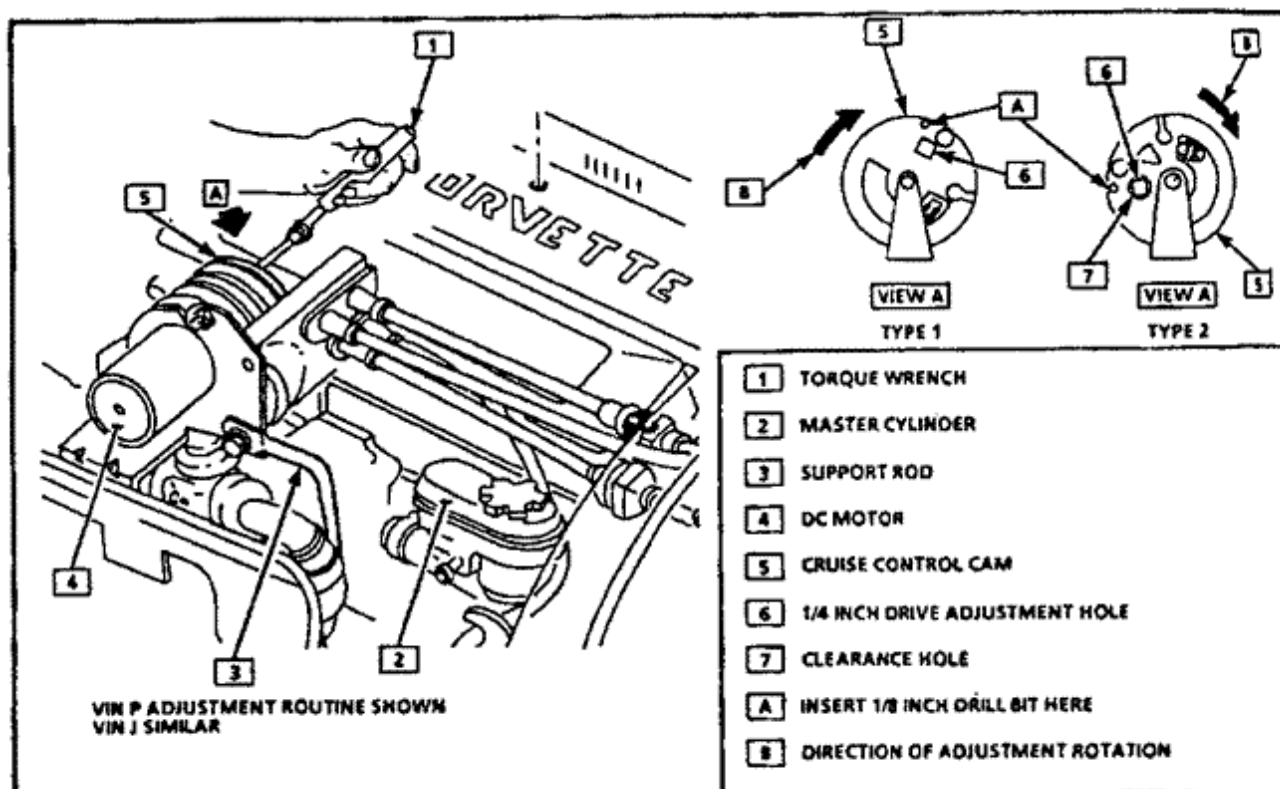
Cable Adjustment Mechanism

Customers with VIN up to 800227 may comment about lack of wide open throttle or low engine power for their 1992 model year Corvette ZR-1.

Adjustment procedures revised at assembly plant.

• ALWAYS MAKE SURE CABLE SHEATHS ARE AT THEIR FULLY EXTENDED POSITION BEFORE PERFORMING ADJUSTMENT PROCEDURE

1. Remove adjuster cam assembly splash cover, foam shield, and cable cam cover.
2. Disconnect cruise control cable from the cruise control servo.
3. Depress reset button on the throttle control cable and fully extend cable sheaths (see figure).
4. Insert a 1/8 inch drill bit into adjuster assembly alignment hole (see figure, item A).

5. Insert a torque wrench with a 1/4 inch drive extension into square hole on the cruise control cam (type 1) or through the cruise control cam into the accelerator cam (type 2) (see figure, item 6).
6. Turn the torque wrench clockwise until obtaining a torque of 4 N.m (35 lbs. in.). During adjustment, several clicks of the adjuster should be heard. If not, repeat step 3.
7. Remove the torque wrench AND drill bit.
