# 1992 Corvette ZR-1: Service Bulletin: Lack of Wide Open Throttle Engine Underpower

**Subject:** LACK OF WOT-LOW ENGINE POWER REVISED CABLE ADJUSTMENT PROC.

**Model and Year:** 1992 CORVETTE ZR-1 WITH 5.7L ENGINE AND MANUAL TRANSMISSION

**Bulletin Number:** 92-214A-7B - (07/01/1992)

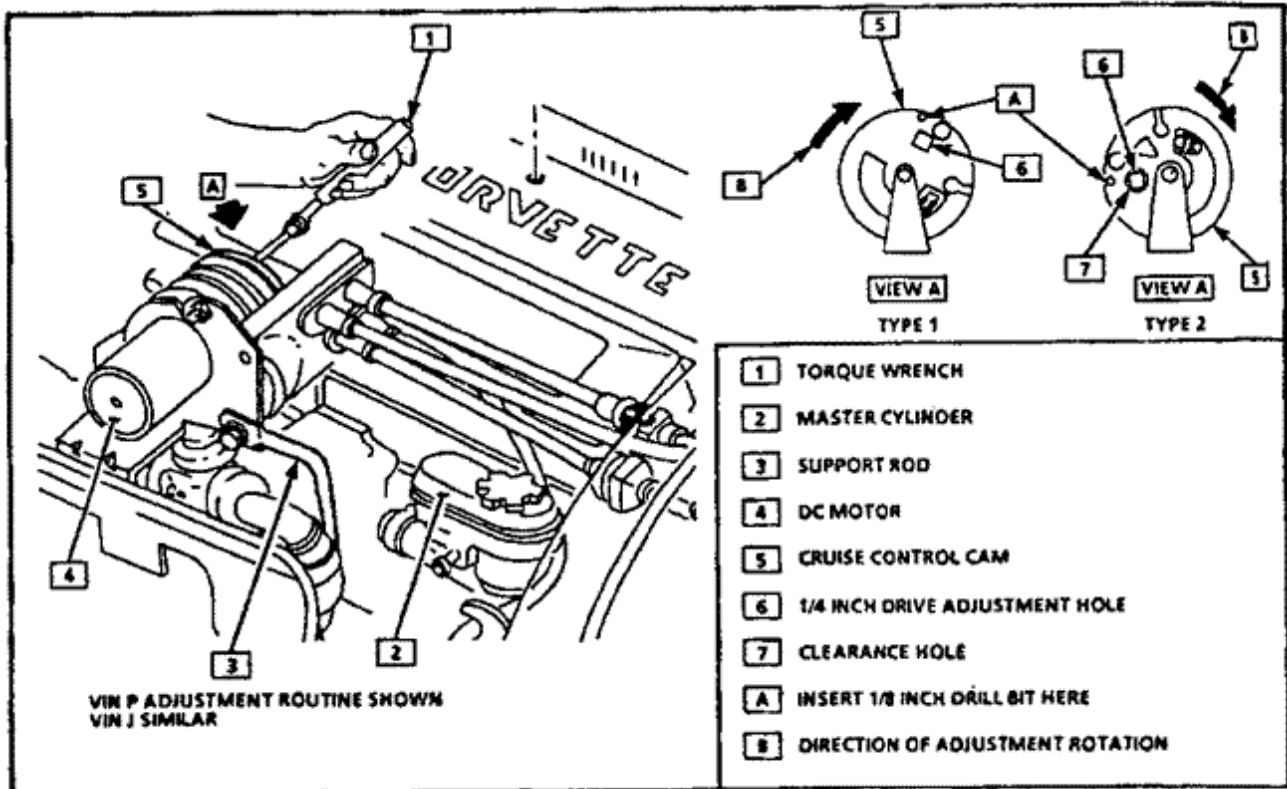
Cable Adjustment Mechanism

Customers with VIN up to 800227 may comment about lack of wide open throttle or low engine power for their 1992 model year Corvette ZR-1.

Adjustment procedures revised at assembly plant.

1. Remove adjuster cam assembly splash cover, foam shield, and cable cam cover.
2. Disconnect cruise control cable from the cruise control servo.
3. Depress reset button on the throttle control cable and fully extend cable sheaths (see figure).
4. Insert a 1/8 inch drill bit into adjuster assembly alignment hole (see figure, item A).

**\*\* NOTICE \*\*** Make certain the drill bit does NOT contact the adjuster assembly gear or improper adjustment and throttle relaxer damage could result.

5. Insert a torque wrench with a 1/4 inch drive extension into square hole on the cruise control cam (type 1) or through the cruise control cam into the accelerator cam (type 2) (see figure, item 6).
6. Turn the torque wrench clockwise until obtaining a torque of 4 N.m (35 lbs. in.). During adjustment, several clicks of the adjuster should be heard. If not, repeat step 3.
7. Remove the torque wrench AND drill bit.

• ALWAYS MAKE SURE CABLE SHEATHS ARE AT THEIR FULLY EXTENDED POSITION BEFORE PERFORMING ADJUSTMENT PROCEDURE
