1991 Corvette: Service Bulletin: Squeak and Rattle Diagnosis Guide

Subject: SQUEAK AND RATTLE DIAG. GUIDE DIAGNOSTIC AID/CORRECTION

Model and Year: 1991 CORVETTE

Bulletin Number: 91-264-10 - (03/25/1991)

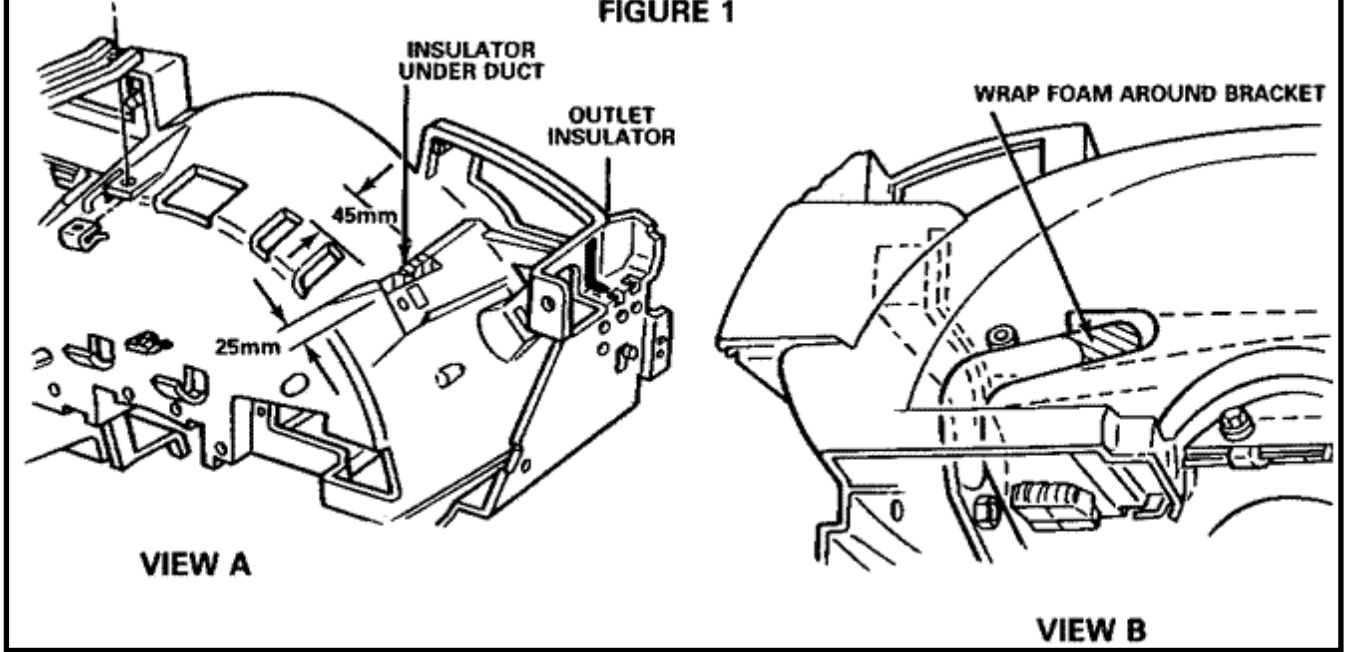
1. Buzzing against instrument 1. Apply felt insulator (1/2" X panel housing. 3"

as shown in Figure 2, view A). - A/C cross car duct

1. Rattle at top of instrument 1. Apply foam insulator (1/8") panel housing. to housing as shown in Figure 2, view A.

2. Rattle at left side SIR 2. Apply foam insulator (1/8") bracket. around bracket as shown in Figure 2 view B. - Instrumentation area

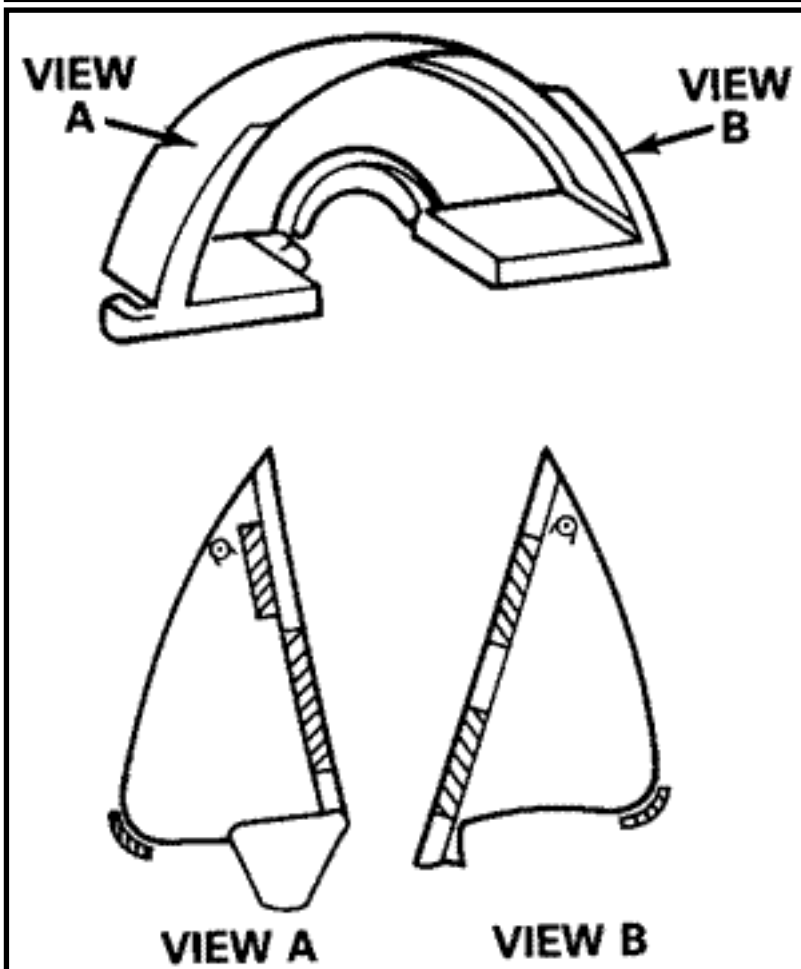
FIGURE 3

1. Squeak in instrument cluster 1. Apply felt insulators to bezel to cover. bezel edges and surfaces in locations as shown in Figure 3, views A and B.

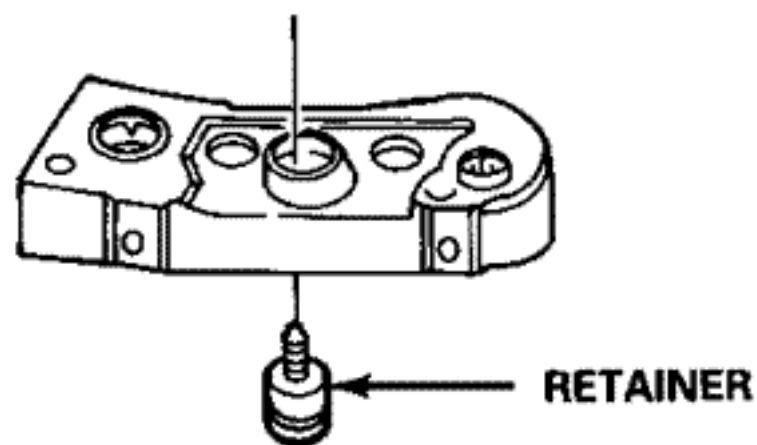
**REMOVABLE ROOF, FRONT
BOLT AND RETAINER**

1. Rattle of front attaching bolts 1. Install new bolt retainers, when panel is stowed in rear. P/N 10 1 75804, see Figure 8.

1. Soak new retainers in warm water to aid in installation.
2. Remove roof panel and stow.
3. Remove upper trim covers at right and left latch areas.
4. Remove right and left sun visors, inside mirror and center garnish molding.
5. Carefully pry original retainer and bolt out of housing using a flat blade screwdriver or other suitable tool.
6. Install bolt in new retainer, align locating rib on retainer with notch in housing and press into place with a "C" clamp and socket.
7. Reinstall garnish molding, inside mirror, sun visors and upper trim covers.

- **PRY BOLT & RETAINER OUT
OF HOUSING WITH FLAT
BLADED SCREWDRIVER**
- **ALIGN LOCATING RIB WITH
NOTCH IN HOUSING**
- **PRESS INTO PLACE WITH
'C' CLAMP**

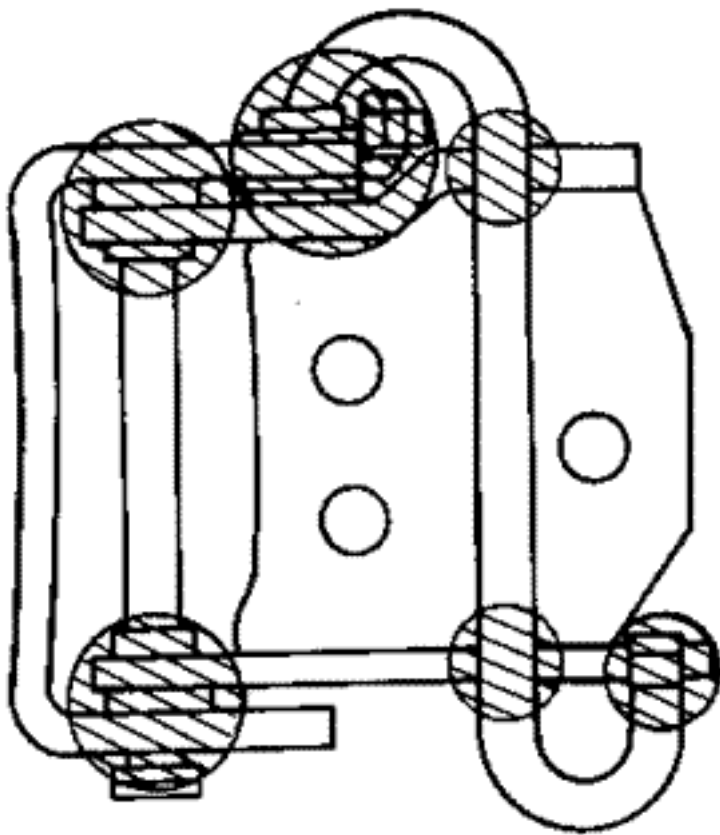
**LUBE AT SHADED AREAS
DOOR UPPER HINGE**

1. Squeaks when opening doors at 1. Lubricate ALL hinge torque hinge torque rod contact areas. rod contact areas with 30 wt. motor oil or grease, see Figure 9. UNDER THE HOOD ----- COMPONENT
