1991 Corvette: Service Bulletin: Squeak and Rattle Diagnosis Guide

Subject: SQUEAK AND RATTLE DIAG. GUIDE DIAGNOSTIC AID/CORRECTION

Model and Year: 1991 CORVETTE

Bulletin Number: 91-264-10 - (03/25/1991)

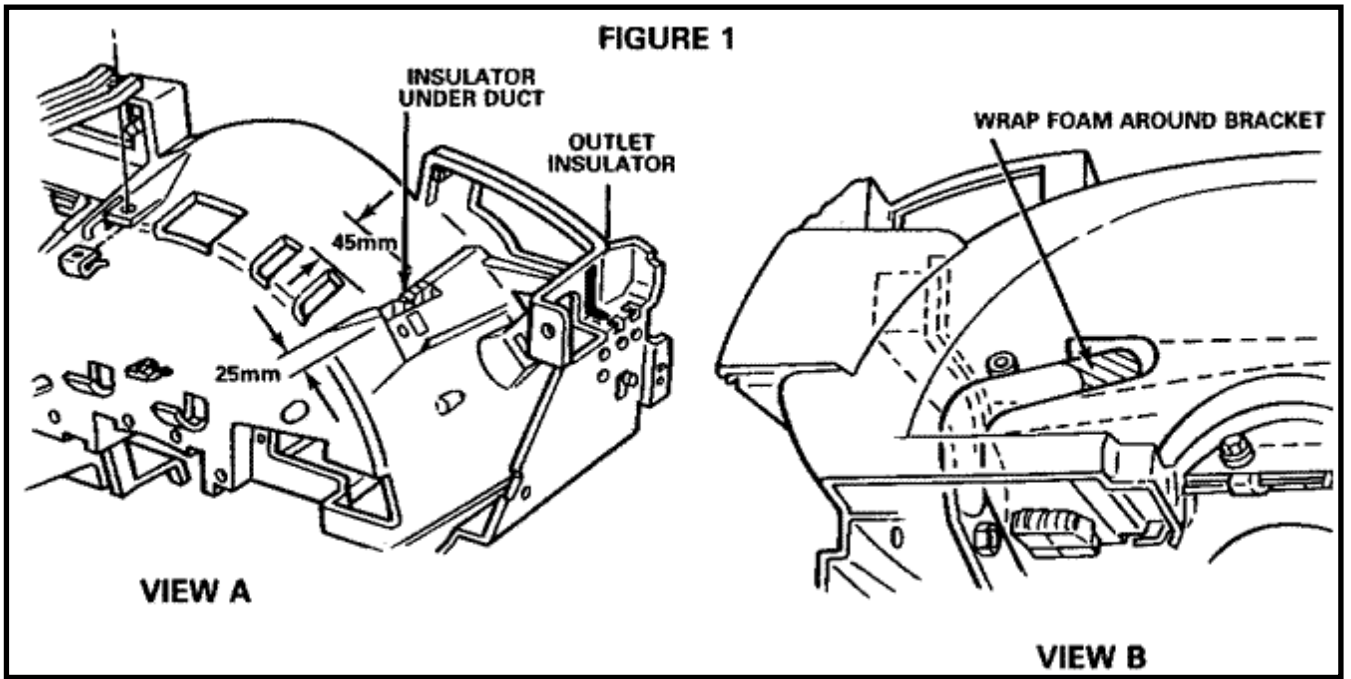
1. Buzzing against instrument 1. Apply felt insulator (1/2" X panel housing. 3"

as shown in Figure 2, view A). - A/C cross car duct

1. Rattle at top of instrument 1. Apply foam insulator (1/8") panel housing. to housing as shown in Figure 2, view A.

2. Rattle at left side SIR 2. Apply foam insulator (1/8") bracket. around bracket as shown in Figure 2 view B. - Instrumentation area
