1989 - 1990 Corvette: Service Bulletin: Improved Access to Inboard Seat Belt Buckle / New Extender

Subject: IMPROVED ACCESS TO INBOARD SEAT BELT BUCKLE/NEW
EXTENDER

Model and Year: 1989-90 CORVETTE WITH AQ9 SEATS

Bulletin Number: 90-291-10 - (06/22/1990)

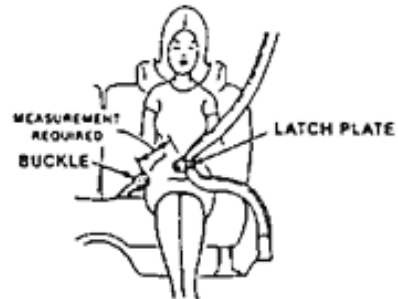
- 0 MEASURE FROM THE LEADING EDGE OF THE LATCH PLATE WITH THE BELT FULLY EXTENDED TO THE FRONT EDGE OF THE BUCKLE (FIGURE 1) AND NOTE DIMENSION BELOW:
