1984 - 1990 Corvette: Service Bulletin: Power Seat Inoperative and/or Blows Fuses

Subject: POWER SEAT INOP/BLOWS FUSES REPAIR/REPLACE HARNESS

Model and Year: 1984-90 CORVETTE

Bulletin Number: 90-412-10 - (03/18/1991)

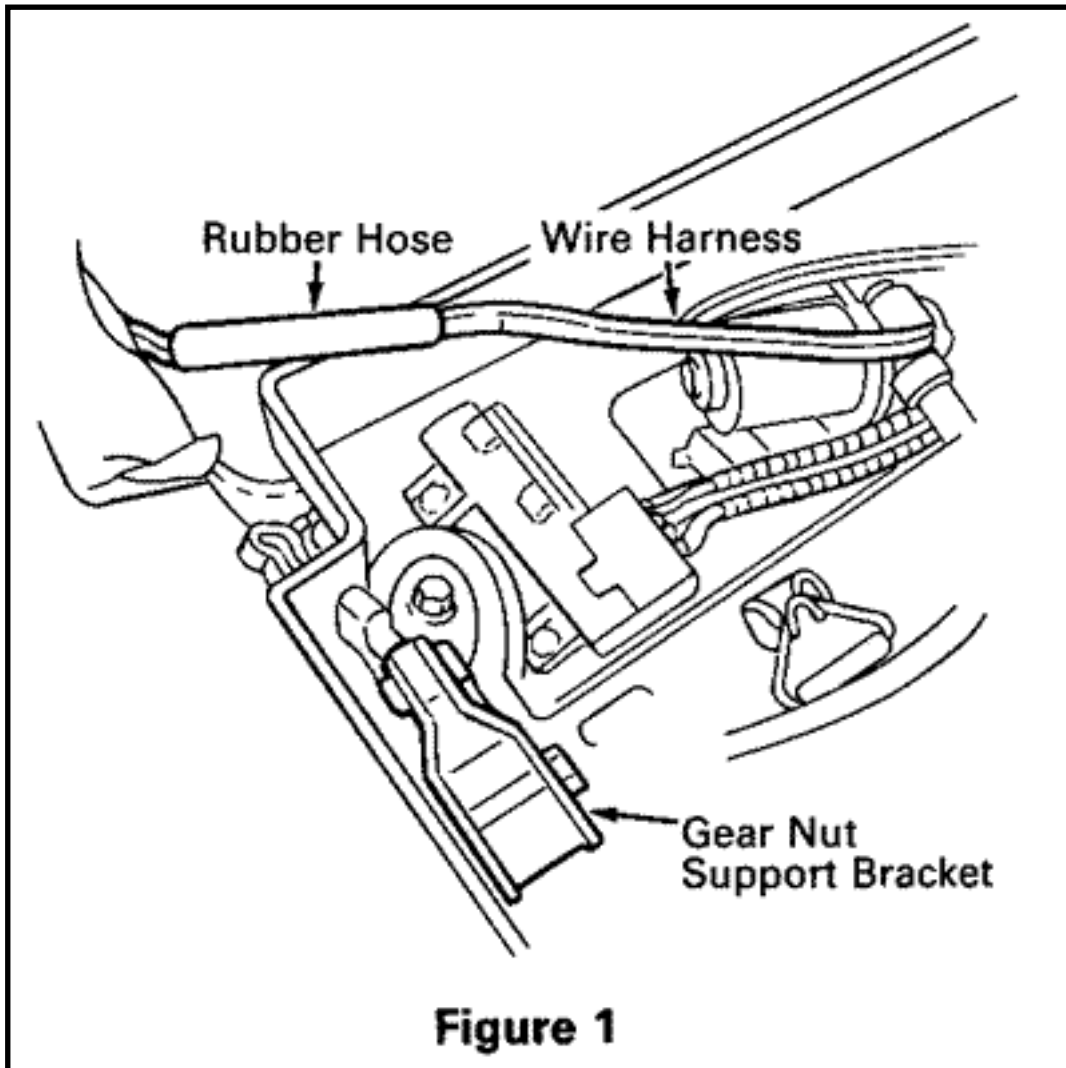
Power Seat (AQ9) inoperative and/or blows fuse.

Seat Control Switch Wire Harness may be shorted at gearnut support bracket. (See Illustration) With seat cushion installed, harness contacts gearnut support bracket and may become shorted with weight of driver/passenger.

Repair and/or replace harness as required. Using a section of rubber hose (gas line) about (4) inches long (split), cover harness as illustrated taping both ends.
