1984 - 1987 Corvette: Service Bulletin: Loose Corvette Door Trim Panel

Subject: Loose Corvette Door Trim Panel

Bulletin Number: 87-116, Number 10

Date: April, 1987

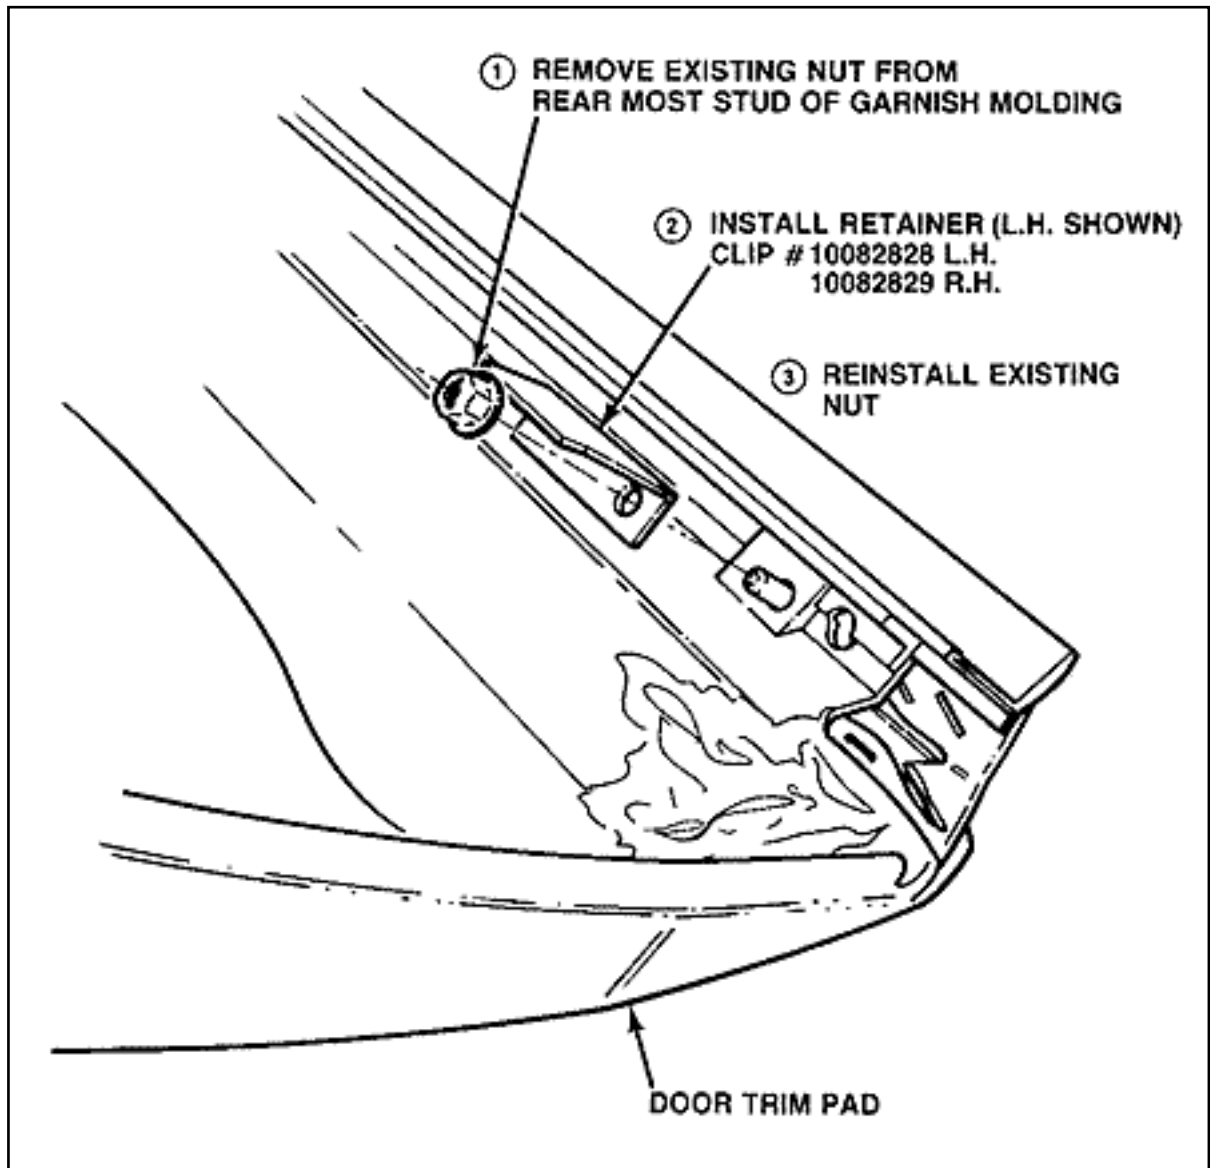
Some 1984-87 Corvette door trim pads may be loose from the door inner panel at the rear upper edge of the door.

If this condition is found it may be repaired by adding a retainer to the door trim panel using the following procedure.

1. Remove door trim panel per instructions in the Corvette Shop Manual.
2. Install retainer, P/N 10082828-9, L.H./R.H. as illustrated, to the trim pads rear upper garnish molding stud using spin nut. (See Illustration)
3. To remove a trim panel with a retainer, push trim panel upward and outboard to disengage clip from door inner panel at beltline.
