# 1992 - 1993 Corvette: Service Bulletin: Noisy/Fraying Accessory Drive Belt

**Subject:** NOISY/FRAYING ACCESSORY DRIVE BELT (INST. SINGLE-SIDED BELT)

**Model and Year:** 1992-93 CORVETTE WITH 5.7L (LT1) ENGINE

**Bulletin Number:** 93-273-6A

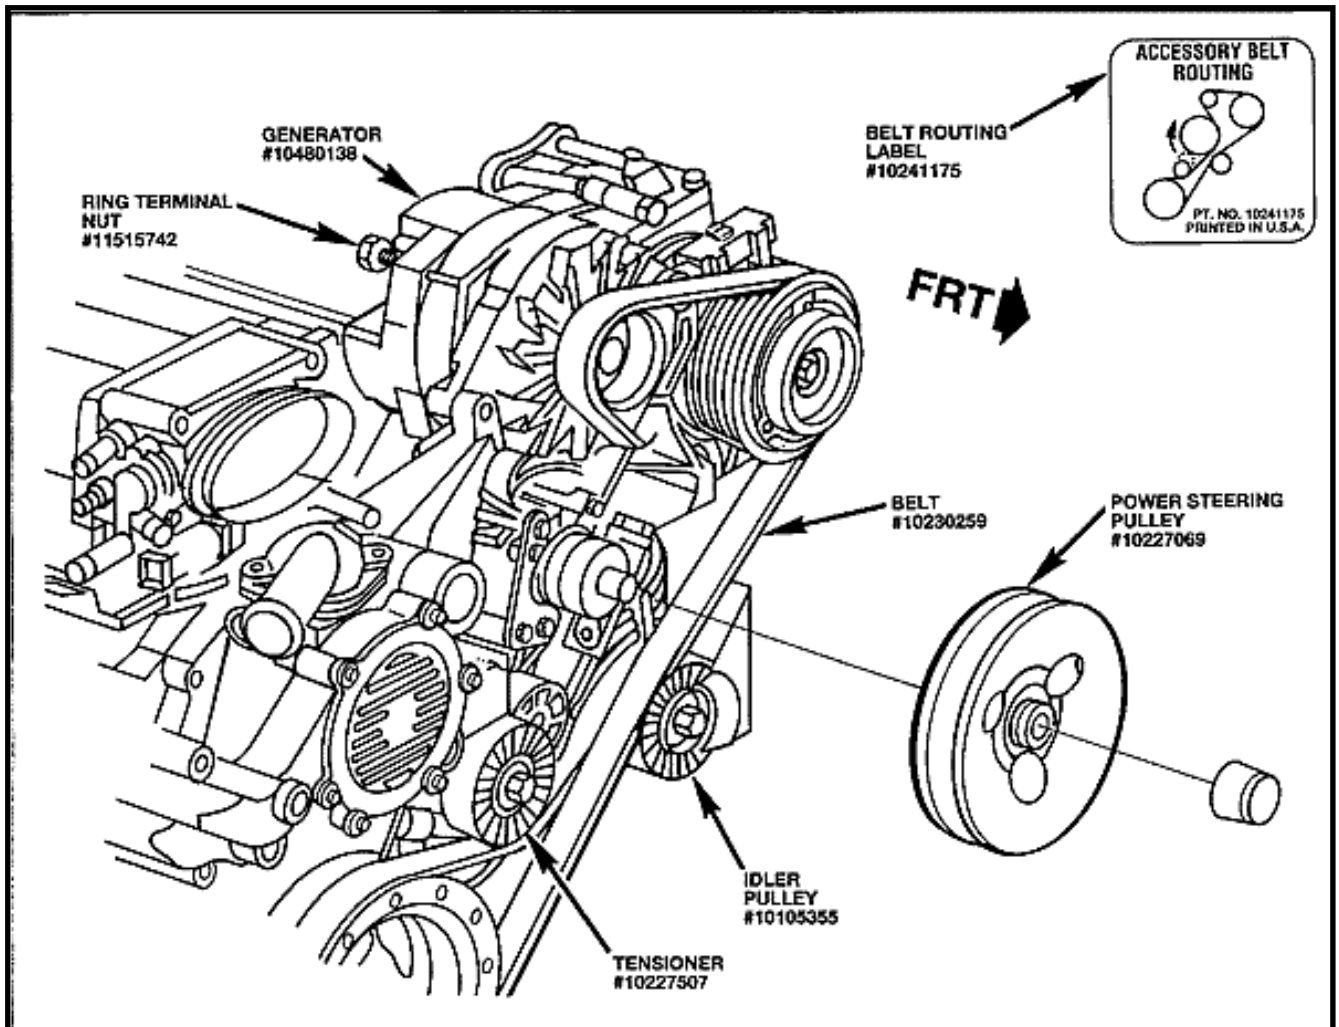
Some owners of 1992 and early 1993 model year Corvettes with 5.7L (LT1, VIN P) engines using the double-sided accessory drive belt may experience a noisy or fraying belt condition.

Inherent stresses and/or processing of the double-sided belt.

To correct this condition a change was made from the double-sided belt system to a new single-sided belt system. Starting the week of March 22,1993, VIN breakpoint #1G1YY23P4P5113150 Corvettes with LT1 engines were built with the new single-sided belt. To repair older units with the double-sided belt to a single-sided belt, the following parts must be installed:

**NOTE:** When replacing the new generator, the ring terminal on the wire harness will have to be opened up the 8.5mm to accommodate the larger stud on the back of the new generator.
