# 1992 Corvette: Recall: Optispark Distributor

**Subject:** OPTI-SPARK DIST. (REPLACE WITH NEW P/N)

**Model and Year:** 1992 CHEVROLET CORVETTE W/ LT1 ENGINE

**Bulletin Number:** 92C11 - (06/15/1992)

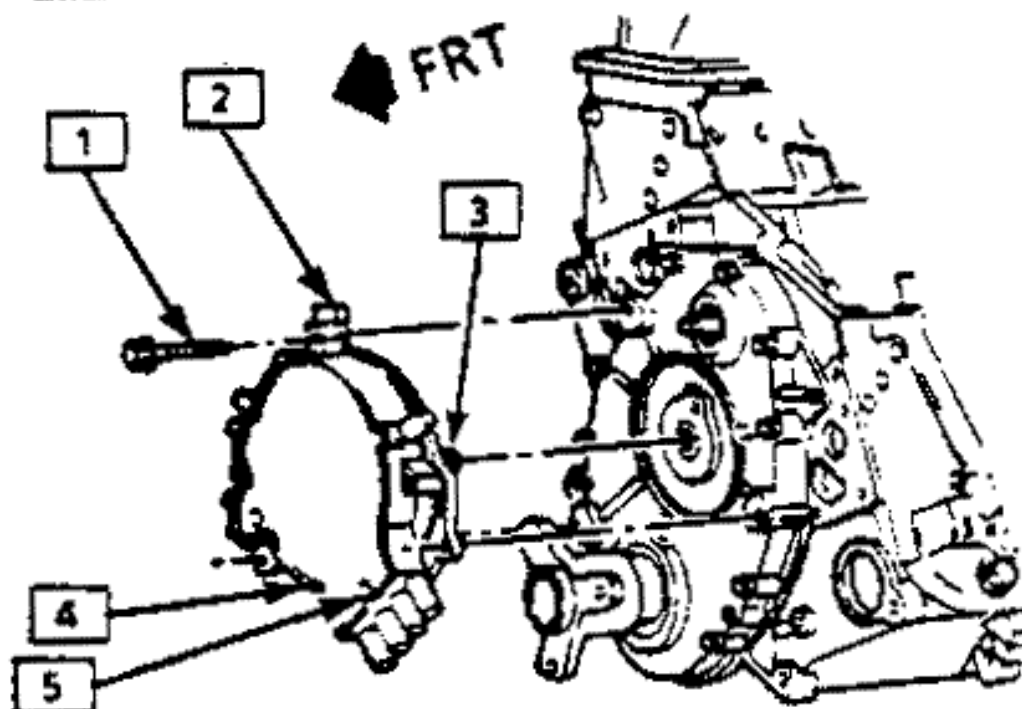
**Figure 3 - Distributor - (VIN P)**

General Motors has determined that certain 1992 Chevrolet Corvettes with LT1 engines (VIN code "P") have been equipped with Opti-Spark distributors which may develop a faulty low-resolution pulse signal. This condition may cause a "no-start" engine stall condition, along with a "Service Engine Soon" light (Code 16).

To correct this condition, dealers are to replace the distributor.

13. Remove three distributor mounting bolts. Pull distributor forward until drive shaft disengages from engine. Mark top surface of shaft to denote location during re-assembly (refer to Figure 3, page 6).
