1990 Corvette: Service Bulletin: SIR Diagnostics and Procedures to Prevent Codes 16 and 26 Due to Corrosion Revised

Subject: SERVICE MAN. UPDATE SEC.9J A/B REV. SIR DIAGNOSTIC PROCEDURE

Model and Year: 1990 CORVETTE

Bulletin Number: 90-436-9J - (11/07/1991)

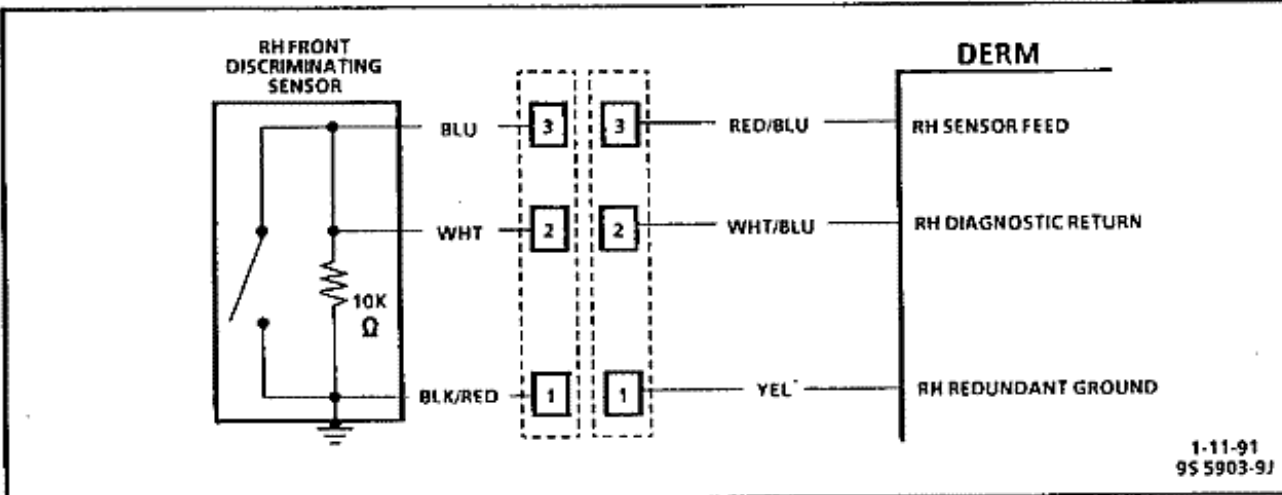
CODE 26 FRONT SENSOR #2 (RH) (SENSOR FAULT)

- 1
- IGNITION "OFF."
 - DISCONNECT SENSOR CONNECTOR.
 - USING ADAPTERS FROM J 37808-10 AND DVM J 34029-A OR DVM J 39200, MEASURE THE RESISTANCE BETWEEN TERMINALS IN THE SENSOR PIGTAIL CONNECTOR AS SHOWN BELOW. NOTE MEASUREMENTS FOR EACH CHECK.

SENSOR TERMINALS	RESISTANCE
1 AND 2	ABOUT 10,000 Ω
1 AND 3	ABOUT 10,000 Ω
2 AND 3	LESS THAN 1 Ω

- WERE ANY OF THE MEASUREMENTS OUT OF RANGE?

1 - BLK/RED
2 - WHT
3 - BLU

SENSOR
PIGTAIL
CONNECTOR
(Front View)

- 2
- REPEAT RESISTANCE MEASUREMENTS IN STEP 1 WHILE "WIGGLING" WIRING AND CONNECTORS. THIS MAY UNCOVER AN INTERMITTENT FAULT WHICH DOES NOT APPEAR DURING STEP 1.
 - WERE ANY INTERMITTENTS NOTED?

- 3
- REMOVE SENSOR; REFER TO "RIGHT SENSOR" ON ATTACHED PAGES.
 - CLEAN ANY PAINT AND/OR CORROSION FROM SENSOR AND FRAME RAIL MOUNTING POINTS AND MOUNTING BOLTS.
 - INSTALL SENSOR; REFER TO "RIGHT SENSOR" ON ATTACHED PAGES TO APPLY SPECIAL GREASE AND LOCK WASHERS UPON INSTALLATION TO HELP PREVENT RECURRENCE OF CODE 16 DUE TO CORROSION.
 - CLEAR CODES (TECH 1 PREFERRED).
 - IGNITION "OFF," THEN "ON."
 - DOES CODE 16 RESET?

- 4
- REMOVE SENSOR; REFER TO "RIGHT SENSOR" ON ATTACHED PAGES.
 - CLEAN ANY PAINT AND/OR CORROSION FROM FRAME RAIL MOUNTING POINTS AND MOUNTING BOLTS.
 - INSTALL NEW SENSOR; REFER TO "RIGHT SENSOR" ON ATTACHED PAGES TO APPLY SPECIAL GREASE AND LOCK WASHERS ON INSTALLATION TO HELP PREVENT RECURRENCE OF CODE 16 DUE TO CORROSION.
 - CLEAR CODES (TECH 1 PREFERRED).
 - IGNITION "OFF," THEN "ON."
 - DOES CODE 16 RESET?
