# 1995 - 1996 Corvette: Service Bulletin: Transmission Fluid Leak From Pump Body

**Subject:** Transmission Fluid Leak From Pump Body (Replace Bushing)

**Bulletin Number:** 57-71-26B

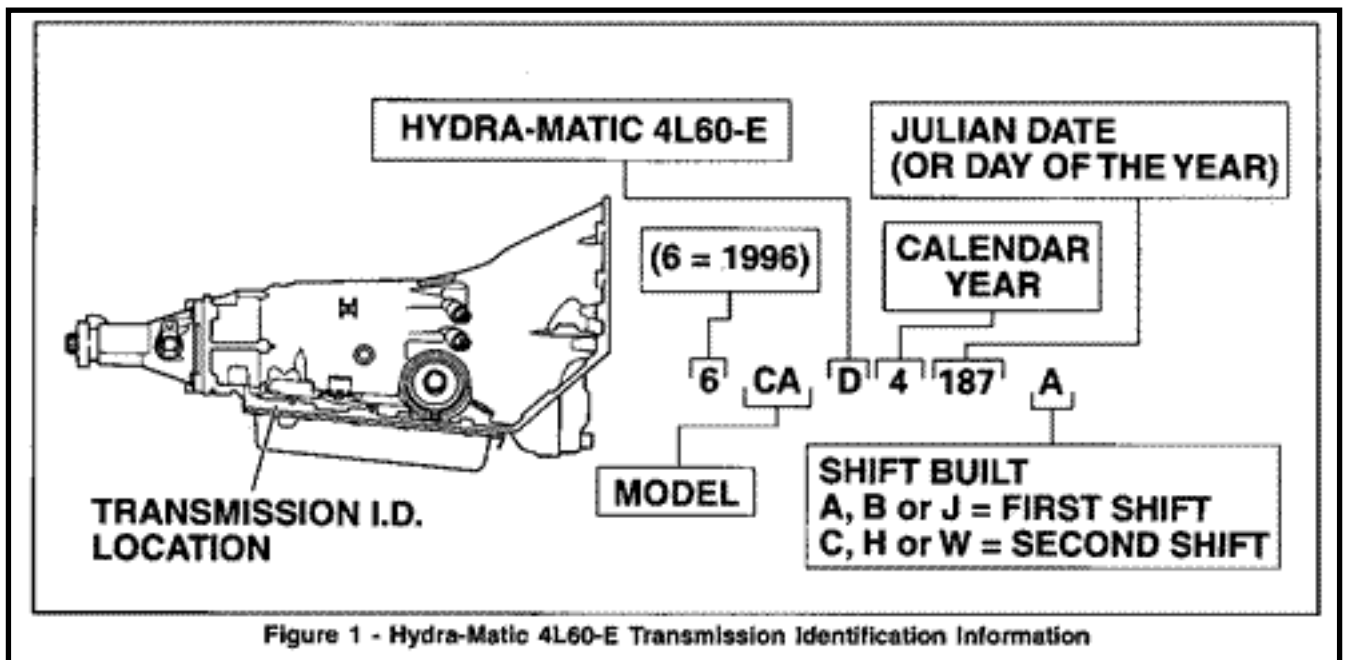
(FIGURE 1) SOME OWNERS MAY EXPERIENCE A PUMP FLUID LEAK. STARTING SEPTEMBER 11, 1995 (JULIAN DATE 254) ALL UNITS ARE BUILT USING A REVISED DESIGN BODY BUSHING.

THE PUMP BUSHING IS SPINNING OR WALKING OUT OF THE BODY.

REPLACE THE PUMP BODY BUSHING USING KENT-MOORE TOOL J41778.
