1995 - 1996 Corvette: Service Bulletin: Delayed Engagement (Replace Pump Cover Assembly)

Subject: Delayed Engagement (Replace Pump Cover Assembly)

Bulletin Number: 67-71-48

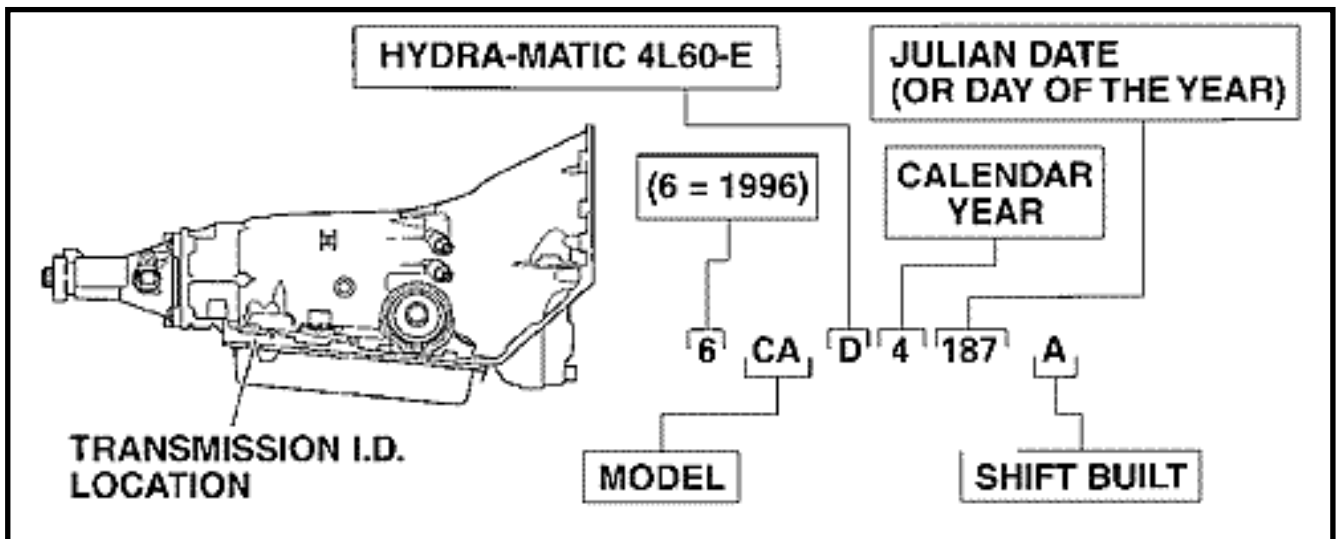
FIGURE 1. - HYDRA-MATIC 4L60-E TRANSMISSION IDENTIFICATION INFORMATION

(FIGURES 1 AND 2) SOME OWNERS OF THE ABOVE MODELS, WITH A HYDRA-MATIC 4L60-E TRANSMISSION (BUILT BEFORE APRIL 29, 1996/JULIAN DATE 6120), MAY EXPERIENCE SOME DELAYED ENGAGEMENT WHEN VEHICLE IS NOT USED FOR MORE THAN 48 HOURS.

TORQUE CONVERTER FLUID LEVEL LOW DUE TO FLUID DRAIN DOWN.
