# 1994 Corvette: Service Bulletin: Garage Shift Delay Engagement (New Garage Shift Package)

**Bulletin Number:** 47-71-20A

REVISION: 09/12/94

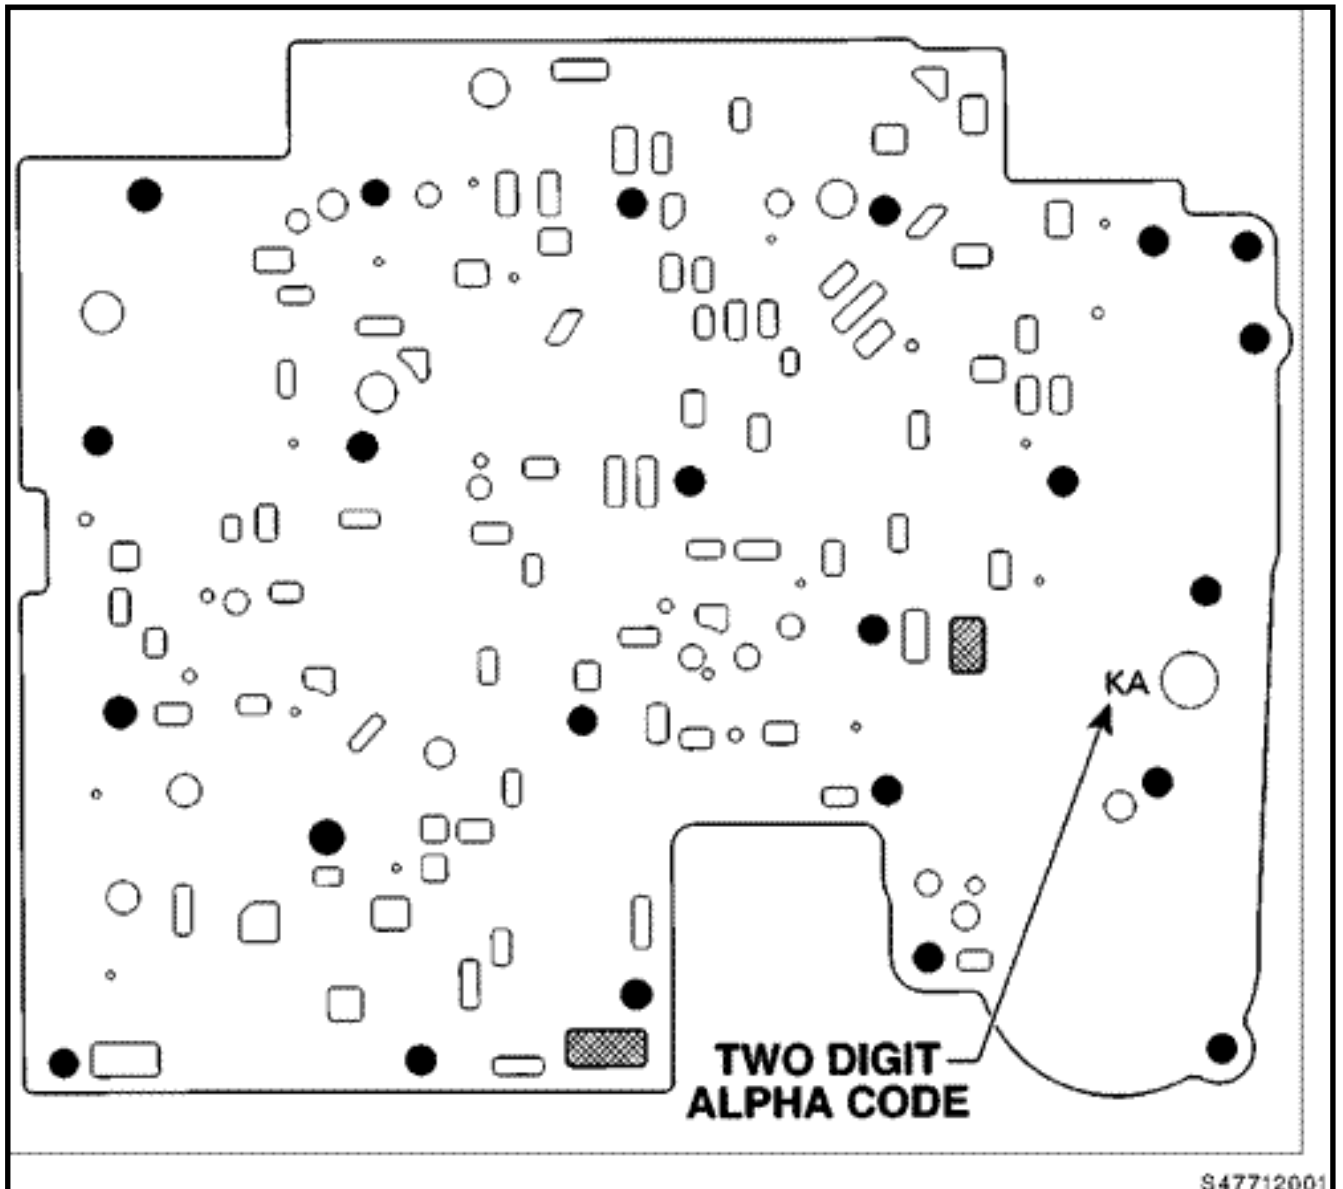
SOME VEHICLES EQUIPPED WITH A HYDRA-MATIC 4L60-E TRANSMISSION BUILT BEFORE MARCH 7, 1994 (JULIAN DATE 066) MAY EXHIBIT A DELAY WHEN SHIFTING FROM PARK TO REVERSE AND/OR SHIFTING FROM PARK TO DRIVE.

THE PARK TO DRIVE CONCERN IS CAUSED BY A DELAY IN THE FORWARD CLUTCH APPLICATION. THE PARK TO REVERSE CONCERN IS CAUSED BY A DELAY IN THE REVERSE INPUT CLUTCH APPLICATION. A DELAYED ENGAGEMENT IS WHEN SHIFTING FROM PARK TO DRIVE OR PARK TO REVERSE AND THE VEHICLE REQUIRES **\*\*MORE\*\*** THAN TWO (2) SECONDS TO ENGAGE REVERSE OR DRIVE.

TO CORRECT THE GARAGE SHIFT TIMING, INSTALL ONE OF THE FOLLOWING PACKAGES.

**NOTE: THE TRANSMISSION SPACER PLATE MUST ALSO BE REPLACED WITH AN ENHANCED GARAGE SHIFT PACKAGE SPACER PLATE, CONSULT YOUR PARTS CATALOG FOR THE PROPER SPACER PLATE PART NUMBER.**

THE NEW SPACER PLATES MUST BE USED WITH THE ENHANCED GARAGE SHIFT PACKAGE AND THE ORIGINAL SPACER PLATES MUST BE USED WITH THE ORIGINAL GARAGE SHIFT PACKAGE. THE SPACER PLATES AND GARAGE SHIFT PACKAGES ARE CALIBRATION SENSITIVE; MIXING SPACER PLATES AND GARAGE SHIFT PACKAGES MAY CAUSE PREMATURE FAILURE. WHEN A GARAGE SHIFT PACKAGE IS CHANGED, THE SPACER PLATE MUST ALSO BE CHANGED.
