# 1992 Corvette: Service Bulletin: Harsh 1-2 Upshift

**Subject:** HARSH 1-2 UPSHIFT INSTALL SERVICE PACKAGE

**Bulletin Number:** 92-318-7A - (09/15/1992)

TRANSMISSION APPLICATIONS: SUBJECT: 1992 HYDRA-MATIC 4L60 Harsh 1-2 Upshift ;Install Service Package

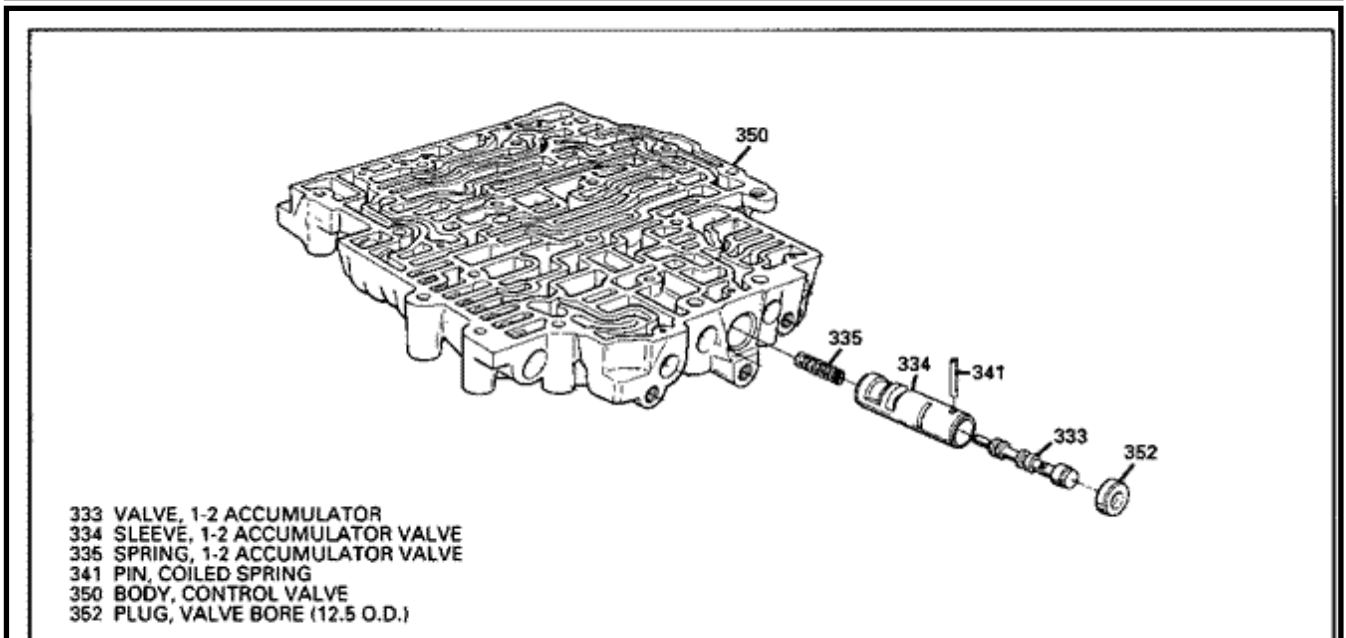
Figure 2

The above condition may be caused due to a tapered 1-2 accumulator sleeve. The tapered bore may cause the 1-2 accumulator valve to stick in the bottom of the bore.

To improve the 1-2 shift, install the service package listed in this bulletin. A 1-2 accumulator valve and 1-2 accumulator valve sleeve (which, normally, is not serviceable) is included in the package.
