1990 - 1991 Corvette: Service Bulletin: 3-2 Coast Down Clunk

Subject: 3-2 COAST DOWN CLUNK (INSTALL SERVO SPRING)

Model and Year: 1990-91 CORVETTE WITH 4L60 AUTOMATIC TRANSMISSION

Bulletin Number: 91-372-7A - (06/27/1991)

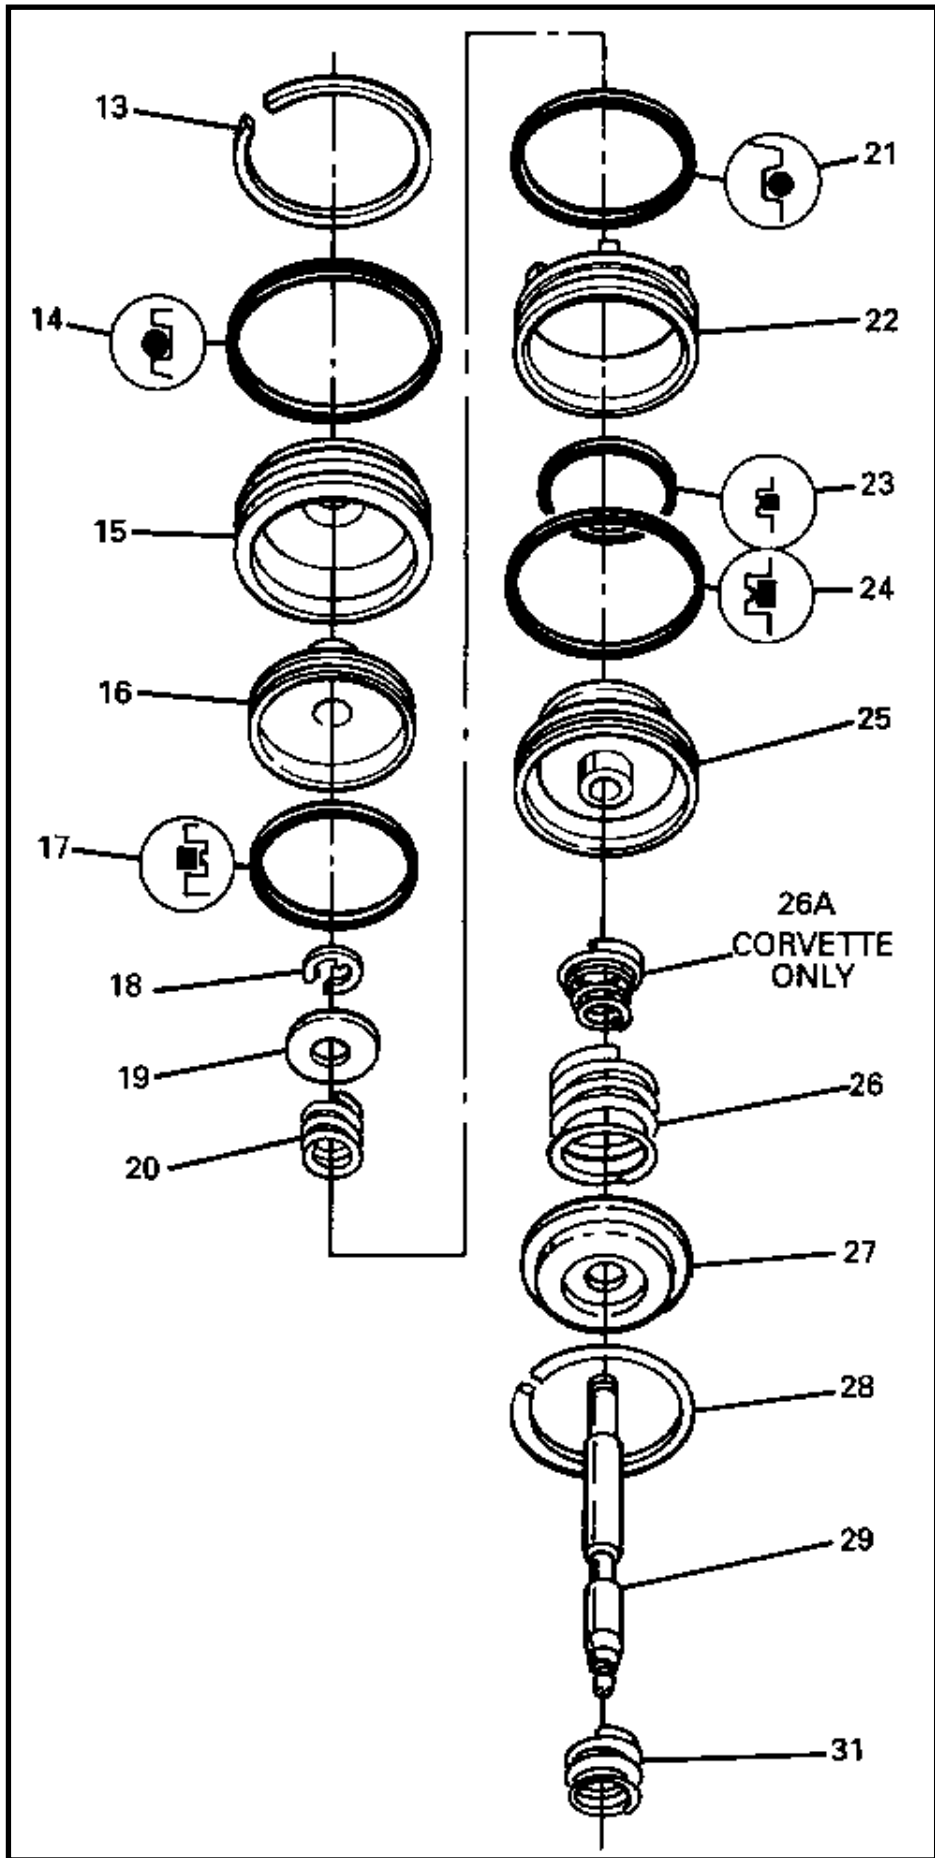
Refer to Figure 2

Some 1990 and 1991 Chevrolet Corvettes may experience a 3-2 coastdown clunk. The clunk can be felt around 10-14 miles per hour while lightly braking to a stop. It is most noticeable in D3 range, but can occur in D4 (overdrive) range.

A new 2-4 servo cushion assist spring and spacer plate have been released to alleviate this condition. The new spring is a conical spring which nests inside the current 2-4 servo cushion spring. The new spacer plate has a modified third clutch exhaust orifice.

Install the new servo cushion assist spring inside the current servo cushion spring as shown in figure 2. Figure 2 shows the ONLY way the spring should be installed. Do not install the spring upside down. The new spring should not be used by itself.

Refer to the Automatic Transmission Unit Repair Section of the appropriate service manual for spacer plate removal and installation information. The 2-4 servo cushion assist spring is not shown in a service manual. Follow instructions for installing a 2-4 servo cushion spring, and add the servo cushion assist spring as shown in figure 2 of this bulletin.
