1989 - 1996 Corvette: Service Bulletin: Information on Corvette ZF 6-Speed Manual Transmission Service Procedure

Model Year: 1989-96 CHEVROLET CORVETTE WITH ZF 6-SPEED MANUAL TRANSMISSION (ML9)

Source: Chevrolet Dealer Service Bulletin

Bulletin Number: 77-72-04

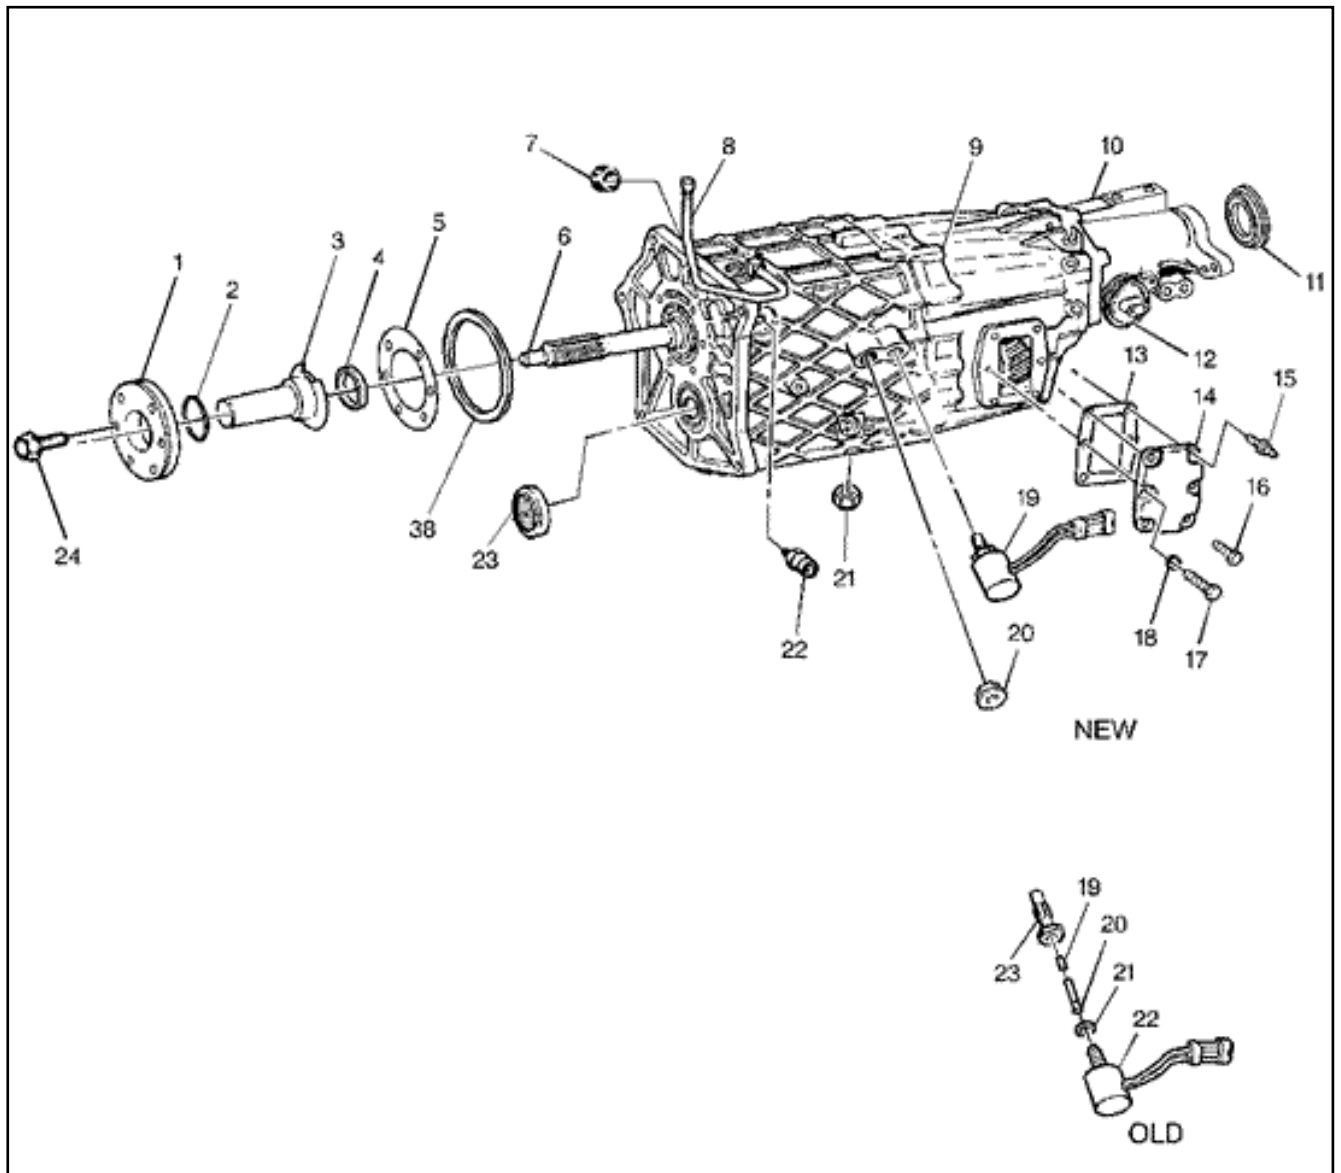
Figure 1

TRANSMISSION LEAKS A) EXTENSION HOUSING REPLACE REAR OIL FLUID EXTENSION SEAL LEAKS. (SEE HOUSING REAR OIL ILLUSTRATION) SEAL. (KENT

B) REVERSE IDLER REPLACE GASKET COVER LEAKS (SEE (SEE ILLUSTRATION) ILLUSTRATION.) NOTICE: REVERSE IDLER SHAFT CAN

C) OIL DRAIN PLUG CHECK FOR TIGHT LEAKS. (SEE FIT. ILLUSTRATION.)

D) BACKUP LAMP CHECK FOR TIGHT SWITCH LEAKS. (SEE FIT; REPLACE AS ILLUSTRATION) NECESSARY.

E) BREATHER TUBE CHECK FOR TIGHT LEAKS. (SEE FIT; REPLACE AS ILLUSTRATION) NECESSARY

CHANGE ITS POSITION. AFTER REMOVING COVER, SCREW IN REVERSE IDLER SHAFT BOLT (17) TO HOLD SHAFT IN POSITION.

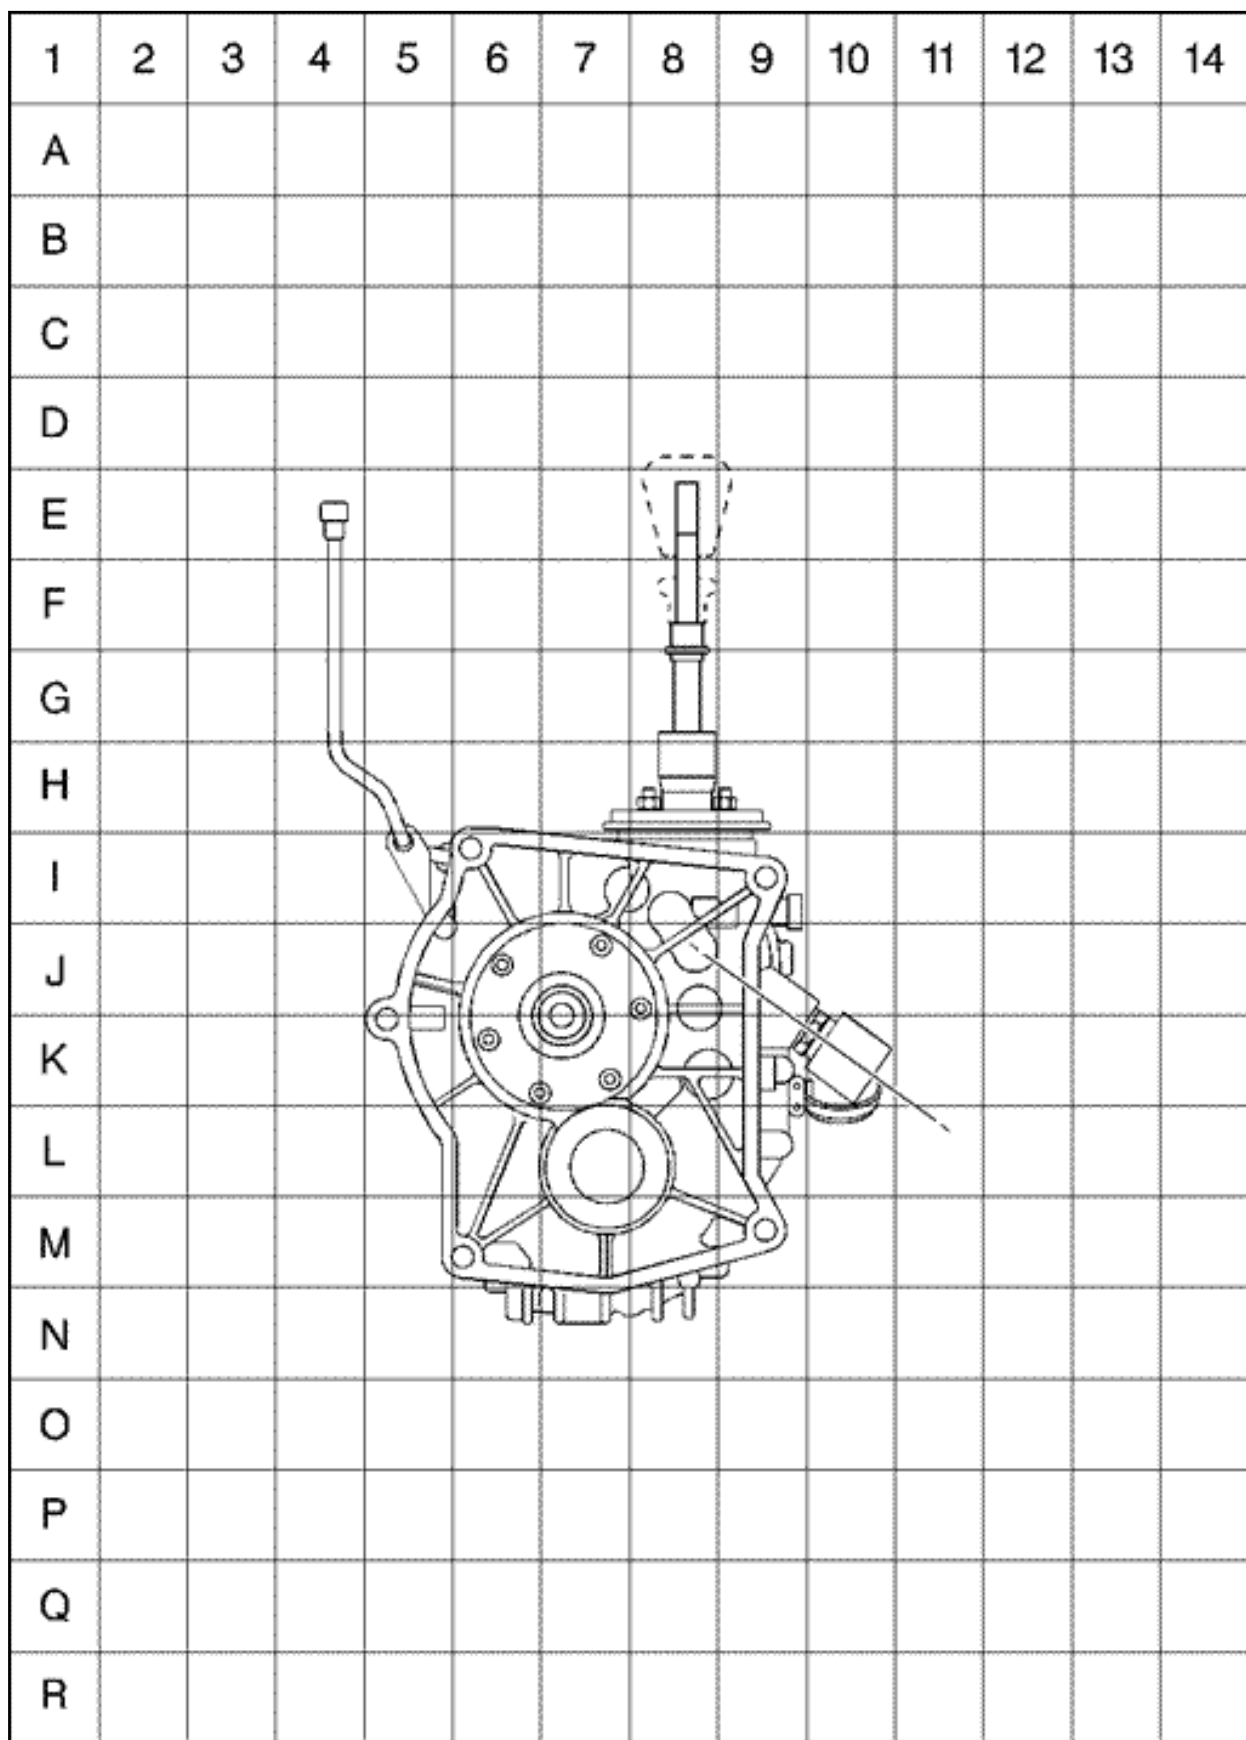
Figure 3

B) COUNTERSHAFT SEAL REPLACE COUNTERSHAFT LEAKS SEAL (SEE ILLUSTRATION). KENT MOORE SPECIAL TOOL #J29381 REQUIRED.
