# 1989 - 1991 Corvette: Service Bulletin: No/Delayed Reverse When Cold

**Bulletin Number:** 91-493-7A - (03/11/1992)

**SUBJECT: ----- No Reverse/Delayed Reverse Cold (Install Long Lipped Reverse Input Clutch Piston Outer Seal)**

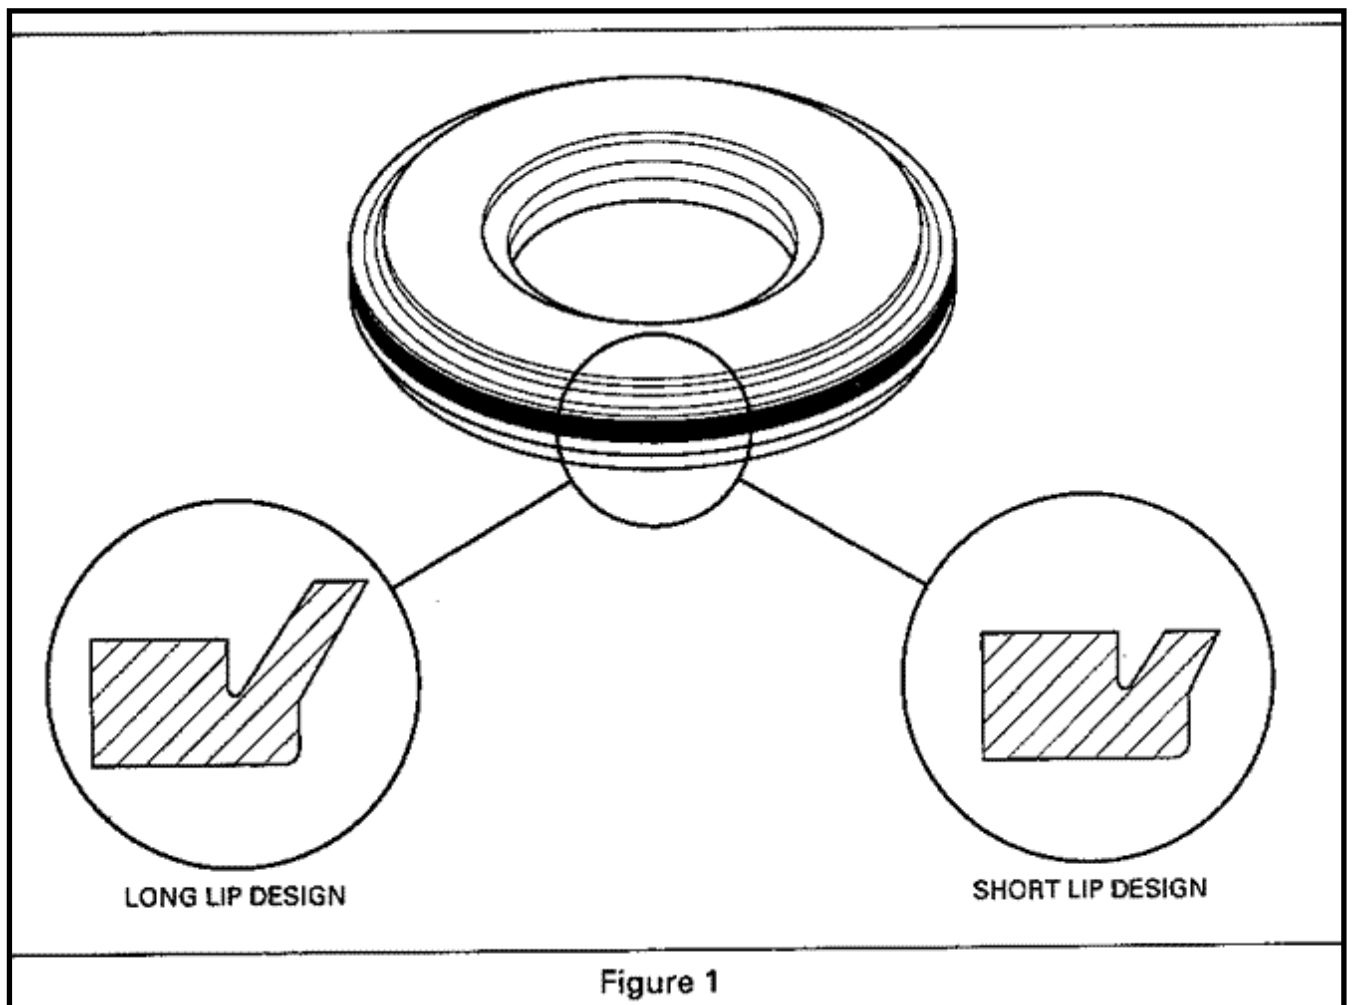
Some 1989-1991 HYDRA-MATIC 4L60 (THM 700-R4) transmissions may exhibit a 'no reverse' or 'delayed reverse' condition when outside temperatures are below zero degrees Fahrenheit.

If a transmission has a 'no reverse' or 'delayed reverse' condition, inspect the reverse input clutch piston outer seal. Determine if the seal is a 'short lip' or 'long lip' design by comparing it to Figure 1. If it is a short lip design, replace it with a long lip seal contained in the service packages listed under Service Parts Information.

If the reverse input clutch piston outer seal is a long lip design, or the newly installed long lip seal doesn't alleviate the delayed reverse condition, the reverse input clutch housing may be out of round. Inspect the housing and replace if necessary.
