1984 - 1985 Corvette: Service Bulletin: Improperly Installed Reverse Idler Shaft Roll Pin

Subject: IMPROPERLY INSTALLED REVERSE IDLER SHAFT ROLL
PIN

Model and Year: 1984-1985 CORVETTE

Bulletin Number: 85-31 - (01/09/1985)

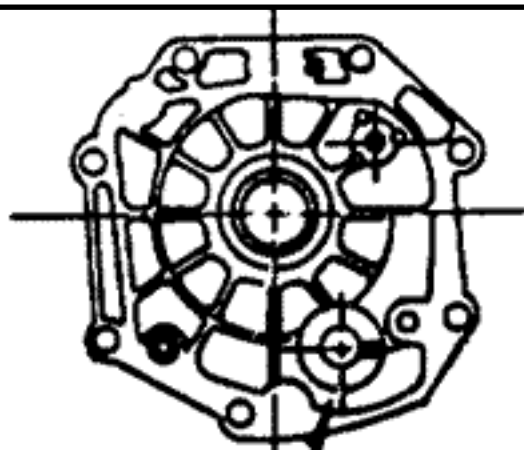
FIG. 1 REVER

Damage to the manual transmission may occur if the roll pin securing the reverse gear idler shaft to adapter plate (Figure 1) is not fully seated to prevent the shaft from spinning and/or backing out. To insure assembly operation results in the shaft securely locked in place, the roll pin has been lengthened from 0.50" to 0.75". When servicing transmissions with the shorter roll pin (0.50"), discard the roll pin and replace with longer roll pin (0.75") maximum.
