1984 - 1985 Corvette: Service Bulletin: Improperly Installed Reverse Idler Shaft Roll Pin

Model and Year: 1984-1985 CORVETTE

Source: Chevrolet Service Bulletin

Bulletin Number: 85-31 - (01/09/1985)

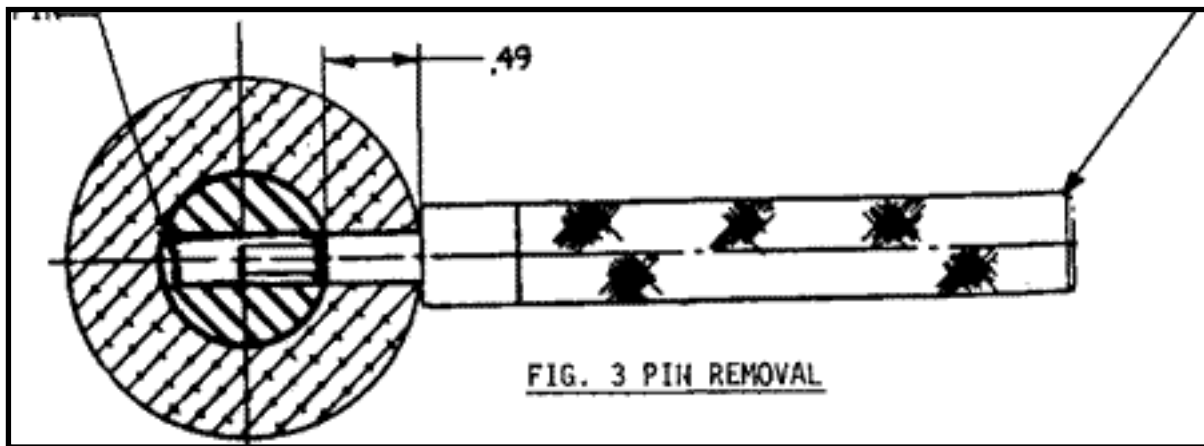
Driving roll pin too hard may cause to jam and result in shaft binding to adapter plate.

1. Insert small punch tool into plate boss hole and carefully drive roll pin into reverse idler shaft (Figure 3).

2. Pull reverse idler shaft from adapter plate and remove roll pin from shaft.
