1992 - 1993 Corvette: Recall: Power Steering Gear Inlet Hose

Subject: PRODUCT SAFETY CAMPAIGN 93CO2 - POWER STEERING GEAR INLET HOSE

Model and Year: 1992-93 CHEVROLET LT1 CORVETTE

Bulletin Number: 93C02

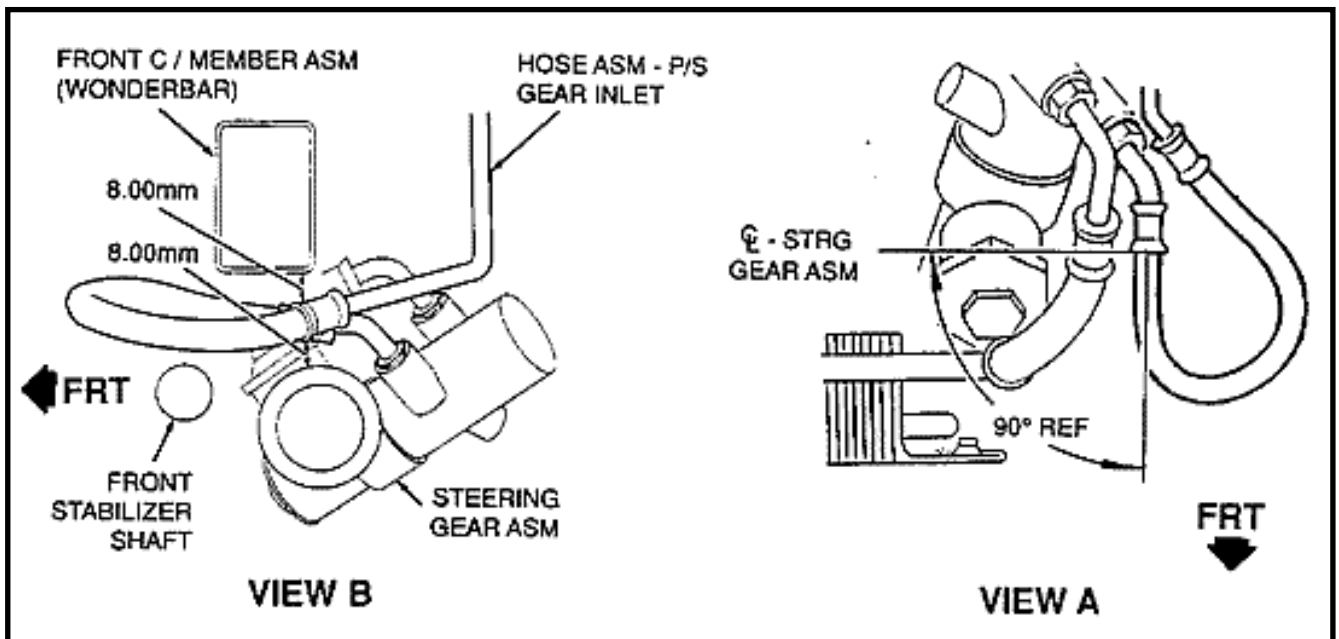
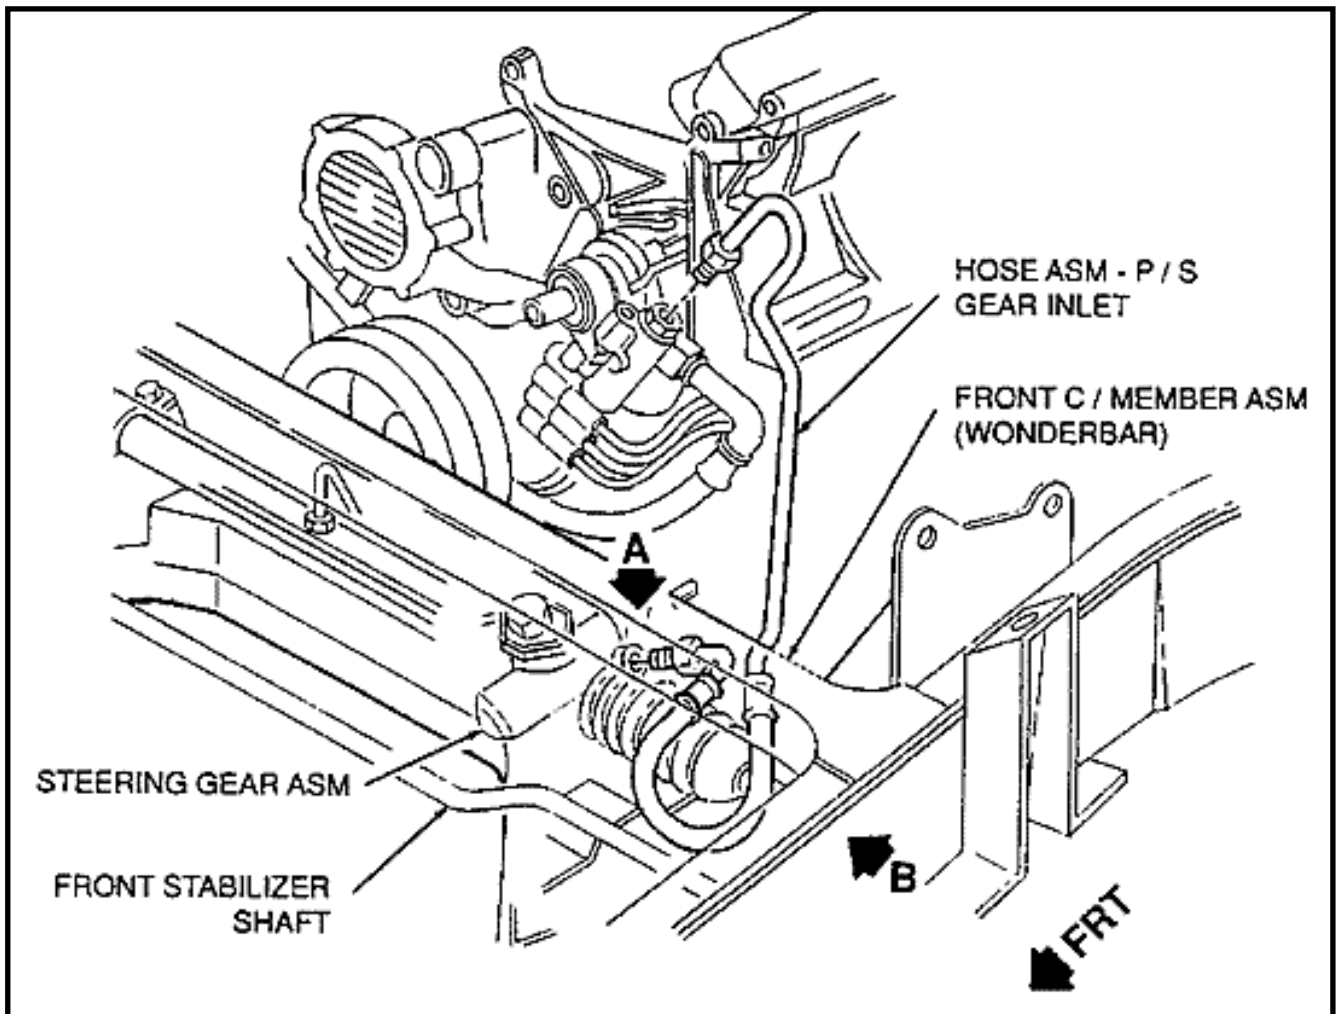
General Motors has determined that a defect which relates to motor vehicle safety exists in certain late 1992 and early 1993 Chevrolet Corvette model vehicles equipped with LT1 engines. These vehicles were assembled with a power steering gear inlet hose which may fracture. Since the fluid within this hose is under pressure, fracture of the hose could cause power steering fluid to spray out of the hose and, if an ignition source is present, an

engine compartment fire could occur.

1. Install new power steering gear inlet hose following procedures on page 3B-6 of either

the 1992 Corvette Service Manual (ST-364-92-1) or the 1993 Corvette Service Manual (ST-364-93PSID).

Notice: Be certain to leave adequate clearance between front cross-member and hose/pipe assembly. View B on page 4 illustrates proper clearance.
