# 1990 Corvette: Service Bulletin: Clicking Noise When Steering Wheel is Rotated

**Subject:** 'CLICKING' NOISE WHEN STEERING WHEEL IS ROTATED

**Model and Year:** 1990 CORVETTE

**Bulletin Number:** 90-327-3B - (08/03/1990)

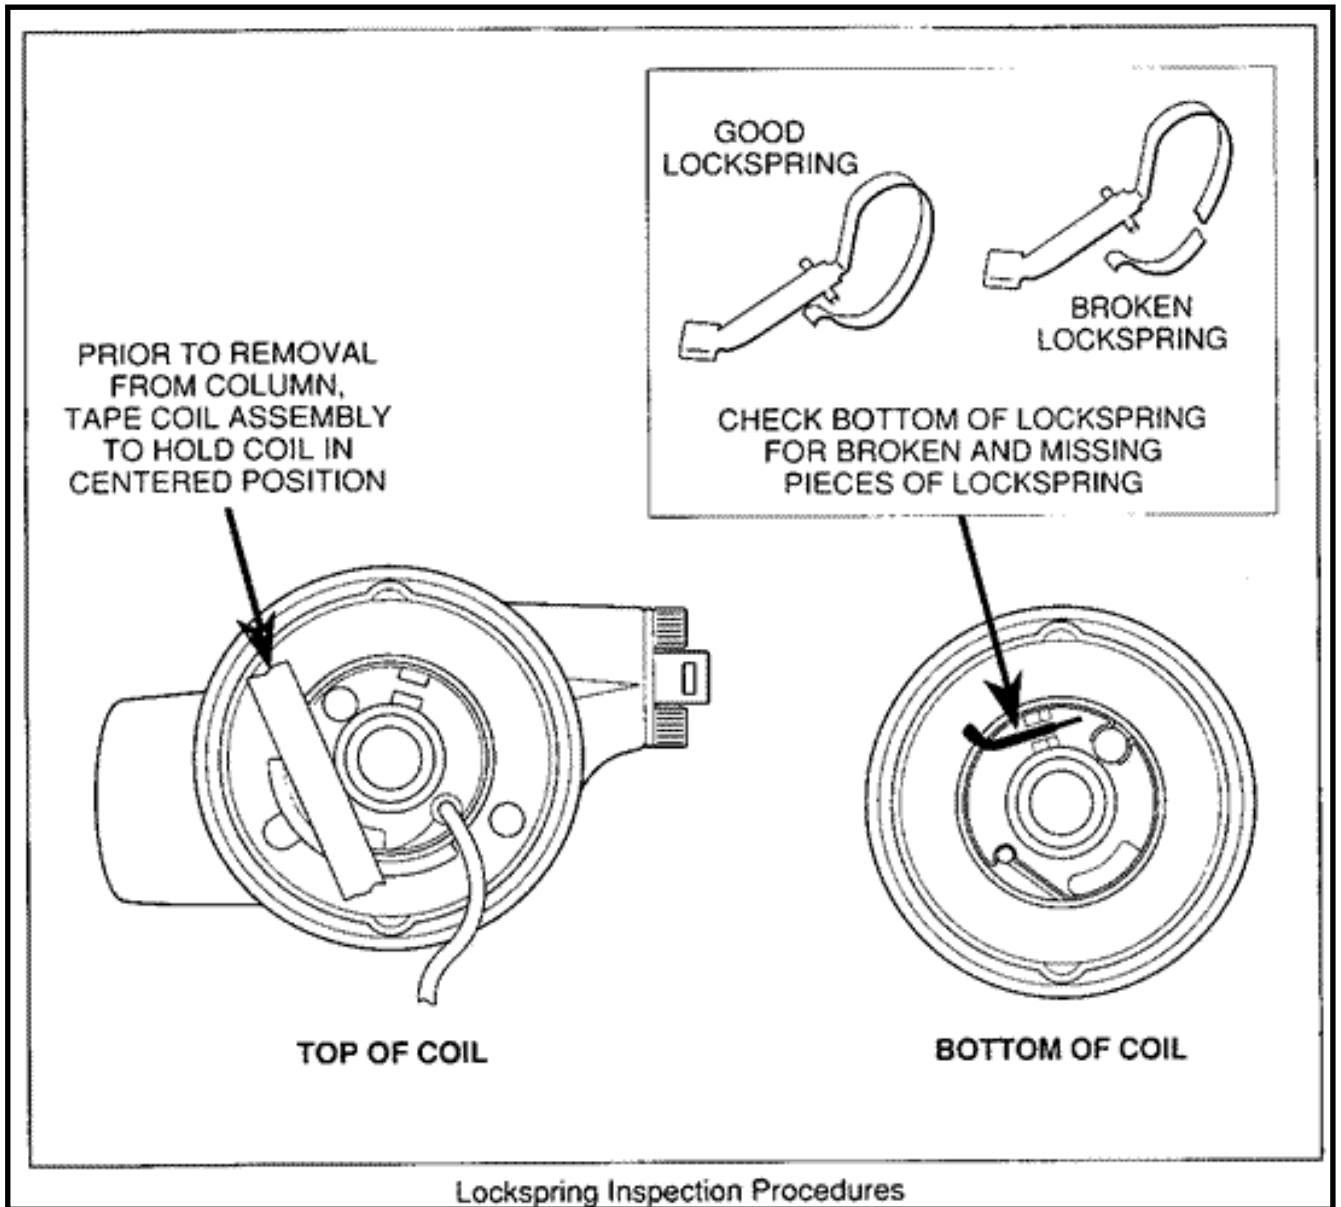
A "clicking" noise may be heard when the steering wheel is turned.

The Supplemental Inflatable Restraint (SIR) coil lockspring, which holds the coil in a centered position during service, may be missing or broken. The brass colored lockspring may not be strong enough to withstand compression during assembly. The SIR system continues to function normally.

1. Black lockspring - latest design, not subject to breakage.
2. Brass colored lockspring - early design, subject to breakage.
3. No lockspring - Some steering columns may have been built without locksprings from VIN's #1 14400 to #1 15822 (Man. Trans.) and #1 16055 (Auto. Trans.).

4. Refer to 1990 Corvette Service Manual for complete instructions on removing the coil assembly from the steering column. Before removing the coil assembly from the column, tape the coil assembly to hold it in the centered position, as shown in the illustration.

5. Remove the coil from the column, turn the coil over, and inspect the lockspring for broken or missing pieces as shown in the illustration.

a. If the lockspring is black, it is not subject to breakage. Leave the lockspring in place.

b. If the spring is brass colored, and is not broken, leave it in place.

c. If the spring is brass colored, and is broken, remove all the pieces of the spring and discard. It is not necessary to replace the lockspring with a new one.
