1988 - 1990 Corvette: Service Bulletin: Power Steering Shudder / Groan

Subject: POWER STEERING SHUDDER/GROAN INSTALL P/S COOLER & HOSE

Model and Year: 1988-90 CORVETTE WITH 5.7L ENGINE

Bulletin Number: 90-376-3B - (10/25/1990)

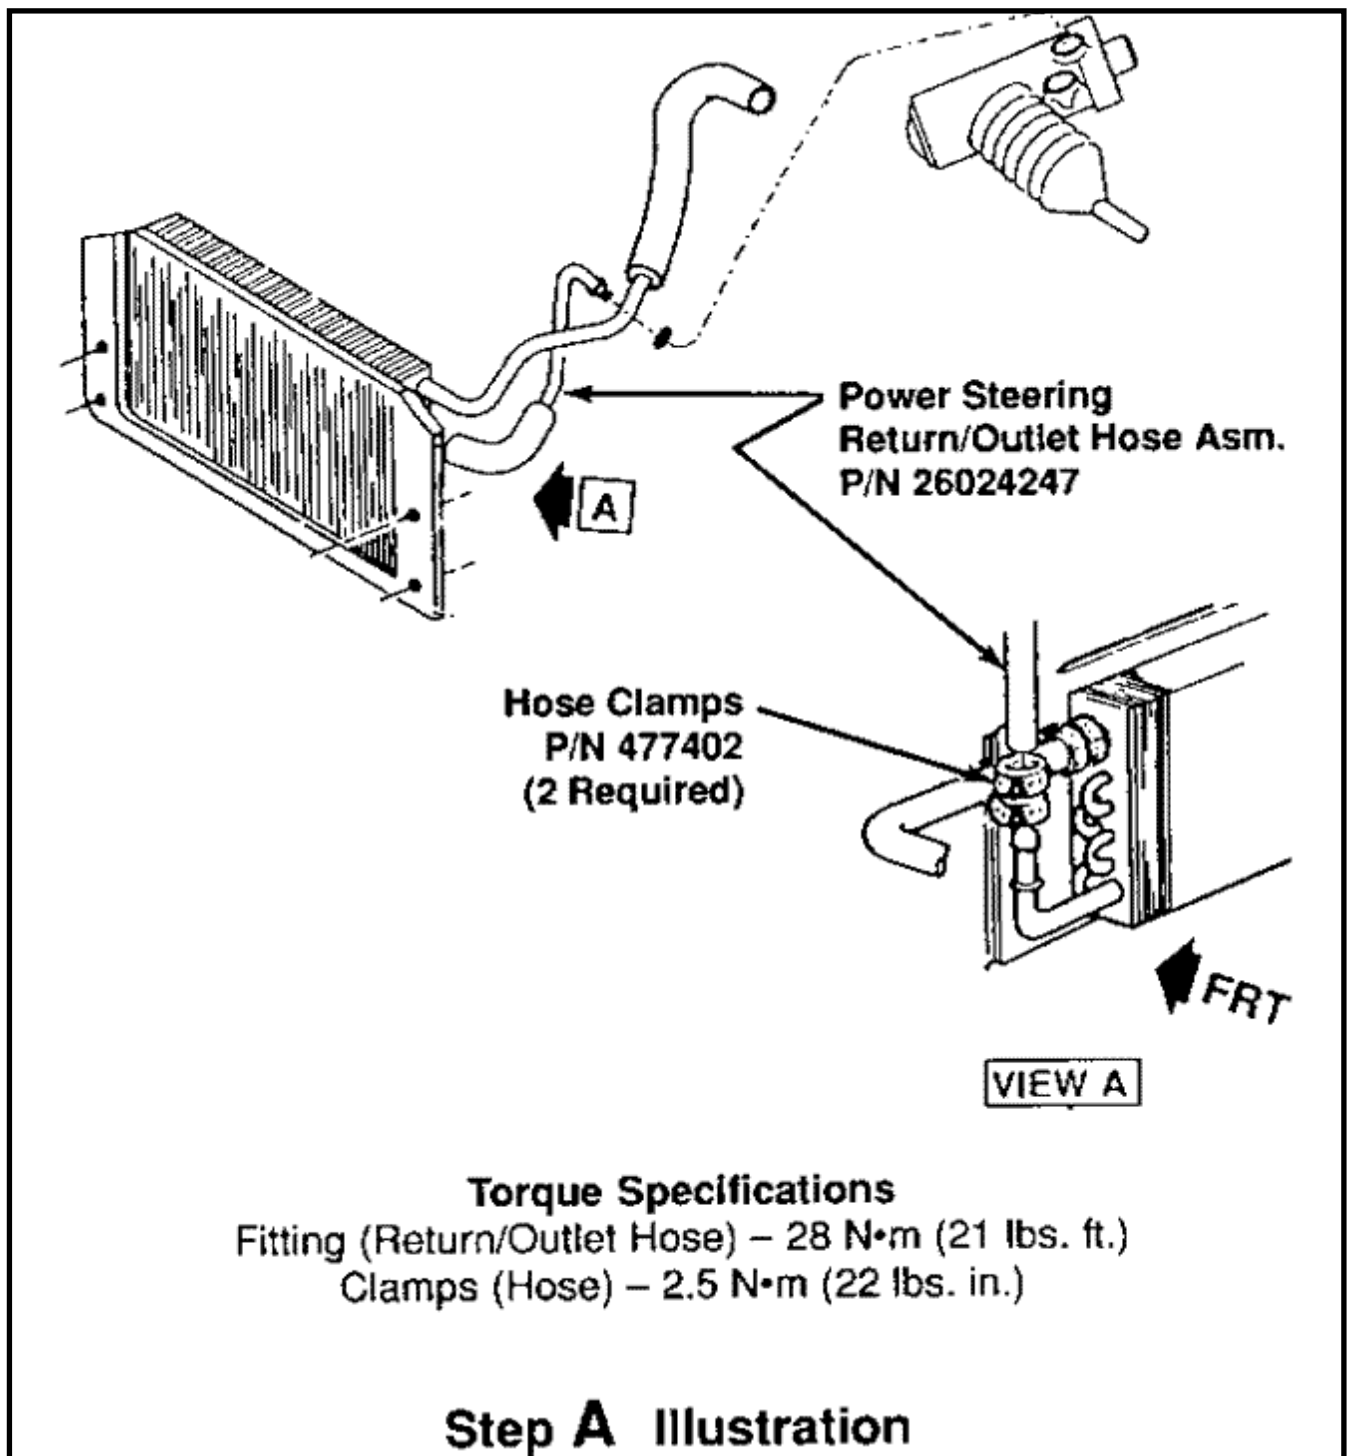
Step B Illustration

Power Steering
Pressure/Inlet Hose Asm.
P/N 262027177

Pipe at Pump End of
Hose Asm. is to be
Against Lower Corner
of Pump

Replace existing pressure/inlet hose (pump to steering gear) with new assembly with internal tuner cable.

Torque Specifications
Fittings (Pressure/Inlet Hose) – 28 N·m (21 lbs. ft.)
