1984 Corvette: Service Bulletin: Rack / Pinion Power Steering Valve Ring Service

Subject: RACK/PINION POWER STEERING VALVE RING SERVICE
Model and Year: 1981-84 CHEVETTE, 1982-84 CAVALIER, CELEBRITY, CITATION AND 1984 CORVETTE
Source: Chevrolet Service Bulletin
Bulletin Number: 84-74 - (06/02/1984)

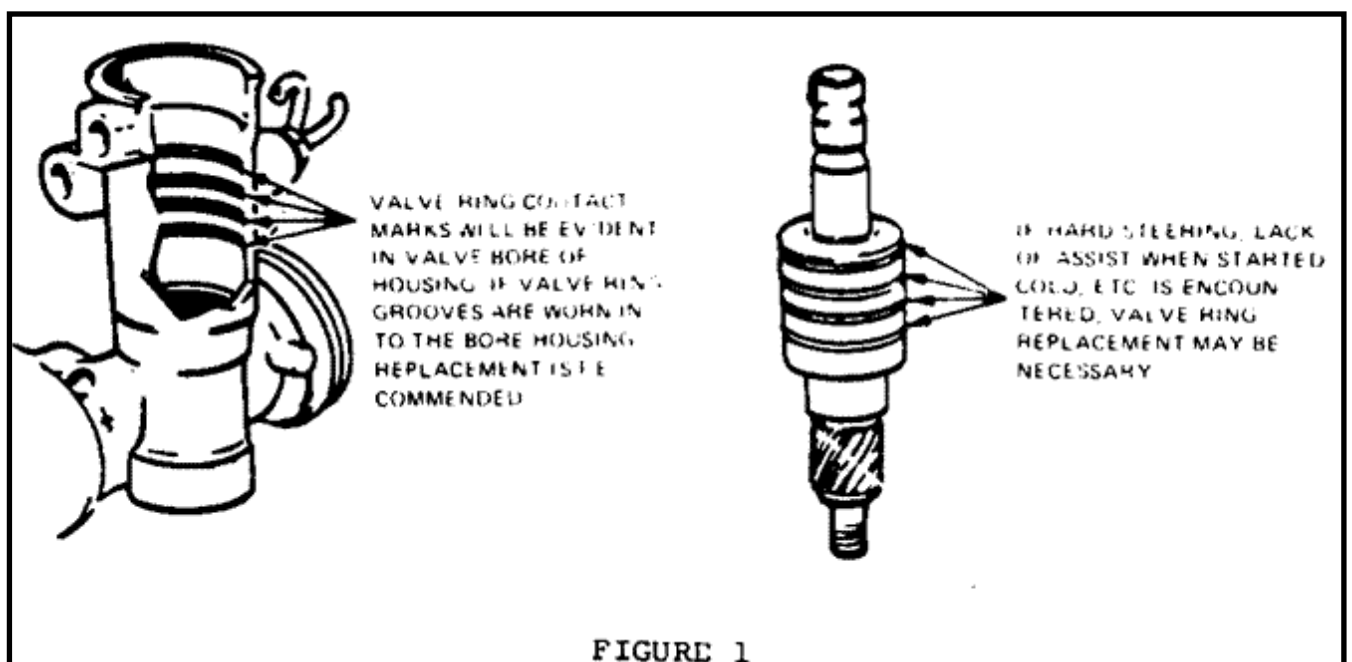
The design intent is that valve rings will remain stationary in the bore of a power rack and pinion assembly. If hard steering, lack of assist when started cold, etc., is encountered with normal pump pressure, inspect the rack and pinion housing valve bore (see illustration).

Ring contact marks in the valve bore is normal. If ring groove wear exists, replacement of the housing is necessary to assure that replacement rings will not eventually wear further into the housing and result in a recurrence of a lack of power assist symptom.

If only one (1) or two (2) of the four (4) ring contact marks in the housing have resulted in ring groove wear, the corresponding ring land of the valve is most likely causing excessive ring drag. Replacement of the valve as well as the housing would then be required.

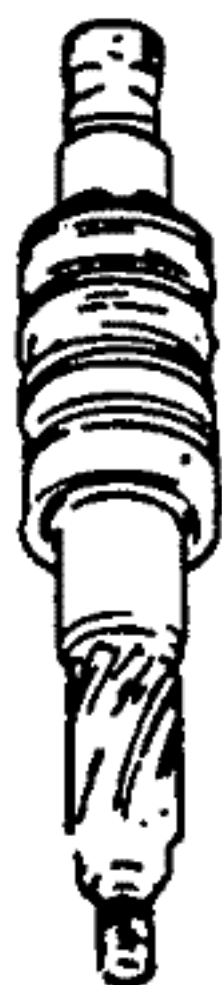
FIGURE 2

The valve and pinion assembly must be pressed out of the housing per Chassis Service Manual procedure. Excessive force or hammer use will likely damage the valve or valve pinion pin. After valve removal, inspect the valve pinion pin for being loose, bent, or protruding beyond the valve machined surface (see illustration). If any of these conditions exist, valve body replacement is required.

Pinion pin must not be bent, loose, or protrude beyond machined surface of valve.

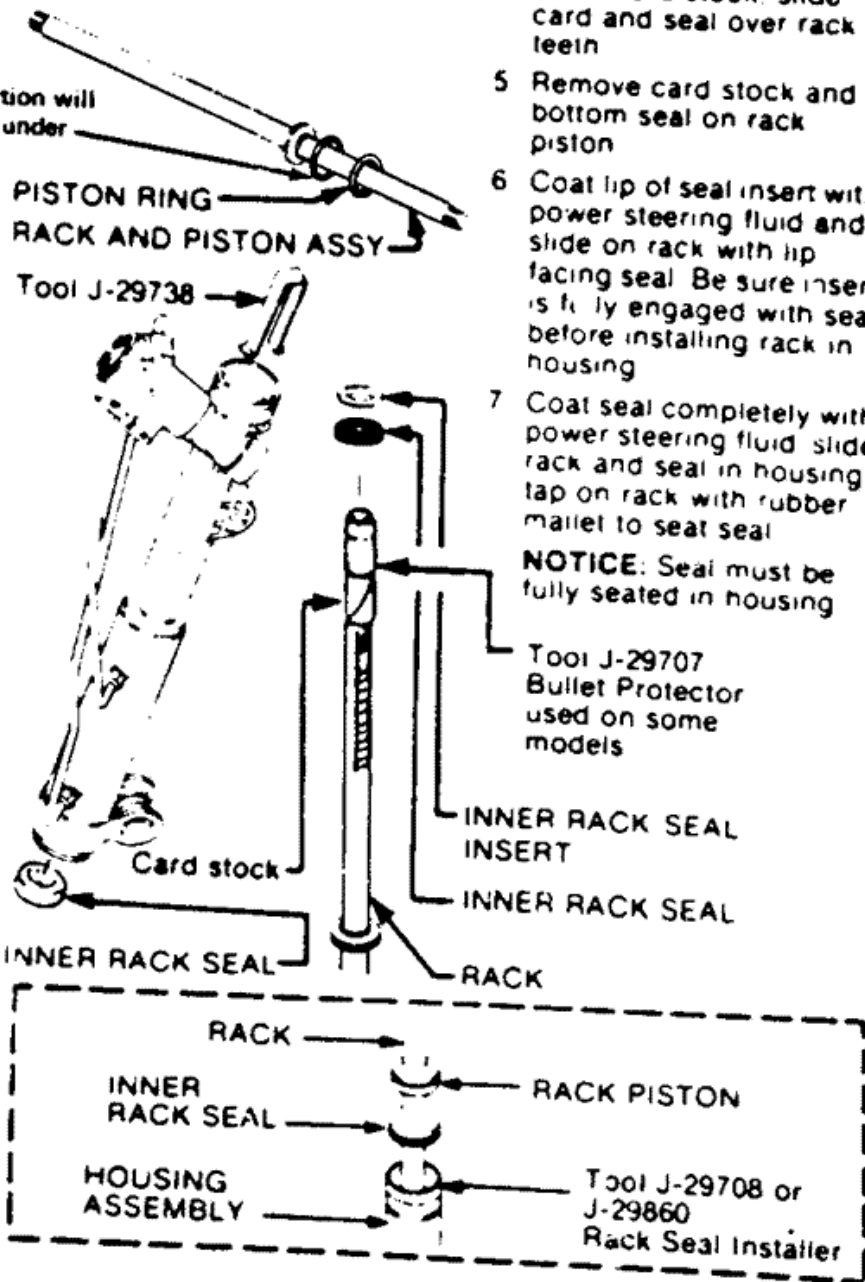
FIGURE 3

A lack of power assist symptom may also be caused by leakage past the rack piston ring in the housing tube bore. Inspect the rack piston ring for damage or distortion. The piston ring to ring land side clearance should not exceed .008". Also inspect the housing tube bore for any nicks, scoring or other imperfection in the rack piston travel area.

Mid 1984 production will have an "O" ring under piston ring.

REMOVE AND INSTALL INNER RACK SEAL, RACK AND PISTON RING

REMOVE

- 1 Remove rack from housing
- 2 Remove piston ring and dispose
- 3 Fit tool J-29738 into housing. Using rod approx 12" long, gently tap on rod until seal is removed
- 4 Dispose of old seal

INSTALL

- 1 Install new piston ring on rack
- 2 Care should be taken not to cut ring at installation
- 3 Wrap card stock around end of rack and rack teeth
- 4 Coat seal lip with power steering fluid, slide seal with seal lip facing piston on to card stock, slide card and seal over rack teeth
- 5 Remove card stock and bottom seal on rack piston
- 6 Coat lip of seal insert with power steering fluid and slide on rack with lip facing seal. Be sure insert is fully engaged with seal before installing rack in housing
- 7 Coat seal completely with power steering fluid, slide rack and seal in housing, tap on rack with rubber mallet to seat seal
