# 1984 Corvette: Service Bulletin: Rack / Pinion Power Steering Valve Ring Service

**Subject:** RACK/PINION POWER STEERING VALVE RING SERVICE  
**Model and Year:** 1981-84 CHEVETTE, 1982-84 CAVALIER, CELEBRITY, CITATION AND 1984 CORVETTE  
**Source:** Chevrolet Service Bulletin  
**Bulletin Number:** 84-74 - (06/02/1984)

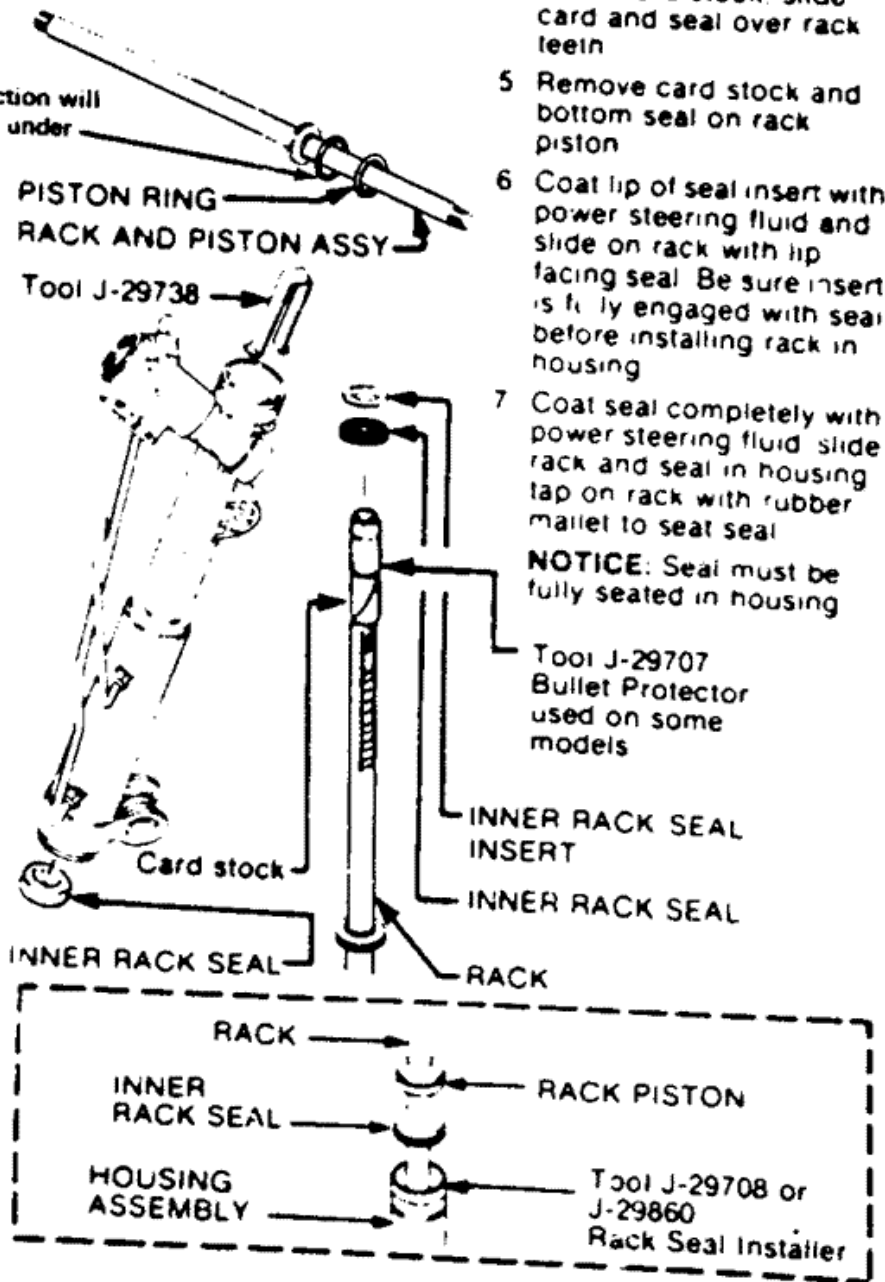
FIGURE 3

Mid 1984 production will have an "O" ring under piston ring.

- 1 Remove rack from housing
- 2 Remove piston ring and dispose
- 3 Fit tool J-29738 into housing. Using rod approx 12" long, gently tap on rod until seal is removed
- 4 Dispose of old seal

- 1 Install new piston ring on rack
- 2 Care should be taken not to cut ring at installation
- 3 Wrap card stock around end of rack and rack teeth
- 4 Coat seal lip with power steering fluid, slide seal with seal lip facing piston on to card stock, slide card and seal over rack teeth
- 5 Remove card stock and bottom seal on rack piston
- 6 Coat lip of seal insert with power steering fluid and slide on rack with lip facing seal. Be sure insert is fully engaged with seal before installing rack in housing
- 7 Coat seal completely with power steering fluid, slide rack and seal in housing, tap on rack with rubber mallet to seat seal
