1984 Corvette: Recall: Rear Axle Differential Cross Shaft Retention

Subject: REAR AXLE DIFFERENTIAL CROSS SHAFT RETENTION

Model and Year: 1984 CHEVROLET CORVETTE MODELS

Bulletin Number: 84-C-25 - (09/20/1985)

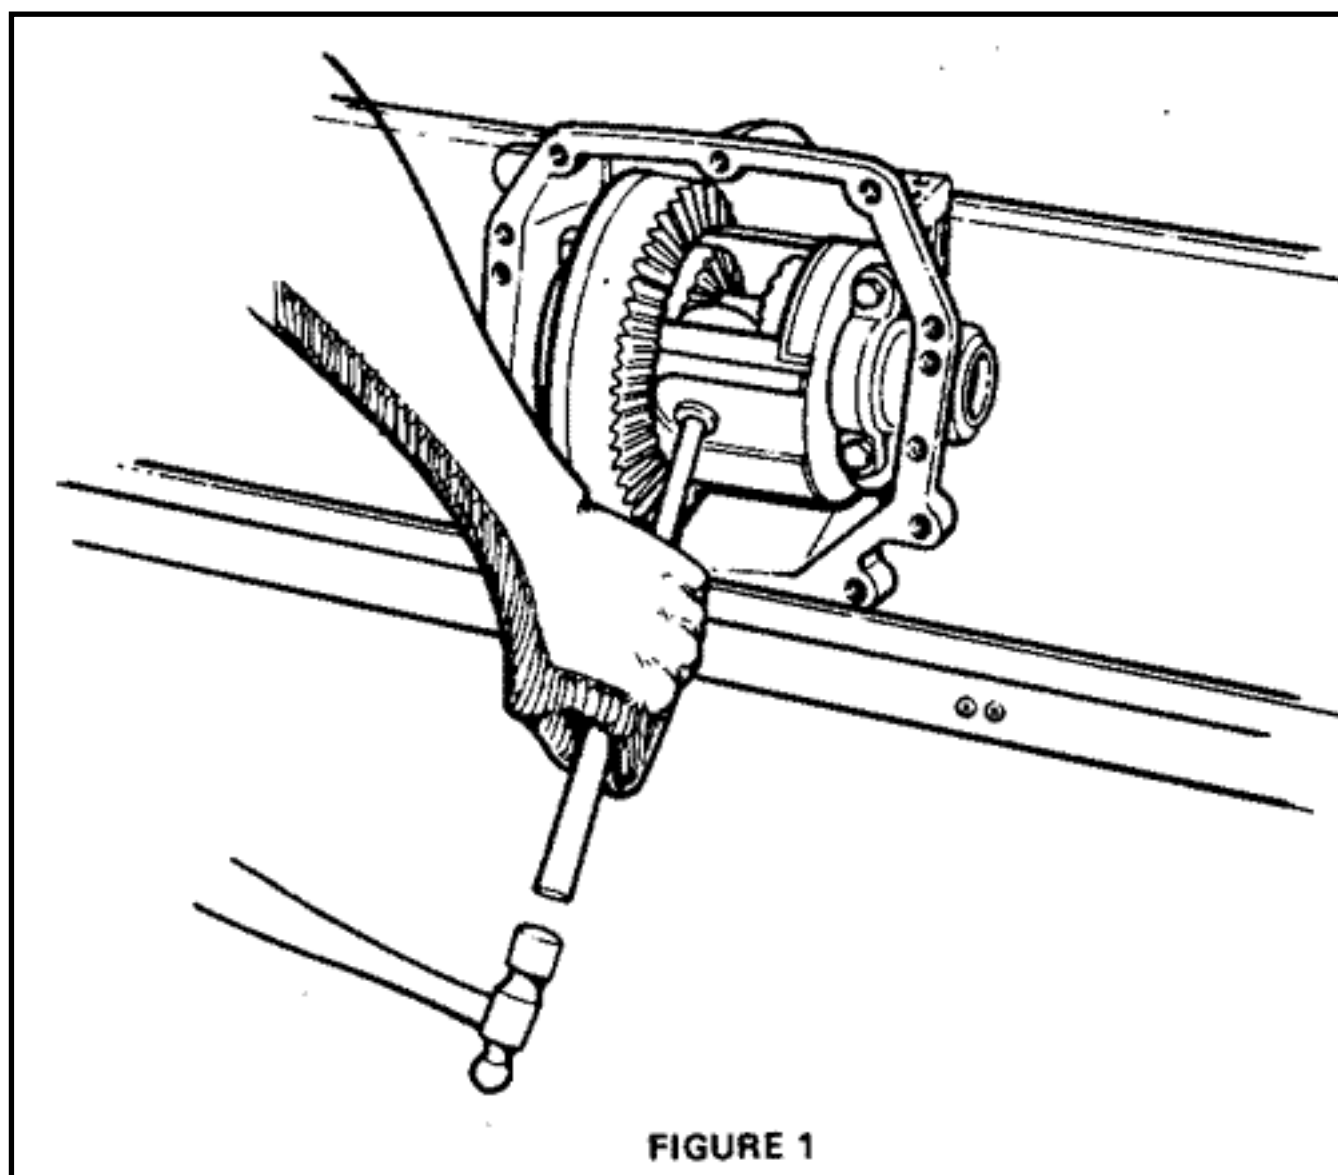
5. Rotate case assembly to position illustrated in Figure 1. With appropriate size drift and small mallet, lightly tap on cross shaft to determine if movement of shaft can be achieved.
