1992 Corvette: Service Bulletin: Brake Pedal Not Fully Returning / Stop Lights Stay On and/or Roughness/Vibration From Rear of Vehicle

Model and Year: 1992 CHEVROLET CORVETTE

Source: Chevrolet Service Bulletin

Bulletin Number: 92-71A-5 - (01/31/1992)

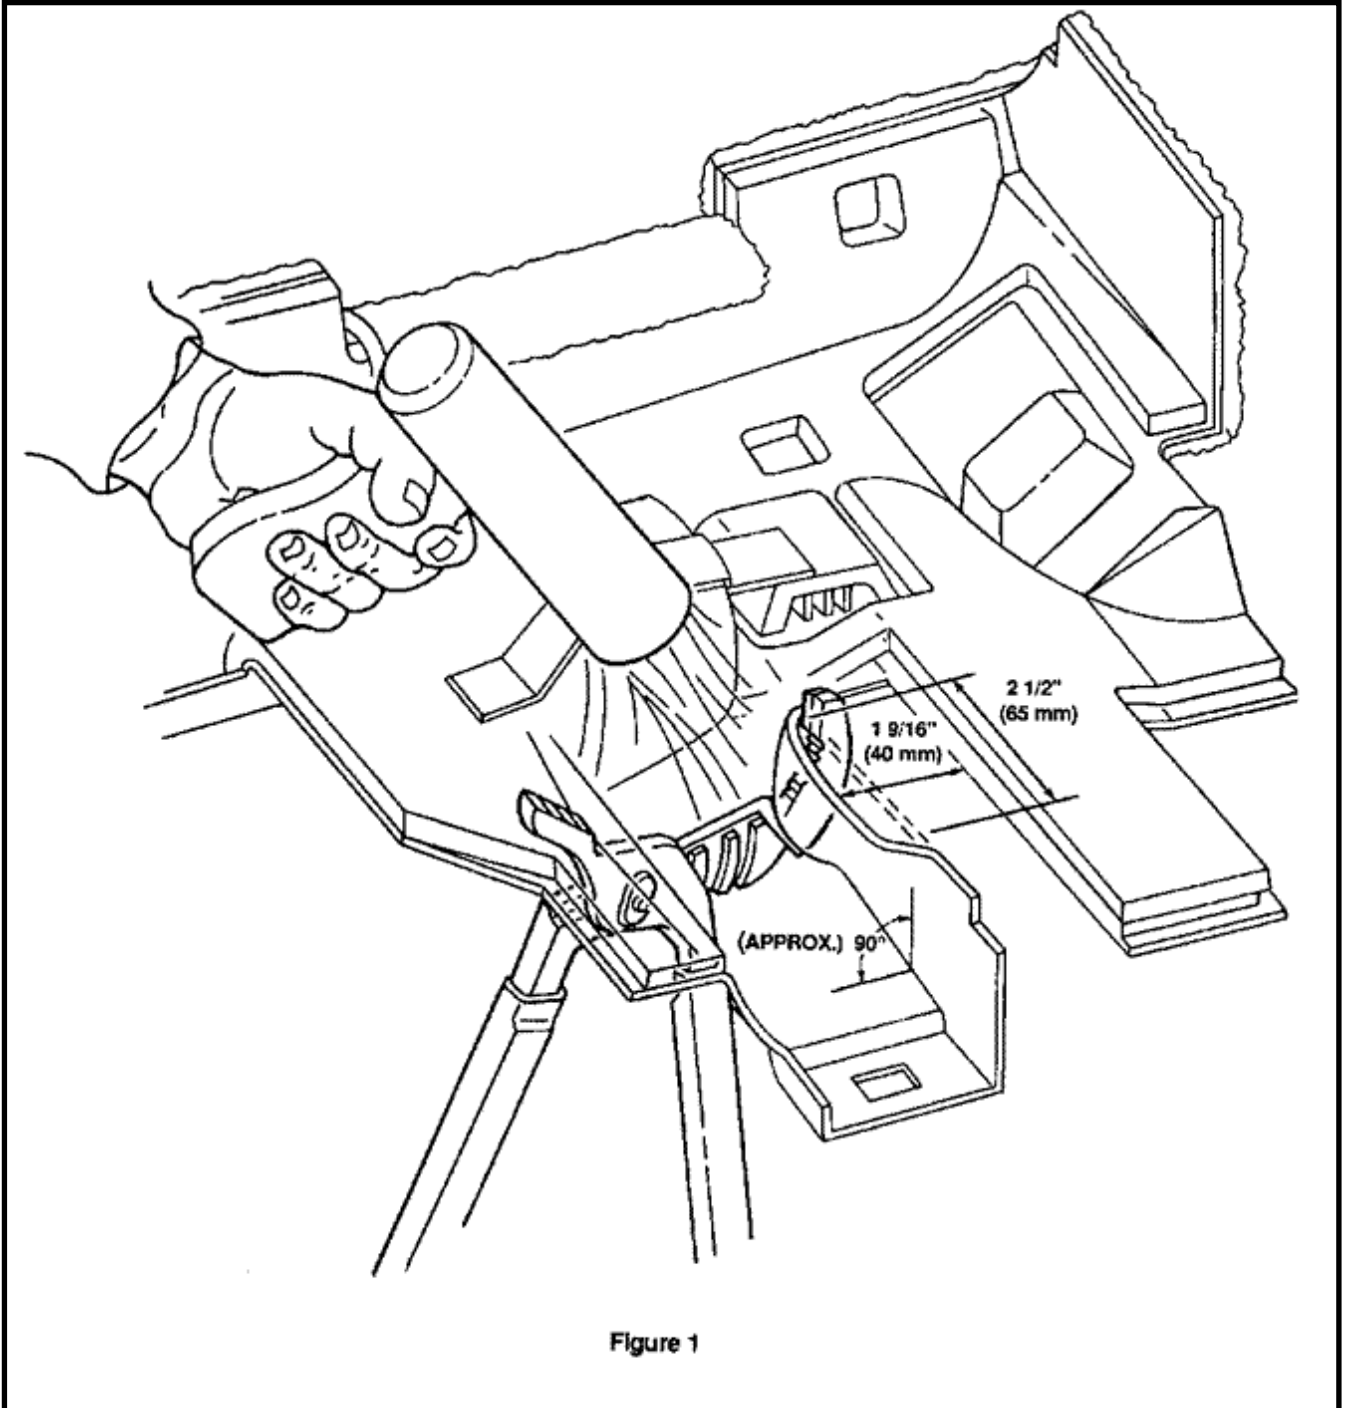
Some 1992 Y-car base Corvettes built from SOP to VIN breakpoint 104324 and ZR1's built from SOP to VIN breakpoint 800193 may exhibit inadequate clearance between the brake service pedal arm and the I/P lower trim panel.

1. Remove LH lower trim panel (per Service Manual, Section 8C-33).
2. Lift away the foam sound deadener from area shown in Figure #1, and tape out of the way.
3. Using a heat gun, warm the trim panel area shown in Figure #1 (USE CARE TO WARM COMPLETE AREA EVENLY).
4. Using Channel Locks (R) size 16 or larger, place near the upper LH corner of the I/P lower trim panel as shown in Figure 1. Quickly reform the brake pedal opening to configuration and dimensions indicated in illustration. If necessary Channel Locks may be moved downward during initial reforming and/or Steps 3 and 4 may be repeated to obtain minimum clearance of 2mm between the brake service pedal arm and the I/P trim panel.

Note: To lessen Channel Lock imprint, place smooth shim stock or aluminum face cover between the Channel Lock face and the warmed surface on the trim panel.

5. Reinstall lower trim panel. Remeasure the clearance between trim panel and the brake pedal arm, using method stated in correction above.
6. If contact still exists, phone Action Center #1 -800-457-8388.
