1992 - 1993 Corvette: Service Bulletin: Cracks/Damage to Cowl Surface

Subject: CRACKS OR DAMAGE TO COWL SURFACE

Model and Year: 1992-93 CORVETTE WITH RPO LT1 ENGINES ONLY

Bulletin Number: 93-134-10

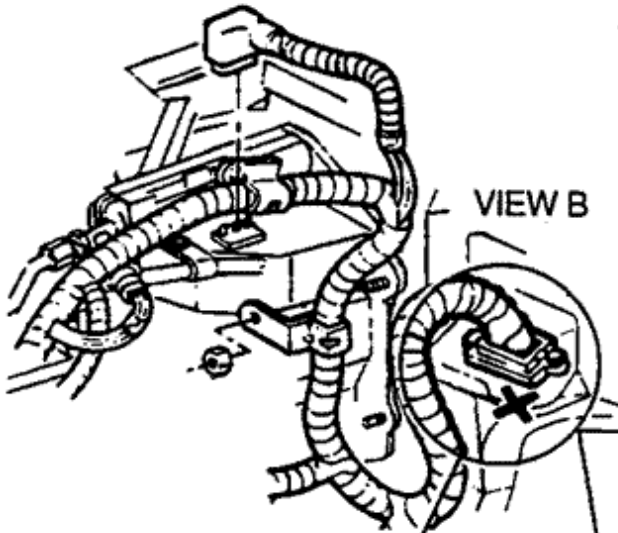
VIEW B

Some 1992-93 Y-cars with LT1 engines may have cracks or damage to the cowl surface:

- Behind the right cylinder head, - Below the wiring harness connector.

Rear of engine may contact the cowl surface when removing transmission or engine from vehicle.

- c. Remove bolts on rear of intake manifold, use 10 mm 1/4" drive socket and flex extension.
 - d. Remove hose and plastic clamp from check valve.
5. Clean damaged area (See View B) with a wax and grease remover and use V.O.C. approved materials where required.

6. Apply enough seam sealing material to fill or cover the damaged area. Paddle material into place, if required.
7. Loosen the harness connector attaching bolts, position GM P/N 10231336 - Spacer, over the damaged area and under the attaching bolt heads and tighten the attaching bolts. The spacer has slots to aid in installation (See View C).

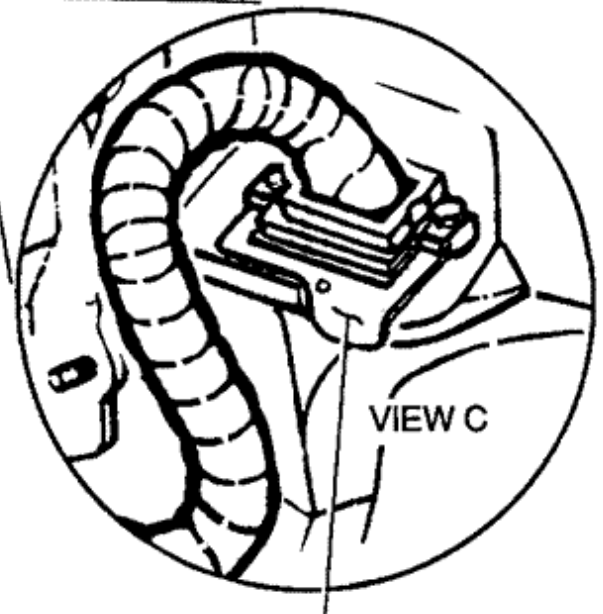
VIEW C

NEW PART IN POSITION
OVER DAMAGED AREA
