1989 - 1990 Corvette: Service Bulletin: Convertible Stowage Lid Not Flush With Rear Deck

Source: Chevrolet Dealer Service Bulletin

Number: 90-183-10 - (02/20/1990)

Subject: STOWAGE LID NOT FLUSH W/REAR DECK-PROCEDURE & STEEL RIVETS

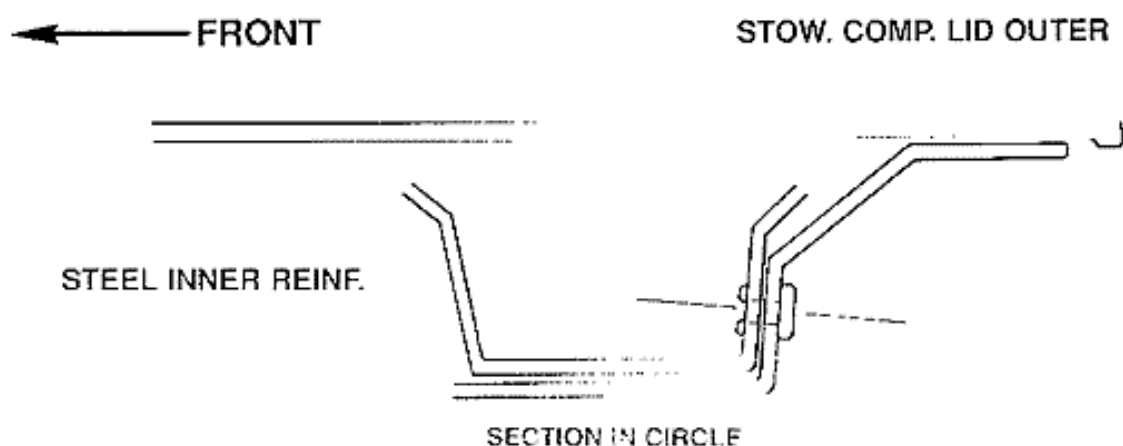
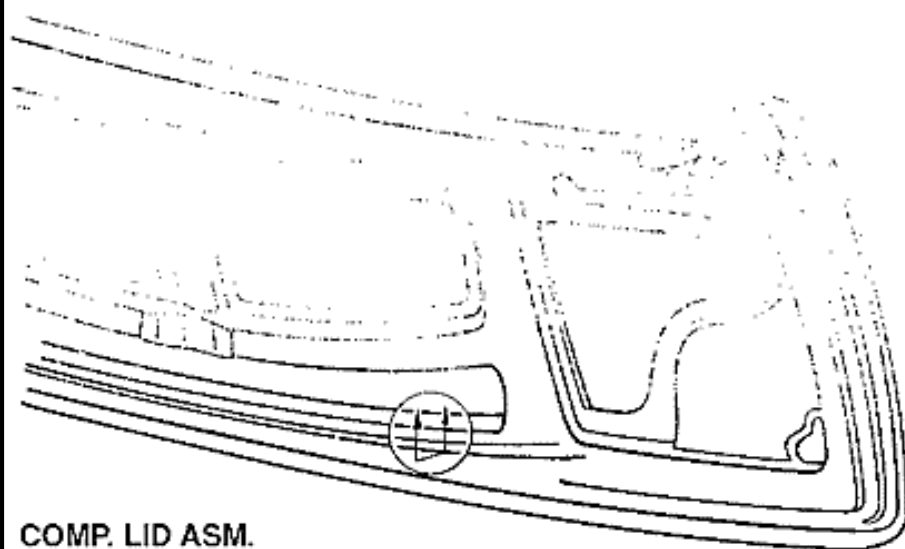
Some 1989 and early 1990 Chevrolet Corvette Convertibles may exhibit a height difference between the stowage compartment lid and the rear deck. This condition may be caused by a lack of adhesive between the steel inner reinforcement and the stowage compartment lid inner panel.

1. Remove the stowage lid as outlined in the Service Manual.
2. Drill 8 (eight) equally spaced 1/8 inch holes through the vertical surface (See Figure 1) of the stowage lid inner panel and the reinforcement.

1. REMOVE STORAGE COMPARTMENT LID FROM VEHICLE AND LAY UPSIDE DOWN ON A CLEAN PROTECTED SURFACE.
2. HOLD WEATHERSTRIP OUT OF THE WAY AND DRILL EIGHT (8) $1/8$ " HOLES IN BACK SIDE THROUGH INNER PANEL AND STEEL REINFORCEMENT (4 HOLES ON EACH SIDE OF CENTER EQUALLY SPACED).
3. INSTALL APPROPRIATE TAPPING SCREW ($5/16$ " LONG) OR STEEL RIVET ($1/8$ " X $1/4$ ").
