1984 - 1993 Corvette: Service Bulletin: Rear Lift Window Hard to Open/Hinge Loose to Glass

Model and Year: 1984-1993 Corvette

Bulletin Number: 93-131-10

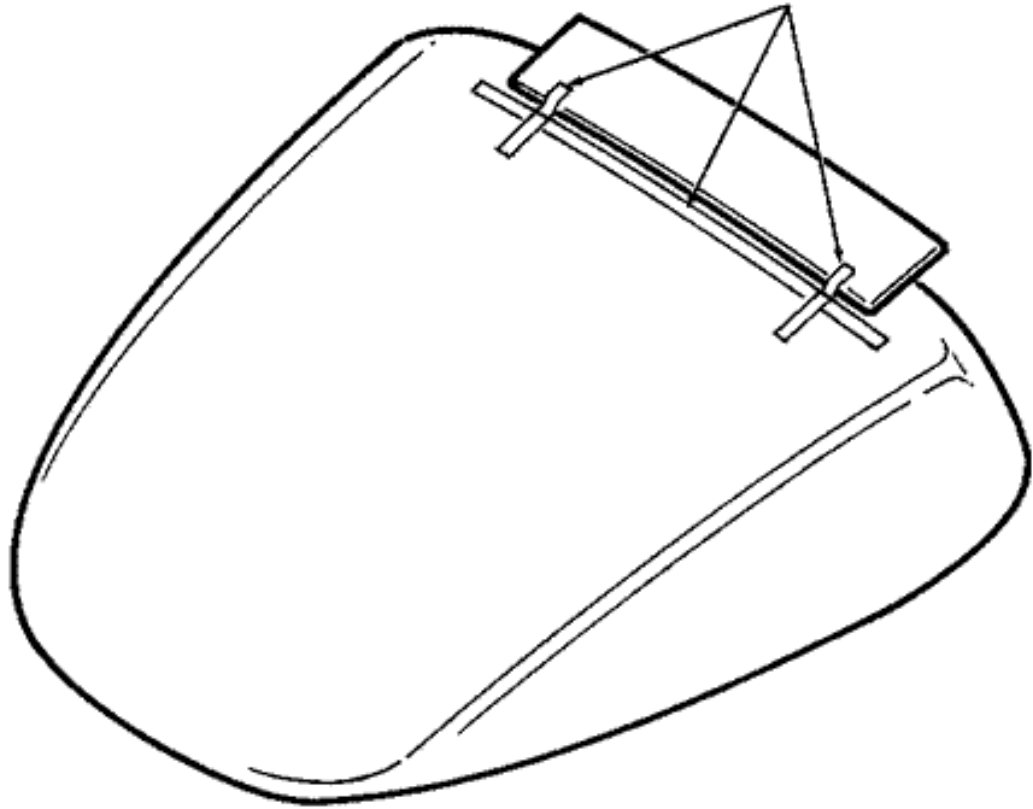
FIGURE 1

MASKING TAPE INSTALLED FOR ALIGNMENT

Apply three pieces of tape to the glass for alignment of the hinge plate to the glass after the glass is removed from the vehicle. Cut the tape spanning the glass and hinge plate as shown in Figure 1.

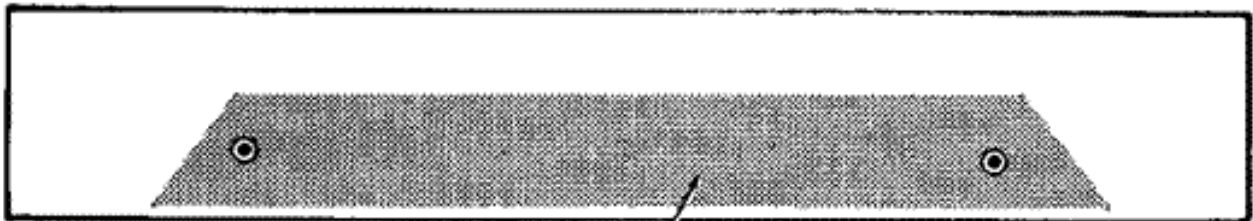
FIGURE 2

SHADED AREA SHOWS AREA TO BE SANDED

12. While primer is drying, Sand the painted surface of the hinge plate with 120 grit sand paper to remove the primer (SEE FIGURE 2). Clean hinge surface with glass cleaner and let dry.
